Deepwater Horizon

**Mississippi Canyon Block 252
Macondo Well**

BP internal investigation

BP has published its internal investigation team's report into the accident on the Deepwater Horizon rig in the Gulf of Mexico on 20 April 2010.

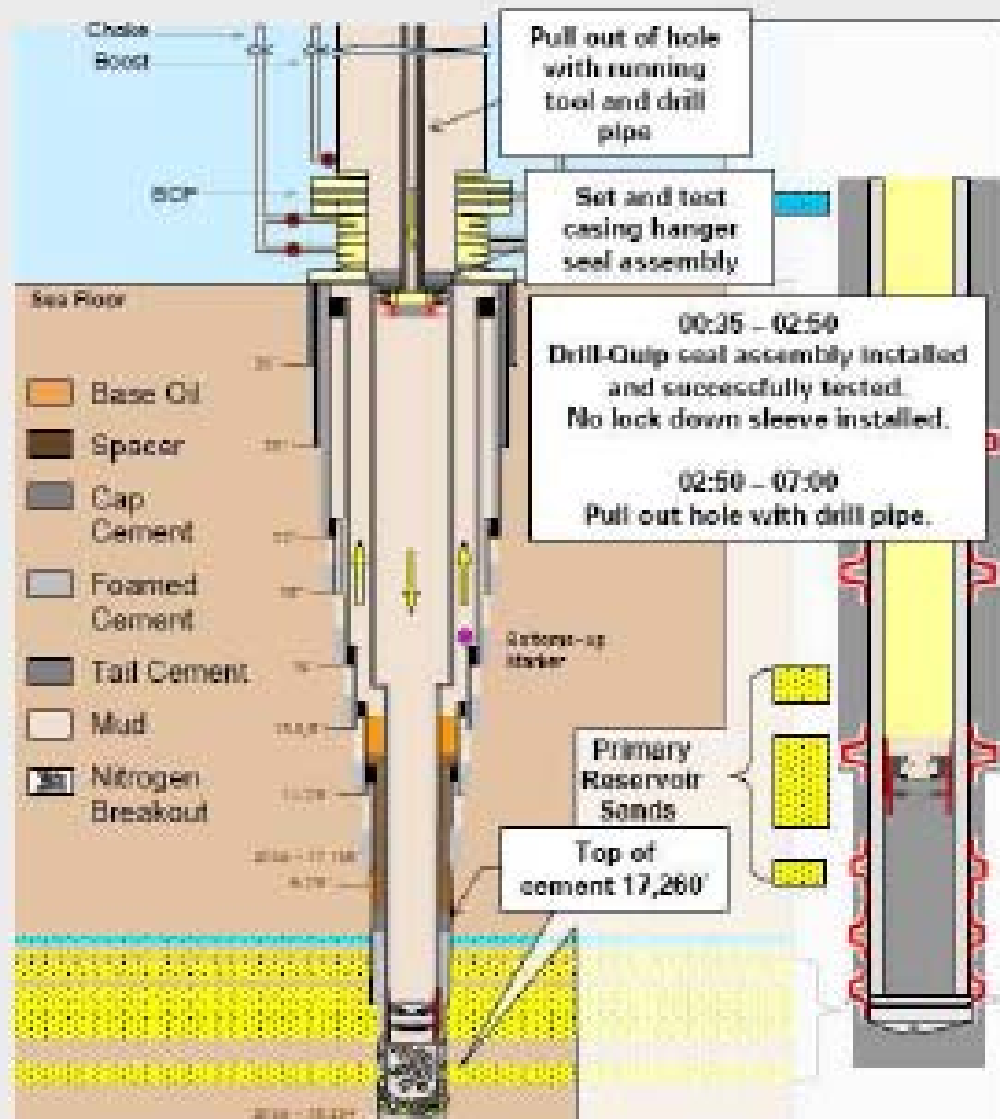
Cement Job

- Nitrogen cement slurry chosen
 - To achieve light weight slurry due to limited pore pressure / fracture gradient window
- Possible risk
 - Stability of foam
 - Relatively small volume
 - Susceptible to contamination
- Mitigation of risk by
 - Thorough testing of slurry design
 - Precise placement
- Centralization
 - 6 inline centralizers spaced across the reservoir sands
 - Additional centralizers not run because incorrectly thought to be wrong type
 - Risk of channeling above reservoir sands known and accepted

The annulus cement barrier did not isolate the reservoir hydrocarbons

- Foam slurry recommended was a complex design
- Risk of contamination using small volume of cement
- No fluid loss additives
- Incomplete pre-job cement lab testing
- Foam slurry was likely unstable and resulted in nitrogen breakout

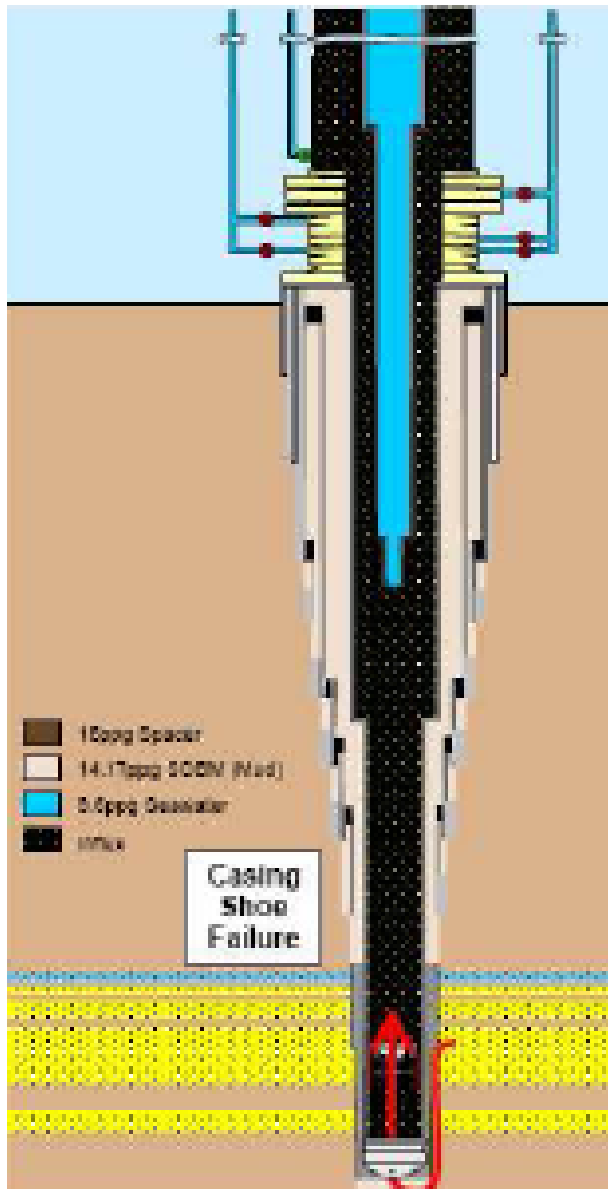
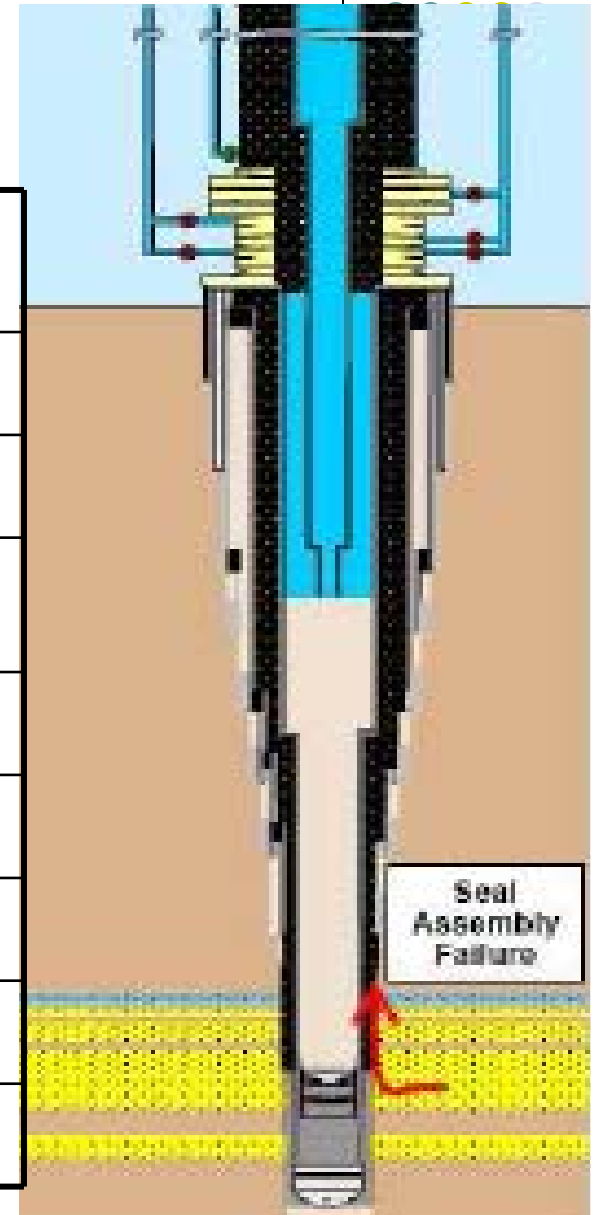
Flow through shoe trak – supporting evidence

Casing shoe failure	Key observations for flow through shoe vs seal assembly	Seal assembly failure
Y	Mechanical barrier failure mode identified	Y
Y	Realistic net pay assumption	N
Y	1400 psi recorded on drill pipe during negative test at 18:30	N
Y	Ability to flow from 20:58	N
Y	Pressure increase from 21:08 to 21:14	N
Y	Pressure response from 21:31 to 21:34	N
Y	Timing for gas arrival to surface	N
Y	Static kill	N

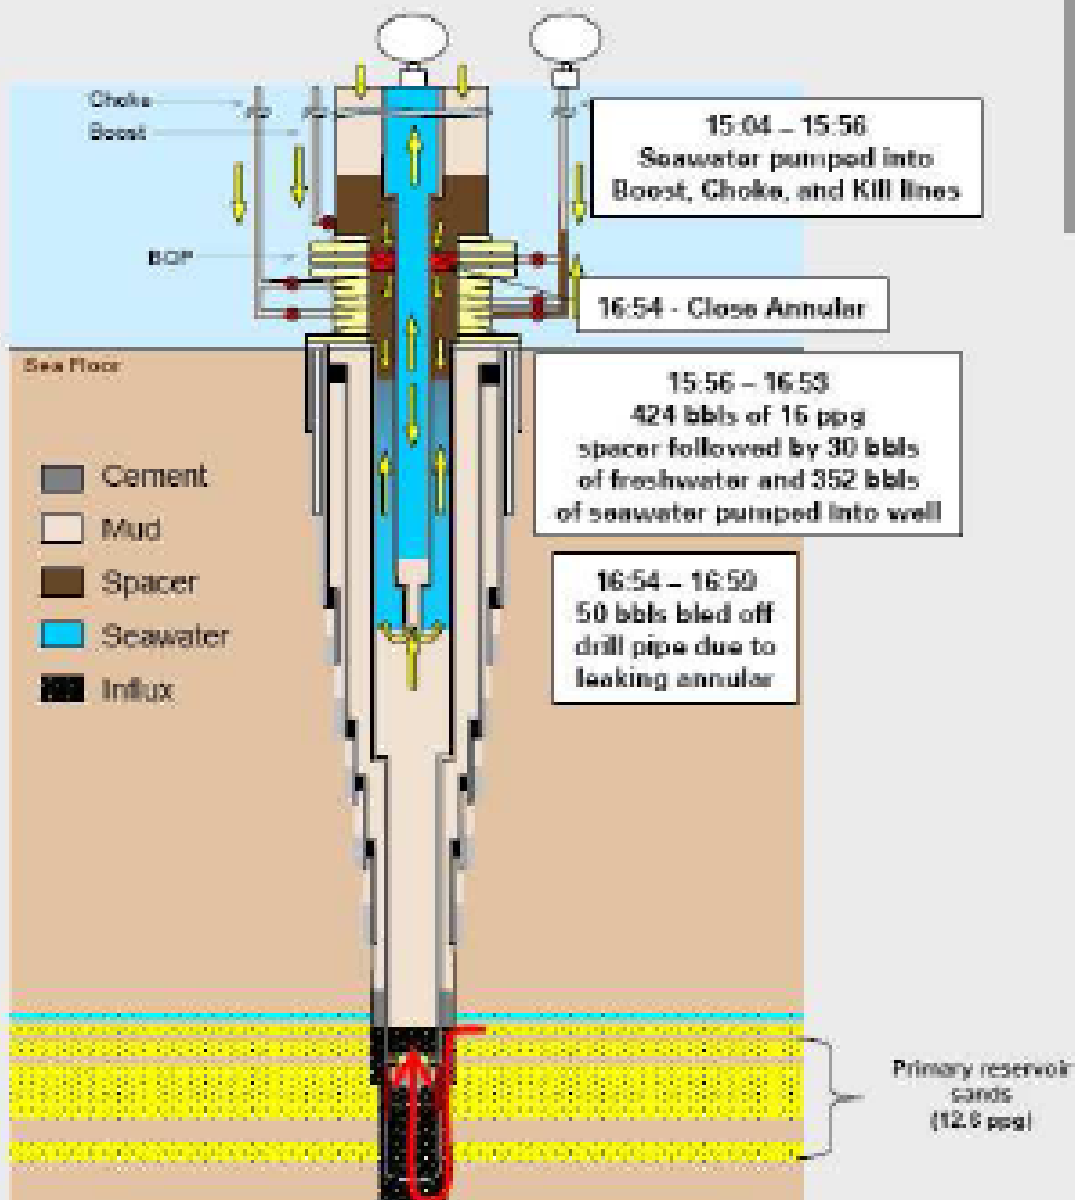
Negative Pressure Test

- Negative test simulates underbalanced condition
- Spacer used between mud and seawater
- Leaking annular at start of test moved spacer across kill line inlet
- Negative test started on drill pipe but changed to kill line
- Bleed volumes higher than calculated
- Drill pipe built pressure to 1400 psi with no flow on the kill line

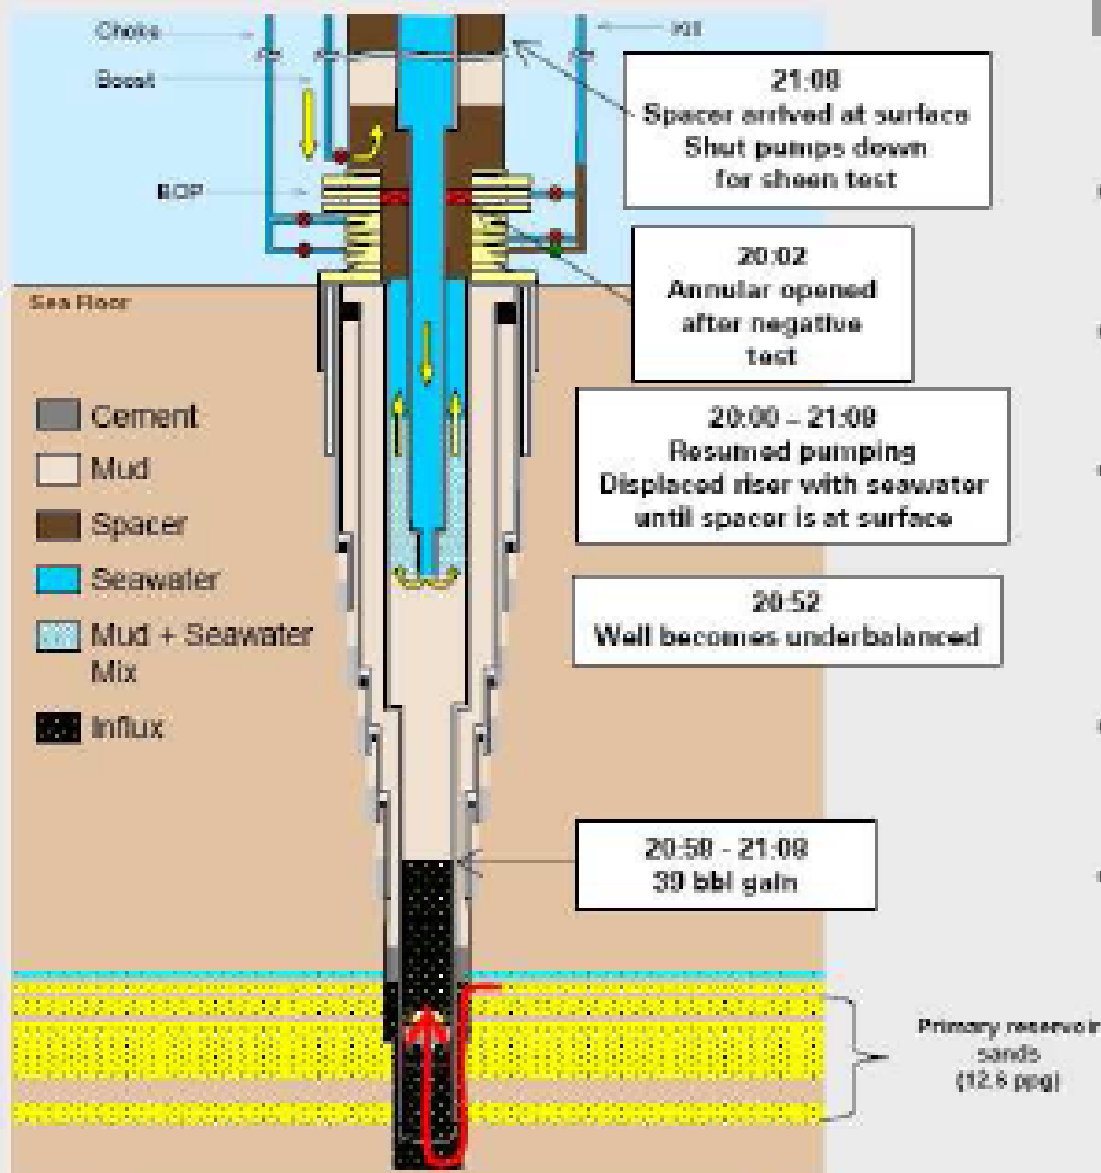
Undetected Flowing Conditions

- 20:02 Resume displacement of mud with seawater
- 20:52 Well becomes underbalanced and starts to flow
- After 20:58 gain being taken and pressure begins increasing
 - Flow from well masked by emptying of trip tank
- 21:08 Pumping stops for sheen test
 - Pressure increases with pump off
- 21:14 Sheen test complete, displacement resumes

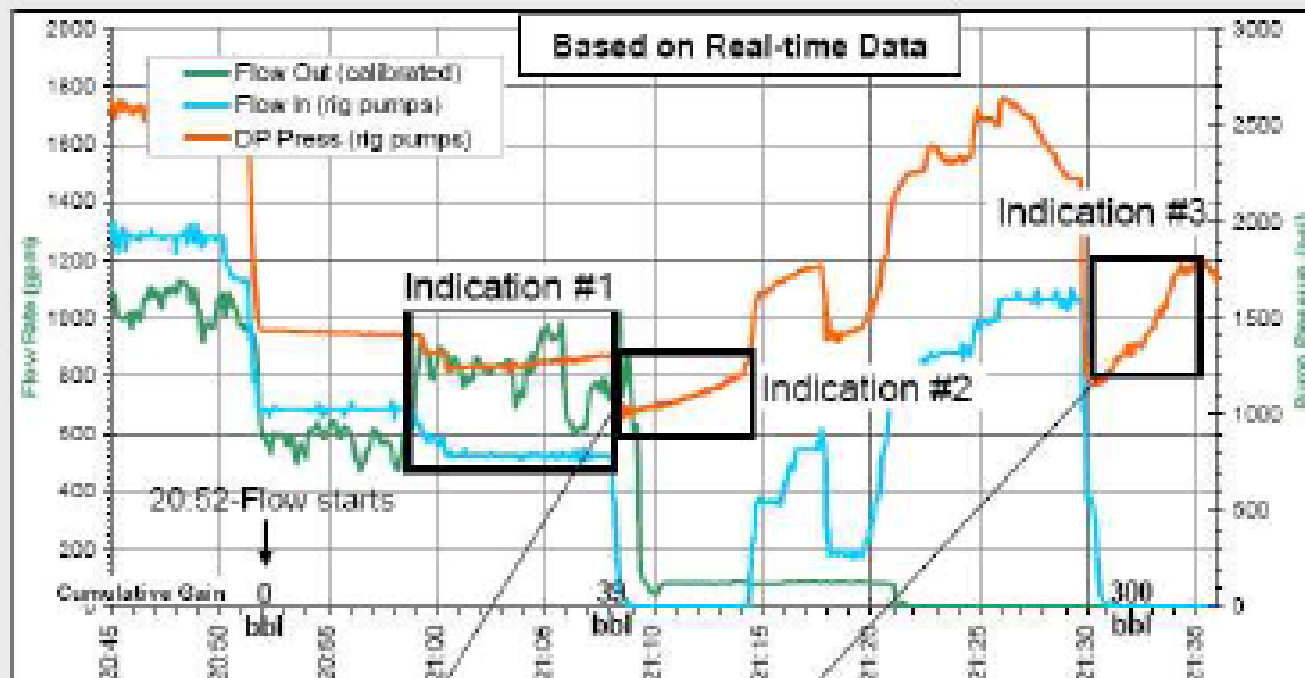
The influx was not recognized until hydrocarbons were in the riser

- #1: Drill pipe pressure increased by 100 psi, (expected decreased); ~39 bbl gain from 20:58 to 21:08
- #2: Drill pipe pressure increased by 246 psi with pumps off
 - Flow out does not immediately drop after shutting down pump
- #3: Drill pipe pressure increased by 556 psi with pumps off; ~300 bbl gain
- No well control actions taken

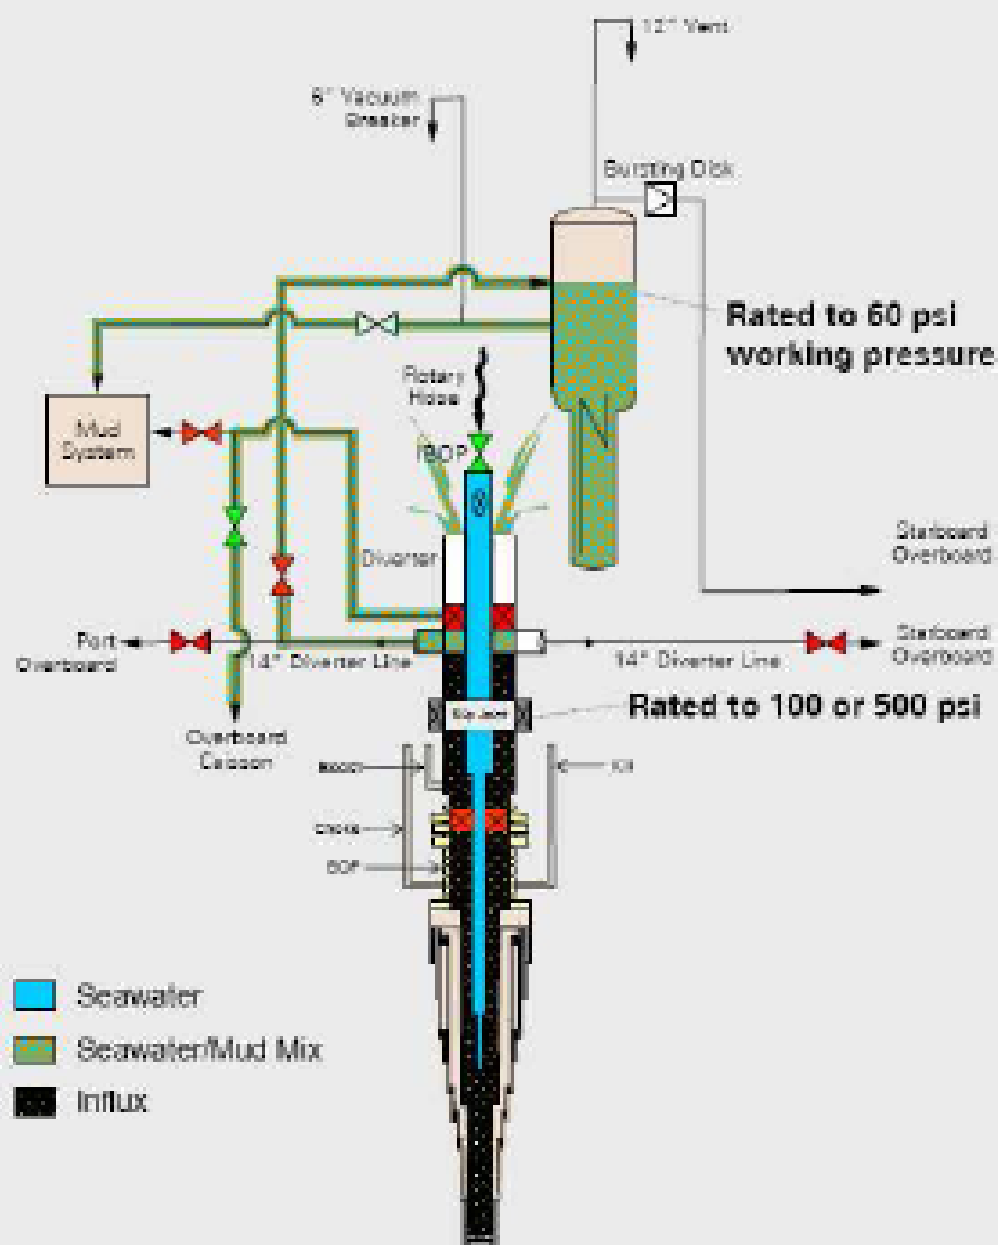
Diversion to the MGS

- Rig crew has the option to divert flow to port/starboard overboard lines or the MGS
- Diverting to port or starboard will result in fluids venting overboard
- Liquid outlet from MGS goes to the Mud System under the main deck

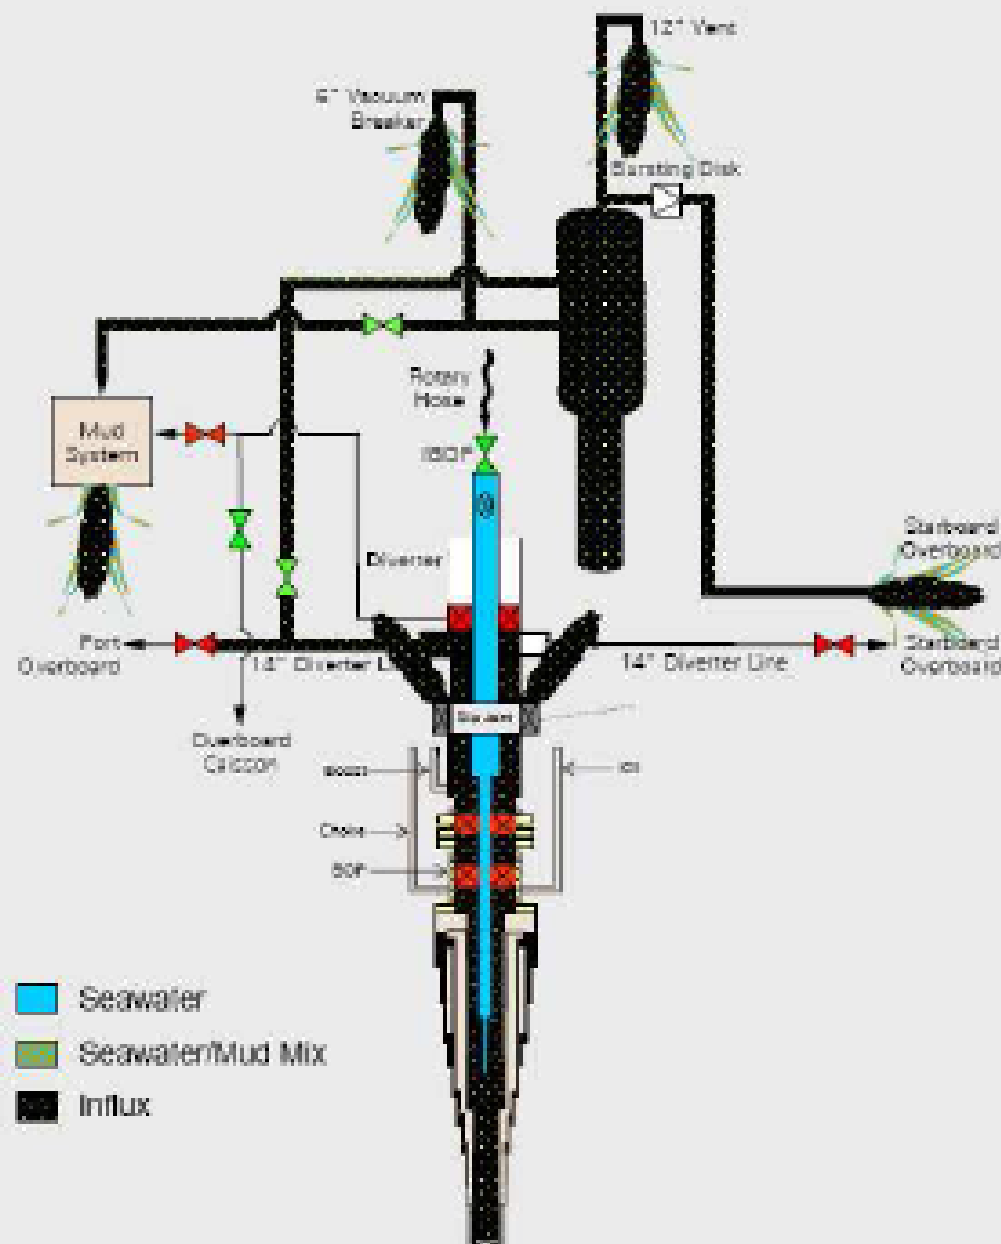
Gas flow to Surface at high rate: 21:46 to 22:00

- Instantaneous gas rates reached 165 mmscfd
- Pressures exceeded operating ratings (above 100 psi)
- Gas would probably have vented from:
 - Slip joint packer into the moon pool
 - 12" MGS "gooseneck" vent
 - 6" MGS vacuum breaker vent
 - 6" overboard line through burst disk
 - 10" mud line under the main deck

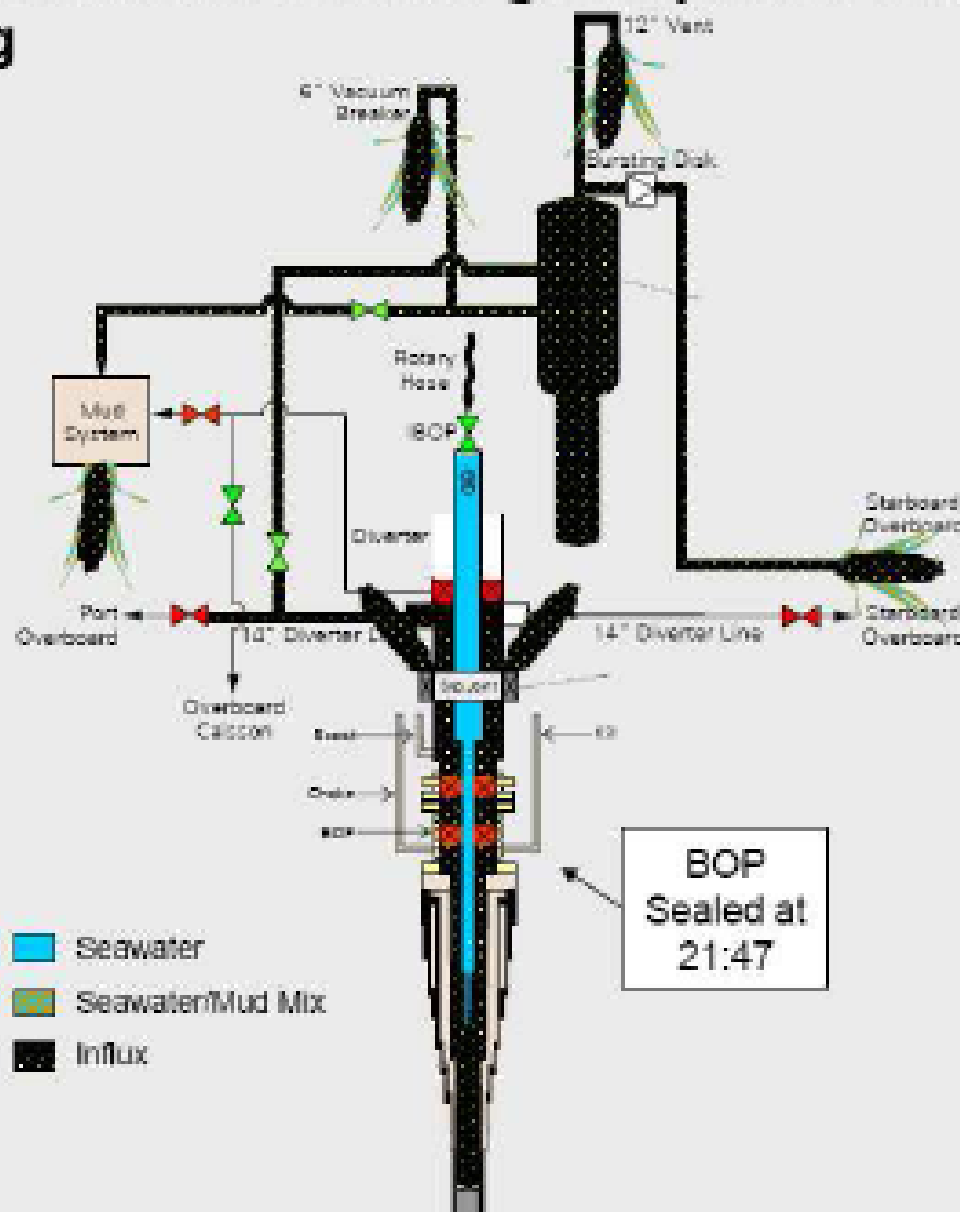
Diversion to the mud gas separator resulted in gas venting onto the rig

- Hydrocarbons were routed to the mud gas separator instead of diverting overboard
- Resulted in rapid gas dispersion across the rig through the MGS vents and mud system

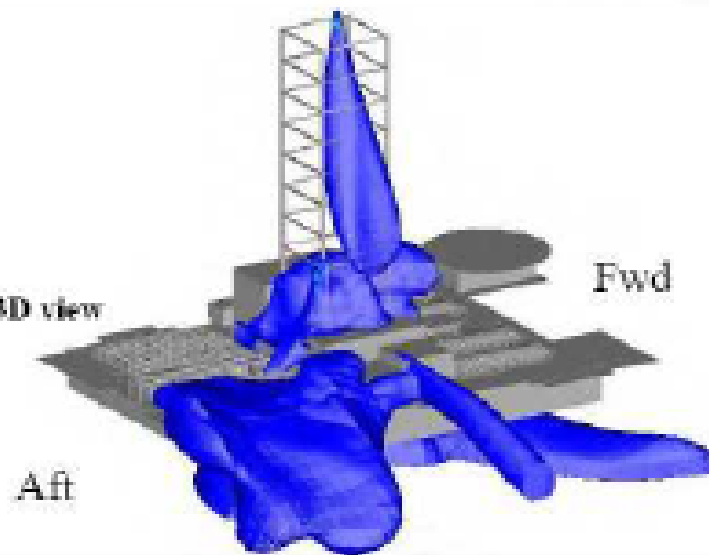
The fire and gas system did not prevent hydrocarbon ignition

- Gas dispersion beyond electrically classified areas
- Gas ingress into engine rooms via main deck air intakes
- The on-line engines were one potential source of ignition

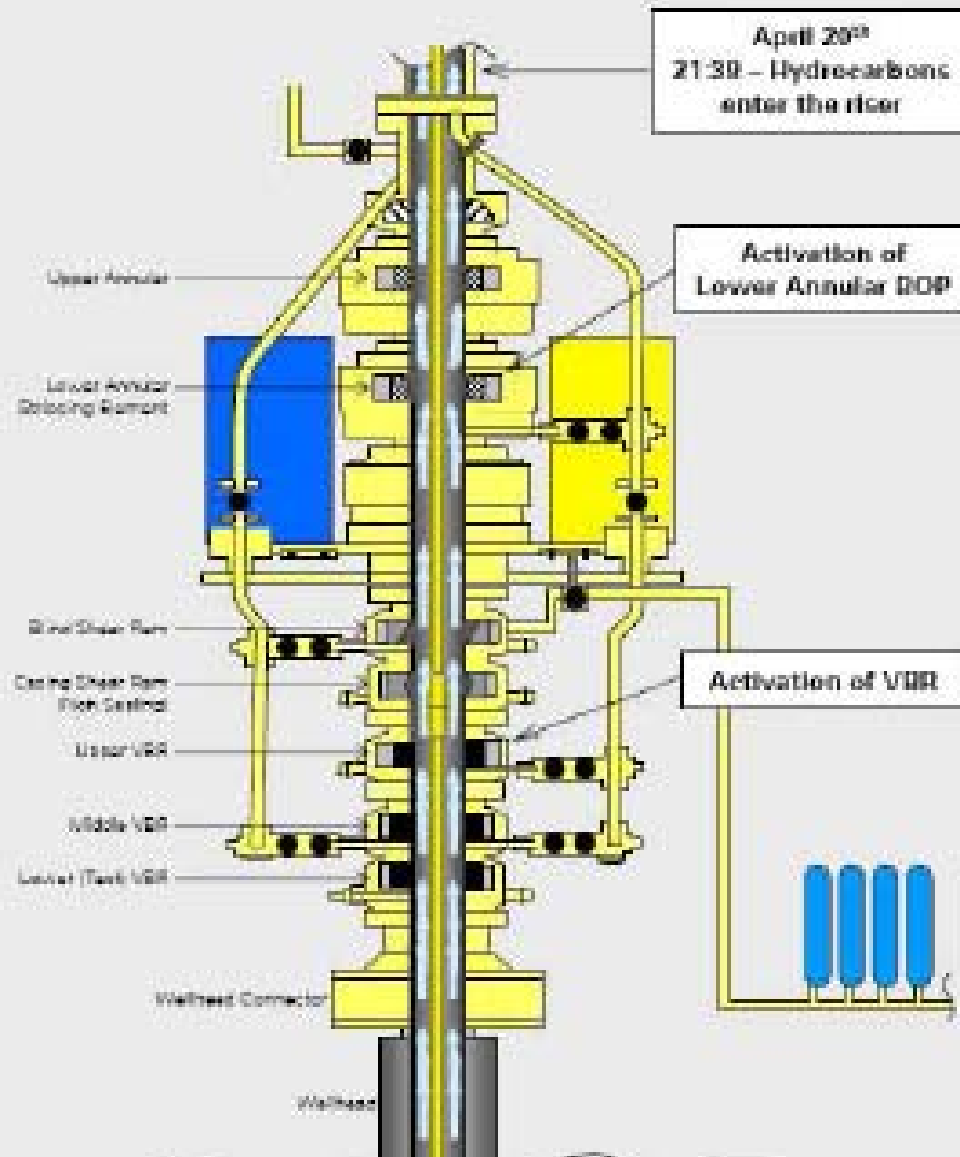
BOP Response (Before the Explosions)

- 21:41 annular BOP closed but appears not to have sealed the annulus
- 21:47 a VBR likely closed and sealed the annulus

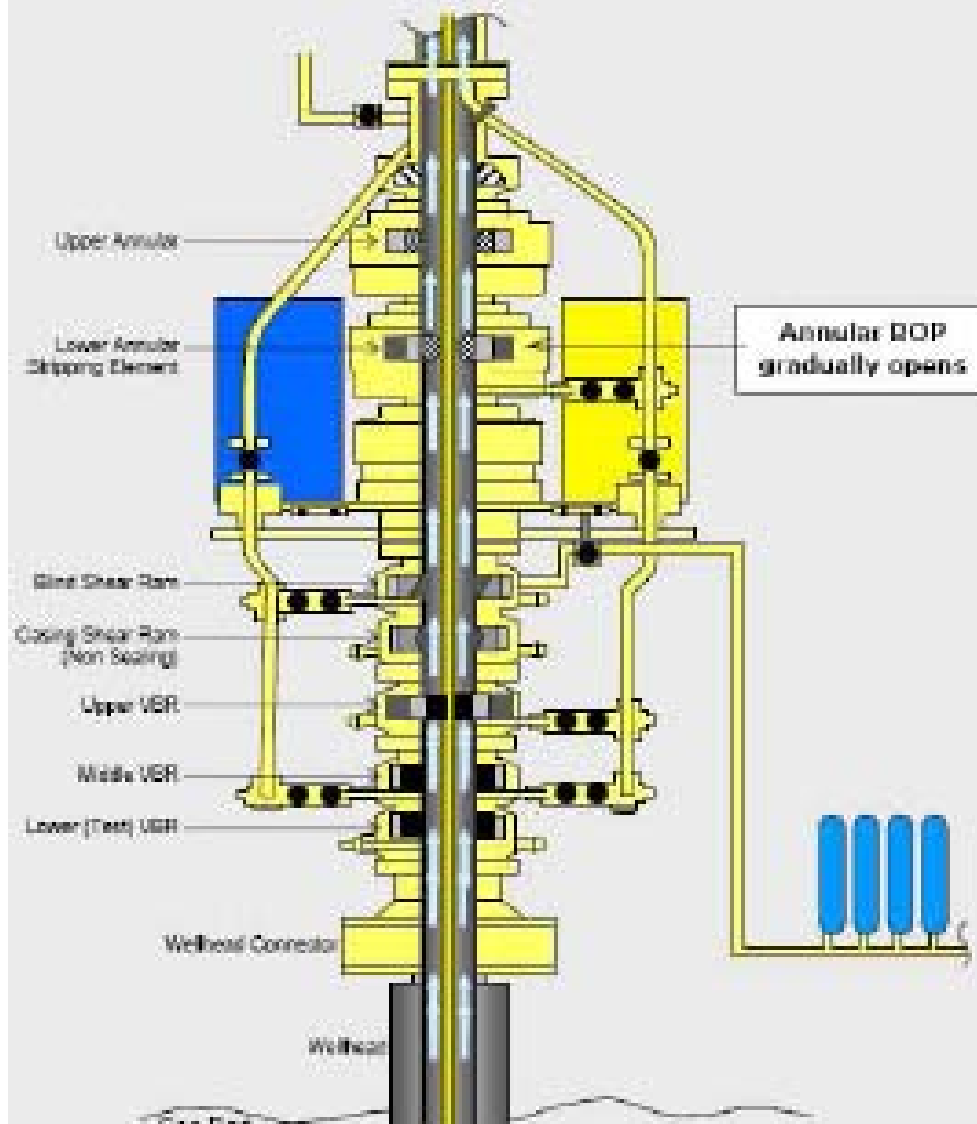
BOP Response (Impact of Explosions)

- Damage to MUX cables and hydraulic line
 - Opening of annular BOP
- Rig drifted off location
 - Upward movement of the drill pipe in the BOP

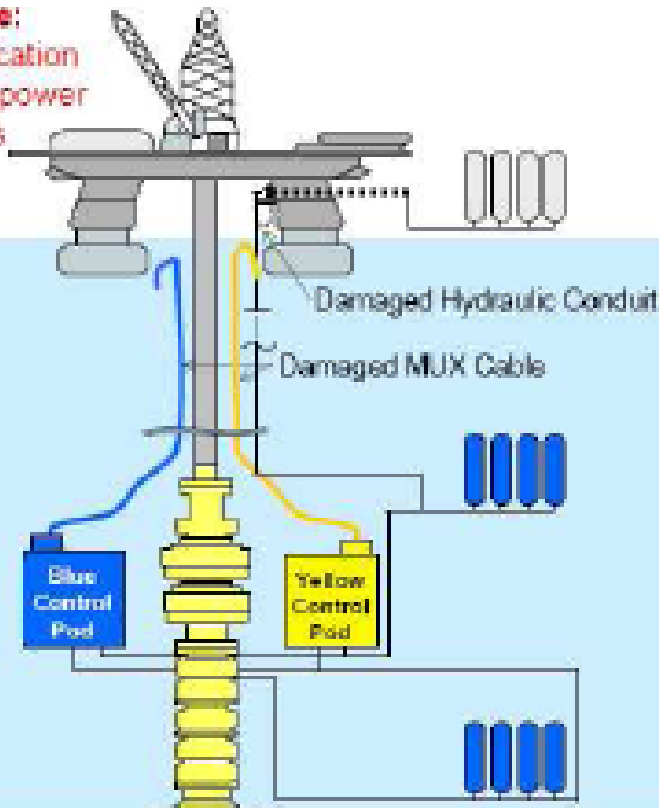
The BOP emergency mode did not seal the well

- EDS function was inoperable due to damage to MUX cables
- AMF could not activate the BSR due to defects in both control pods
- Auto-shear appears to have activated the BSR but did not seal the well
- Potential weaknesses found in the BOP testing regime and maintenance management systems

- BP Drilling Operating Practice and Management Systems
 - Engineering technical practices and procedures
 - Further enhance deepwater capability and proficiency
 - Strengthen rig audit action closeout and verification
 - Introduce integrity performance management for drilling and wells activities
- Contractor and service provider oversight and assurance
 - Cementing services
 - Drilling contractor well control practices and proficiency
 - Oversight of rig safety critical equipment
 - BOP configuration and capability
 - BOP minimum criteria for testing, maintenance, system modifications and performance
