Safety Alert

ALERT 05 – 28

FATAL INCIDENT RESULTS FROM REMOVED DECK OPENING COVER

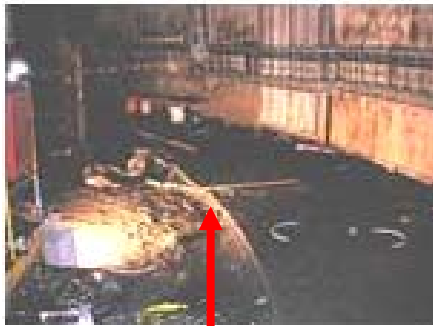
The initial investigation showed that the safety barriers guarding the manhole were removed and not reinstalled in place by previous teams working in the area.

A board covering the manhole. The incident area in similar lighting conditions

- Ensure there is a documented and functioning isolation process in place to manage removal and reinstallation of safety barriers.
- Ensure that manholes/openings in the floor have identifiable covers that can be locked in place, where possible.
- Prevent work in bad lighting, STOP the work if you feel that lighting is inadequate.
- Ensure people understand the important and practice good housekeeping at worksite.
- Identify needs for accessing manholes and openings at the design stage and provide built in design safety features.

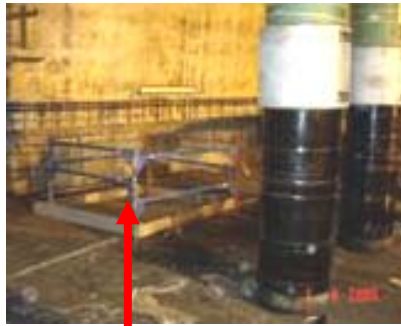
Barriers around the manhole after the incident with general lighting on
