Safety Alert

From the International Association of Drilling Contractors

ALERT 07 – 24

HIGH POTENTIAL DROPPED OBJECT

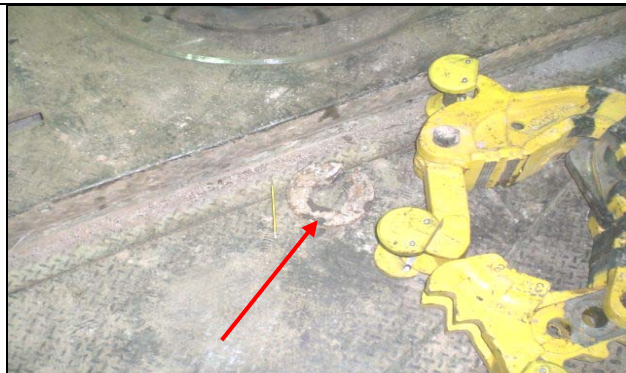
During normal drilling operations a dropped object consisting of a tong bucket counterweight weighing approx. 8 -10 lbs fell from the mast. The Driller heard noises coming from above and looked up and saw a object falling. He immediately yelled to the Floormen to stand back. The Floormen all moved and stood to the side of the rig floor. The counterweight landed on the rig floor beside the rotary table on the Driller's side. It bounced approximately 6 feet and landed on the rotary table. No injuries were incurred as a result of this High Potential Near Miss incident. The Operation was shut down and an investigation conducted.

The Site Welder had failed to correctly secure the additional tong counter weight segments. There was a failure by Supervisors to recognize and calculate the difference in the height of segments that ultimately caused the weights to protrude from the counter weight bucket. No pre-task safety meeting was conducted and a potentially hazardous situation was not recognized. The Rig's Supervisors did not implement a Management of Change (MOC) plan for change-out of equipment. The changing of the tongs was conducted by the Floormen on the rig floor under the supervision of the Driller, Assistant Driller and Rig Manager. None of these personnel were aware of the potential dangers associated with replacing the existing tongs with a newer and heavier set.

Tong counter weight segment landed beside rotary table and bounced a further 5-6 feet.

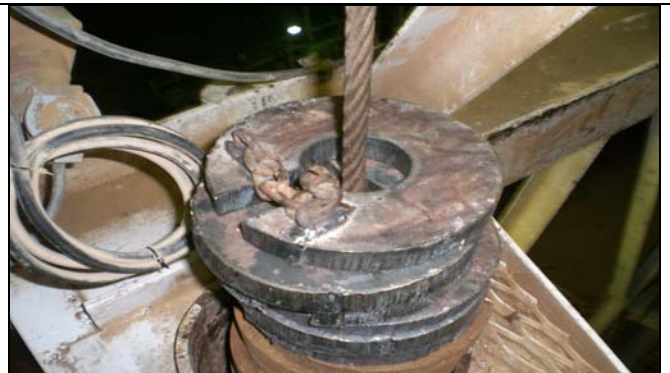
Corrective action towards securing tong counterweight segments

- The new tongs were replaced with the old tongs until the counter weights were safely modified to ensure positioning stability.
- Tongs were replaced and counterweights were modified (MPI Certified).
- An investigation was conducted and a meeting was conducted to discuss the incident and make all personnel aware of the potential for serious injury/fatality on a routine decision to change out tongs and make additions to the tong counter weights.
- Ensure that the inspection process be included in the Rig Site Dropped Objects Management System (DOMS).
