# Safety Alert

ALERT 07 – 34

## COUPLING FAILURE BETWEEN DRAWWORKS DRIVE SHAFT AND ELECTRIC AUXILIARY BRAKE....ALLOWS BLOCKS TO FALL

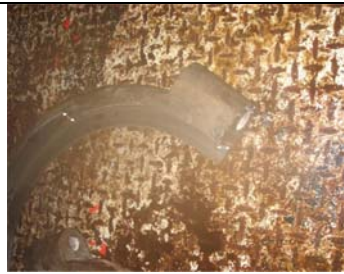
Investigation revealed that the coupling sleeve that mates the electric brake shaft to the drawworks drum shaft had disengaged allowing the string to fall. This occurred because the coupling sleeve's female spline had not fully engaged and was only partially covering the drawworks drum shaft male splines. An inspection showed signs of excessive wear at the shaft end. This partial engagement was due to the rotating sleeve gradually backing off the drawworks drum shaft thereby allowing it to contact and wear down the coupling's cast iron shifter ring (which had 80% wear) which engages the sleeve with the drum shaft. This occurred because the shifter ring's control lever was not fully elevated although it was locked secure.

The picture at left shows the worn shifter ring as a result of the allowable movement of the sleeve due to the 2cm play in the lever locking assembly. This picture clearly demonstrates the quantity of wear on the shifter ring. Approximately 80 % of the ring had been worn down in about 5 months. The last ring was changed out after 5 years in service. A 2 cm space existed between the lever and its seating position allowing play in the shifter lock assembly. This space allowed the coupling sleeve to slowly back off the drum shaft until it finally disengaged allowing the blocks to fall. See Fig. 2 below.

- Ensure the entire linkage system between the electric auxiliary brake and the drawworks drum shaft (including shifter ring, control lever, coupling sleeve, etc.) has safety critical status on the Preventive Maintenance System.

- Manufacturer was contacted for more detailed information on the installation of coupling (sleeve, control ring, lever, etc) and alignment of shafts. In addition maintenance information was obtained on the frequency and details of visual checks for correct engagement of the coupling sleeve, acceptable level of wear on the ring assembly, and measurement specifications on the shaft splines.

- Maintenance supervisors are to update PMS for the electric auxiliary brake/drawworks linkage system with additional information obtained from the Manufacturer.

- Ensure that adequate maintenance history of electric auxiliary brake/drawworks linkage system is detailed and updated in PMS.
- Ensure that sleeve and shift ring assembly follows a strict, structured greasing program to minimize wear on ring and splines.

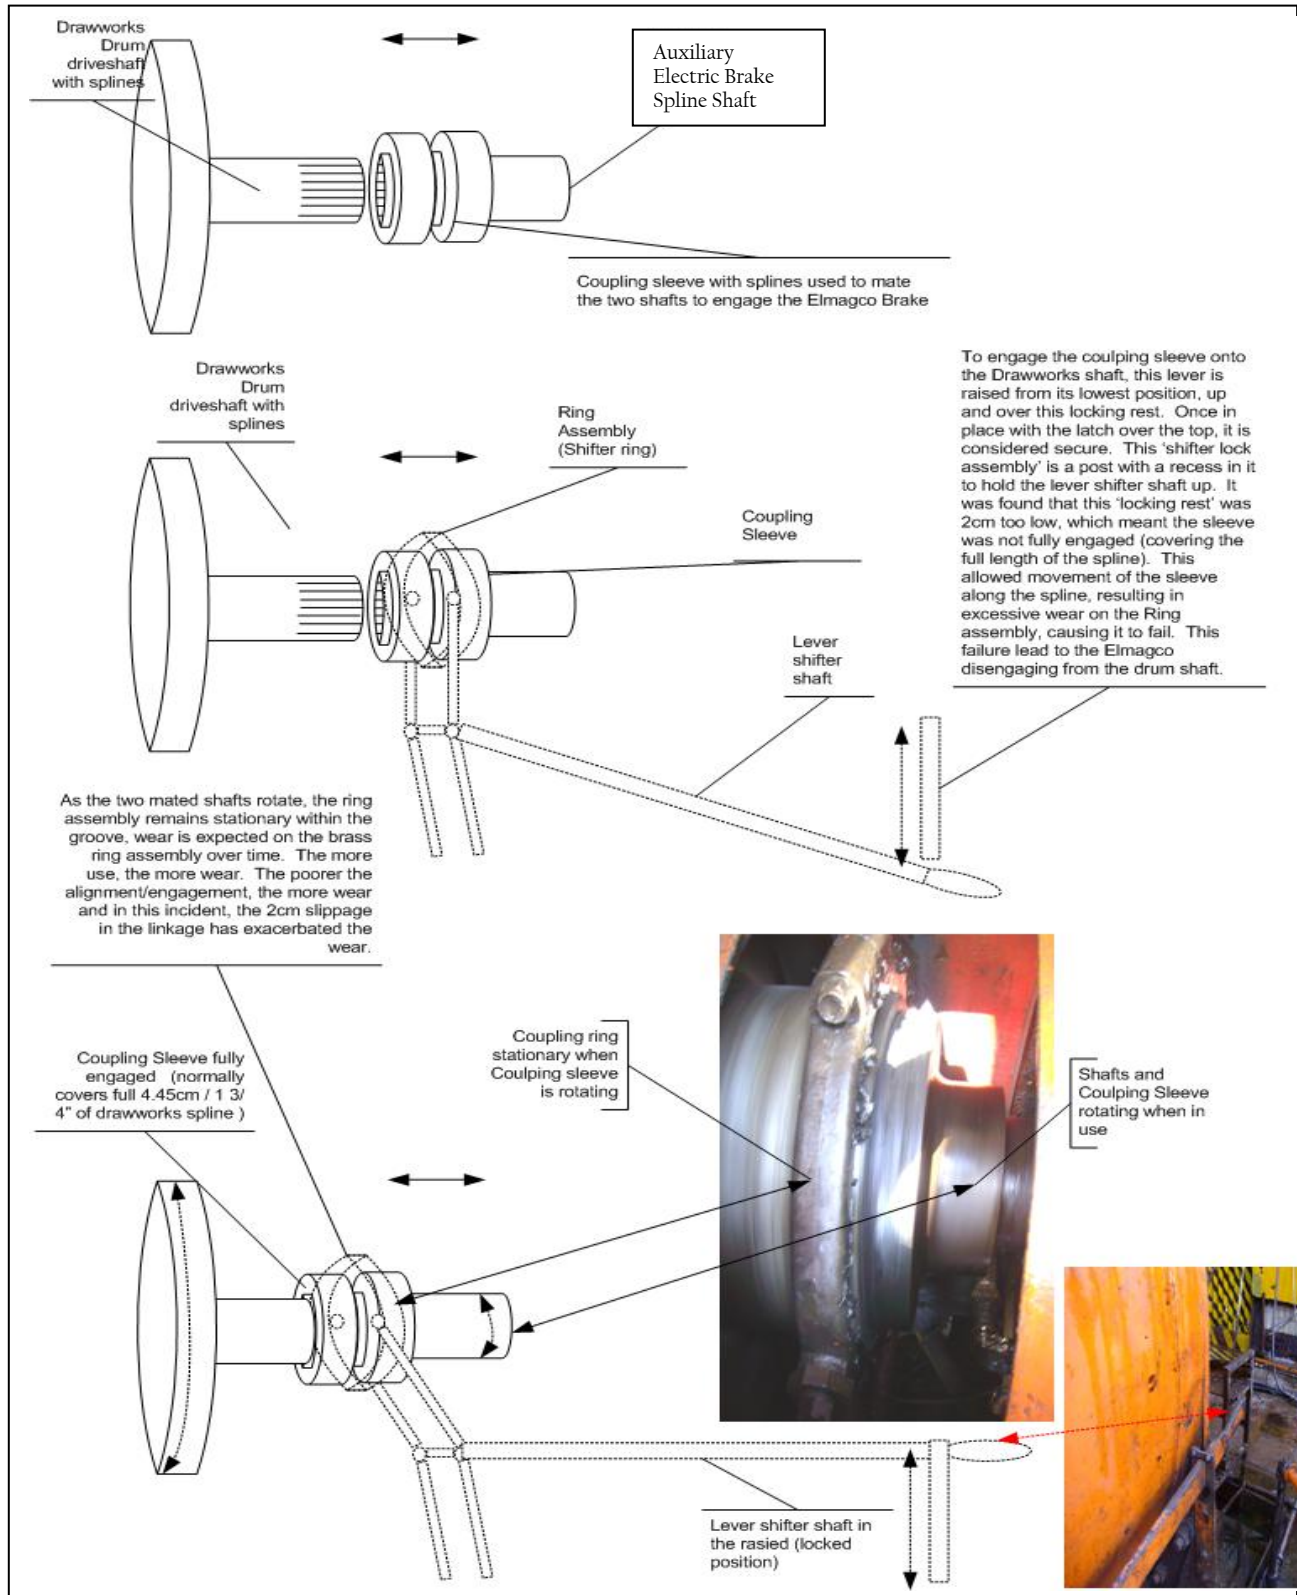
Fig. 2. Showing linkage system between drum and electric brake shafts and how coupling sleeve backed off drum shaft and wearing away ring assembly.
