UNITED STATES COAST GUARD

REPORT OF INVESTIGATION INTO THE CIRCUMSTANCES SURROUNDING THE MULTIPLE RELATED MARINE CASUALTIES AND GROUNDING OF THE

MODU KULLUK

ON DECEMBER 31, 2012

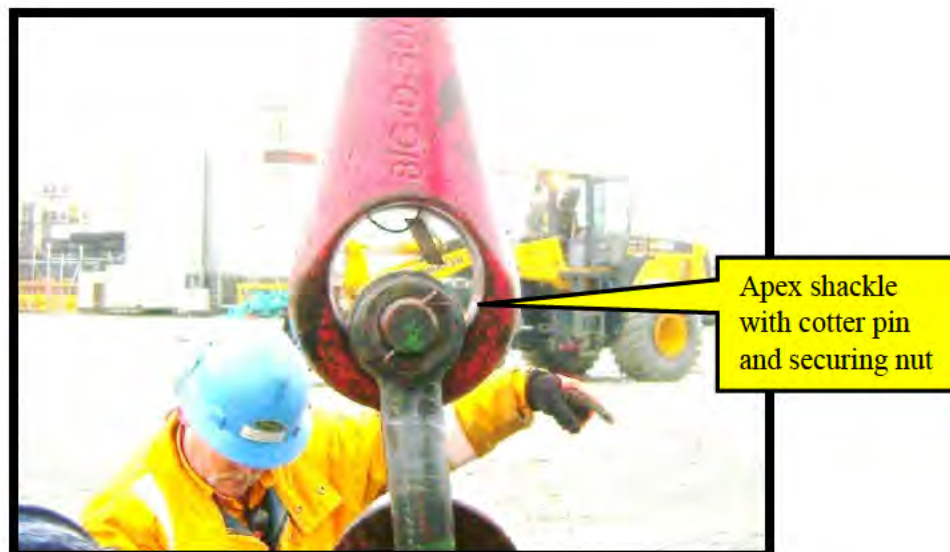
inspection. Additionally, the cotter pin was not removed or replaced.⁵¹ It is assumed that this is the same cotter pin that was installed for the July 2012 tow at the beginning of the season. Figure 13 shows a photo provided by the warranty surveyor that shows the “apex” shackle and cotter pin.

Figure 13: OSI Terminal workers hoist the tow plate and pennant wire. The photo shows the 120 ton shackle (original photo brightness adjusted) with the cotter key. The shackle (described as apex shackle) connects the tow plate to the 100' tow pennant socket. (Photo courtesy of GL Noble Denton, Mr. [REDACTED])

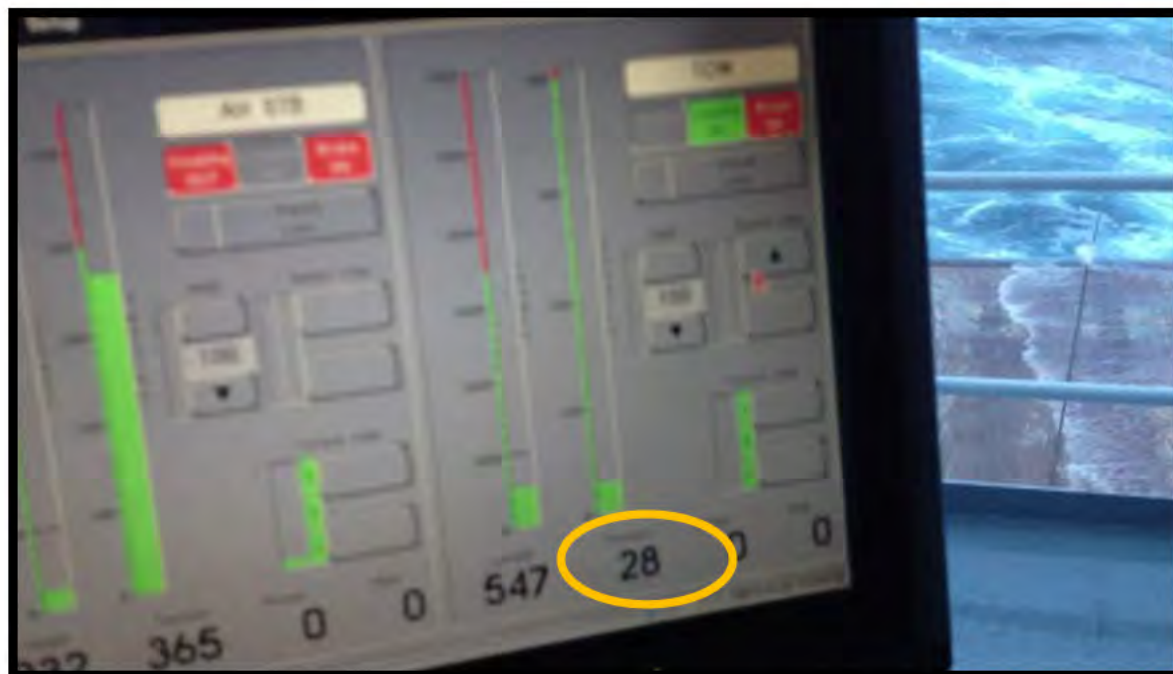
Figure 18: Screen capture from video showing tension reading of 28 tons on main tow drum. (Cell phone video screen capture provided by Mr. [REDACTED] AIVIQ Mate)

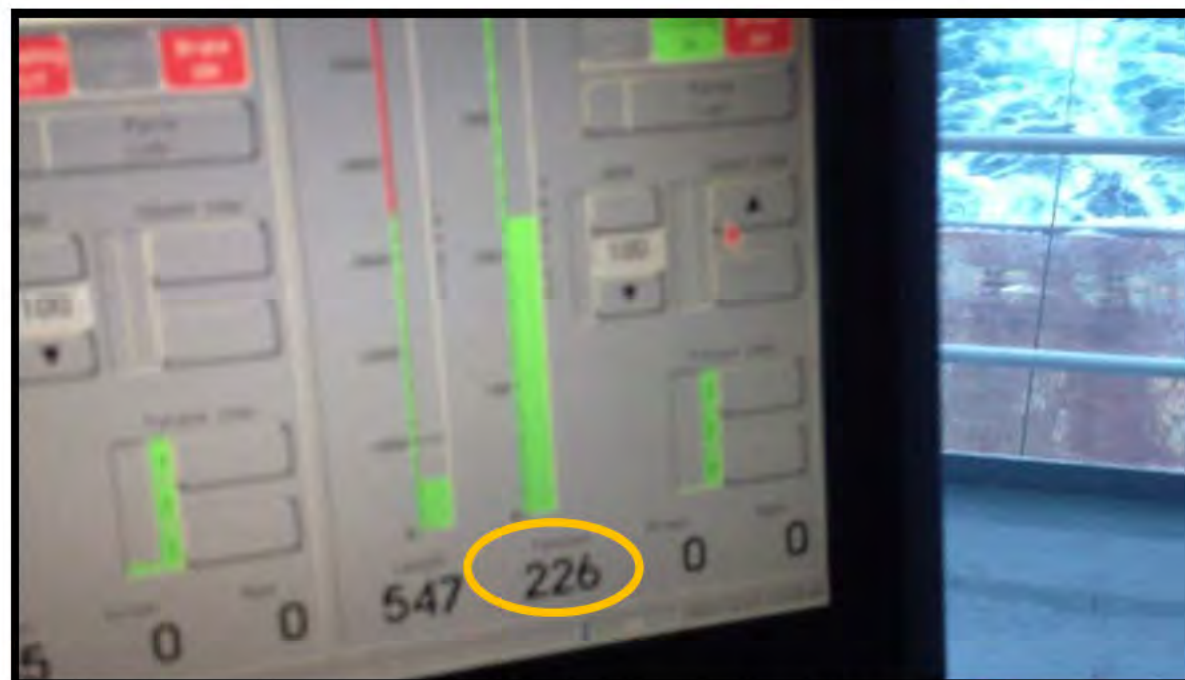
Figure 19: Screen capture from video showing tension reading of 226 tons on main tow drum. (Cell phone video screen capture provided by Mr. [REDACTED] AIVIQ Mate)

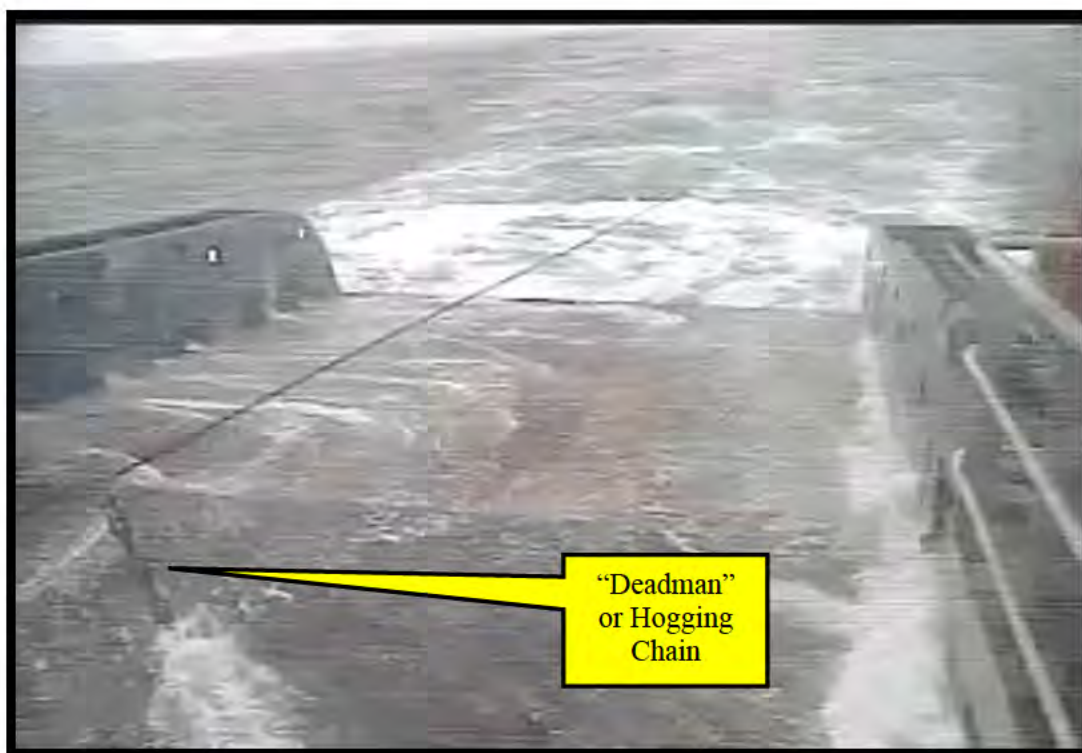
Figure 20: Screen capture of towline moments before failure of the shackle on the morning of December 27, 2012 *(From AIVIQ CCTV recording and provided by ECO)*

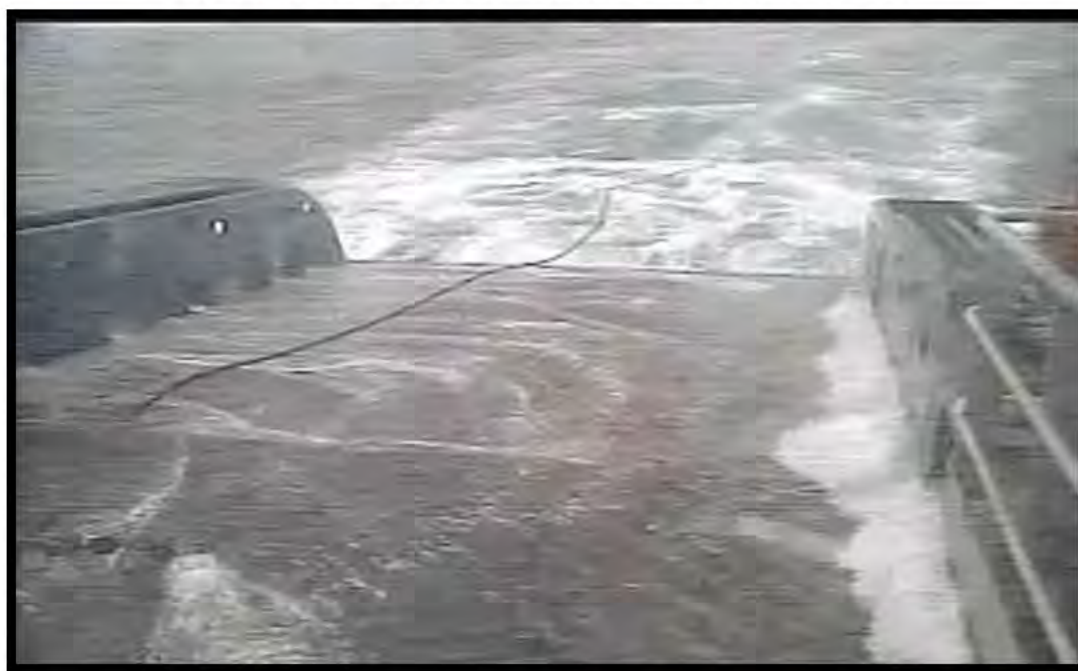
At approximately 1135, the towing operation experienced a failure of the towing shackle. The KULLUK was reported adrift at 56° 15' N and 152° 24' W. Examination of the towing equipment revealed a 120 ton shackle that connected the AIVIQ pennant wire to the triangular towing plate was missing and was not recovered. The SHELL Marine Manager was informed of the towing gear failure. SHELL notified the tug vessel GUARDSMAN and oil spill response vessel NANUQ, both located in Seward, Alaska, to make preparations to get underway. The USCG received notification by VHF radio at 1324 on December 27, and dispatched the USCGC ALEX HALEY⁵ on patrol to proceed to assist.

Figure 21: Screen capture of towline at moment of shackle failure on the morning of December 27, 2012 *(From AIVIQ CCTV recording and provided by ECO)*

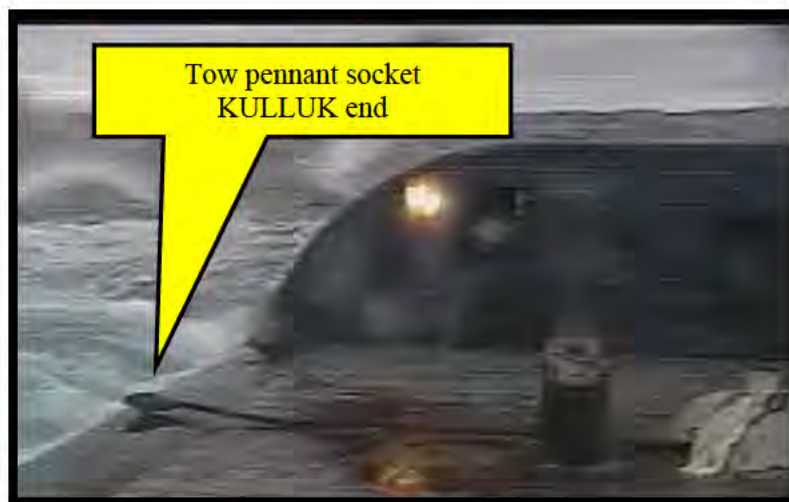
Figure 22: Screen capture showing retrieved pennant wire and socket, missing shackle later in the morning of December 27, 2012. (From AIVIQ CCTV recording and provided by ECO)

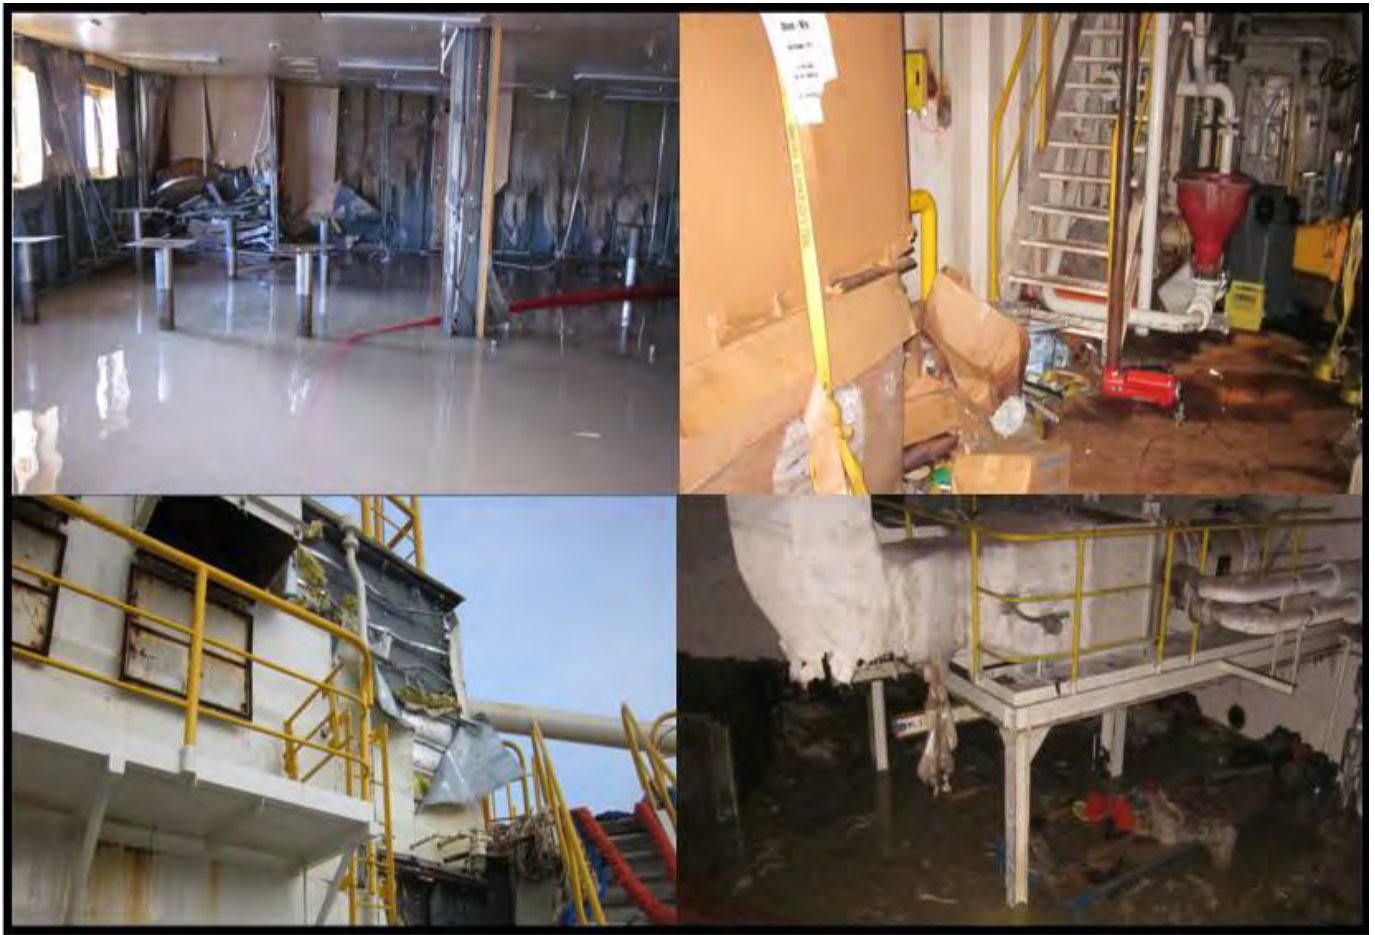
Figure 45: Composite photographs showing damage to topside areas of the KULLUK taken by USCG Inspectors after the grounding and prior to refloating. (*USCG Photos*)

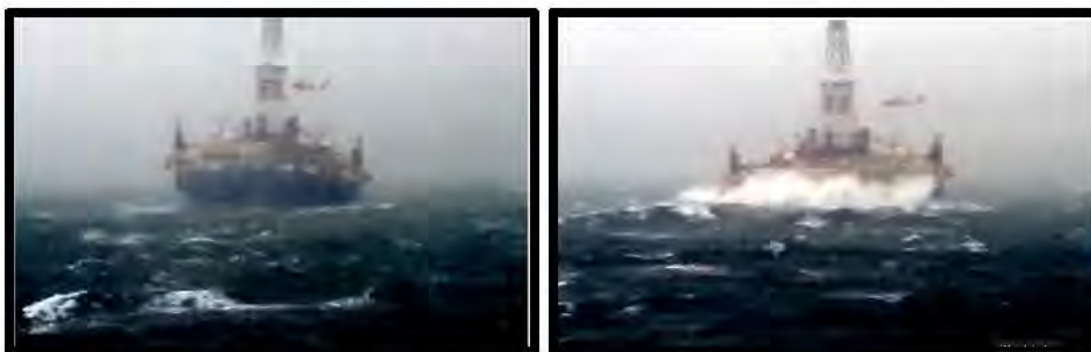
Figure 48: Screen captures showing extreme pitching resulting in the KULLUK burying hull into seaway and causing increased towing resistance. (Taken from YouTube video taken by unknown AIVIQ crewmember during afternoon hours of 31 December with AIVIQ and ALERT towing, video titled “KULLUK rescue 2012 Gulf of Alaska”)

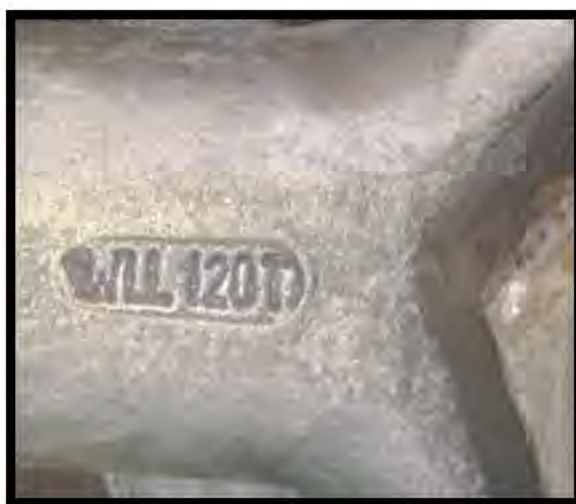
Figure 55: Photo of Working Load Limit Stamped on Bow of 120 Van Beest Green Pin® Super Shackle. (USCG Photo)

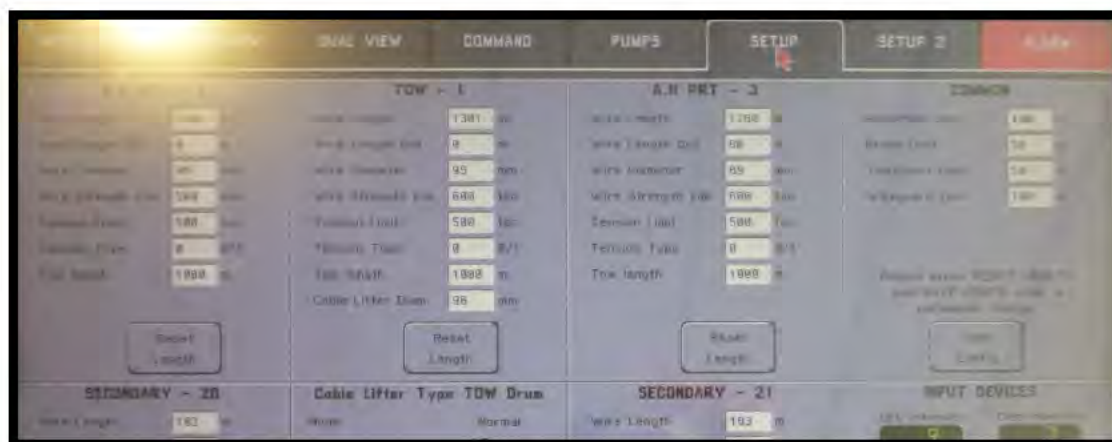
Figure 58: Photo of Towcon Setup screen showing “wire strength limit” for main towing drum is set at 600 tons. (USCG Photo)

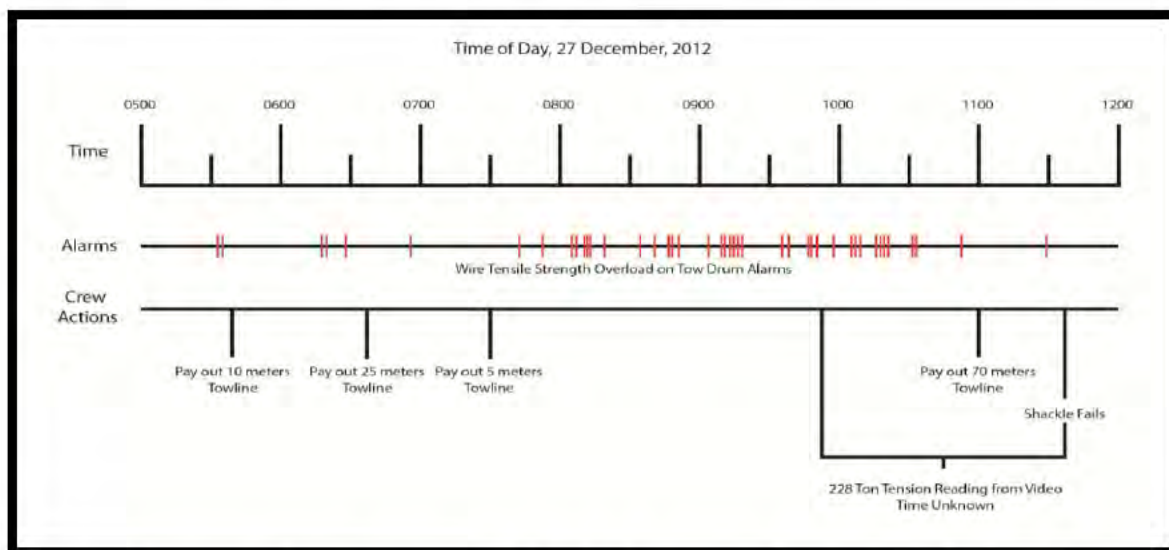
Figure 60: Summary of main towing drum data for the morning December 27, 2012 indicating time, alarms received towline length and shackle failure.¹⁰⁷ (USCG analysis)

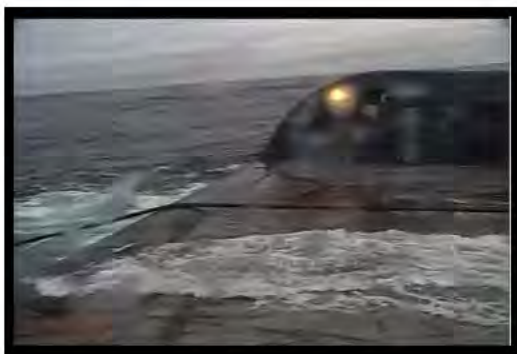
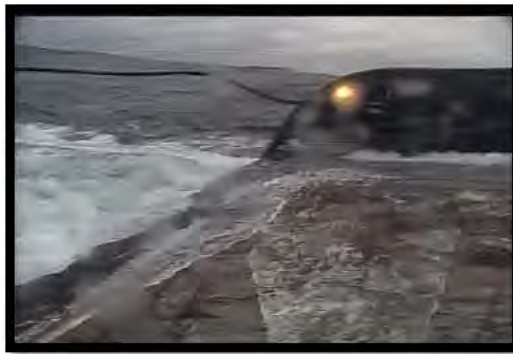
Figure 64: Starboard aft CCTV stills showing fluctuations in towline tension. Still on left shows lower tension at 11:32:06. Still on right shows high tension at 11:32:10 at the time of the shackle failure. *AIVIQ CCTV Provided by ECO*

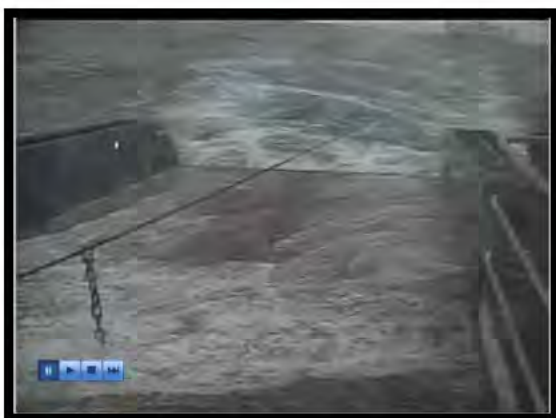
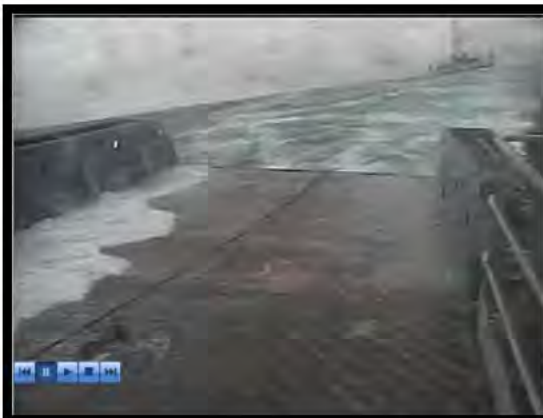
Figure 65: Port Forward CCTV stills showing fluctuations in towline tension. Still on left shows high tension at 10:54:48, demonstrated by the stiffness of the hogging chain (bottom right of still) and towline appearing to lead nearly horizontally toward KULLUK. Still on right shows low tension at 10:54:52, a mere 4 seconds later, with a slack Deadman chain and towline on the deck. *(AIVIQ CCTV Provided by ECO)*

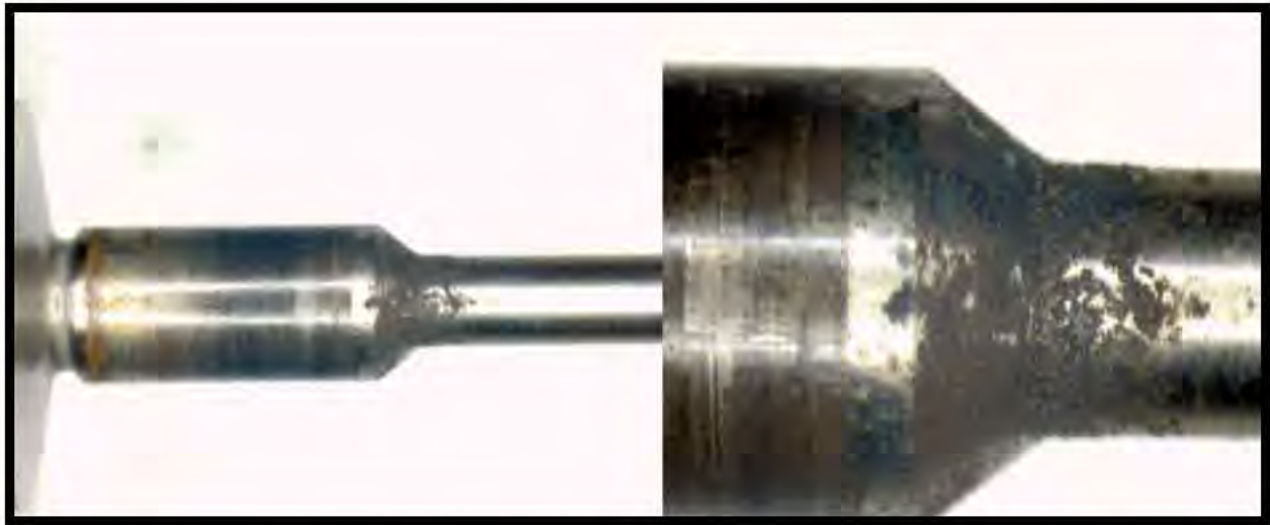
Figure 68: Two photos showing significant corrosion of injector check valve. *(Provided by Caterpillar)*

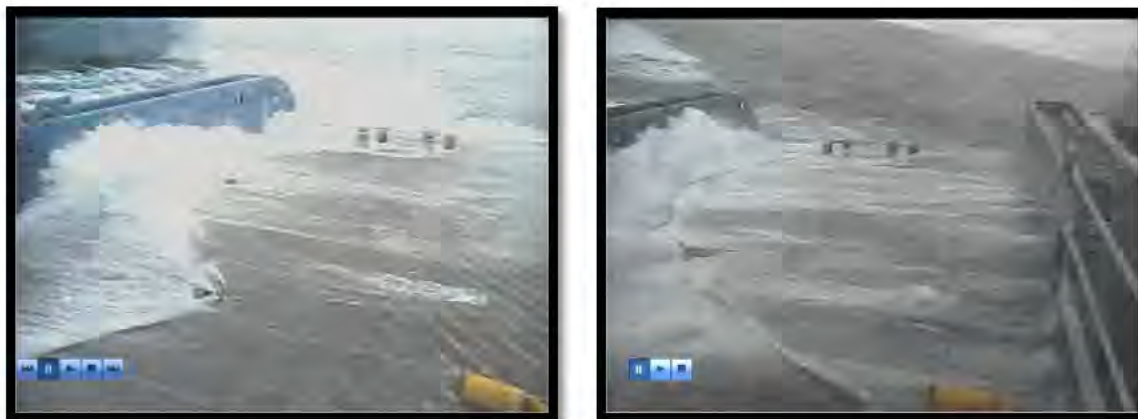
Figure 71: (left) Still from Port Forward CCTV showing seawater flowing over aft working deck and entering safety deck area at 14:39:09 on December 27. (right) Similar occurrence at 14:49:19 on December 27. (AIVIQ CCTV Provided by ECO)

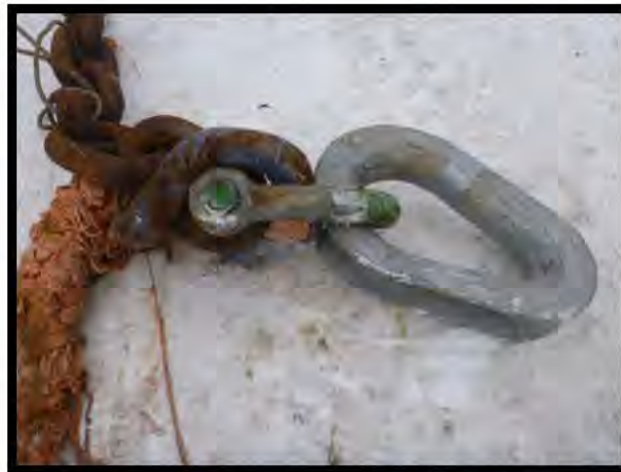
Figure 75: Photo of recovered emergency towline (eye on the KULLUK end of the emergency towline) showing missing thimble lashings allowing towline to separate from hard thimble. Blue Cordura® protection is also damaged. (*USCG Photo*)
