Safety Alert

From the International Association of Drilling Contractors

ALERT 12 – 31

HIGH POTENTIAL - DROPPED PONY COLLAR

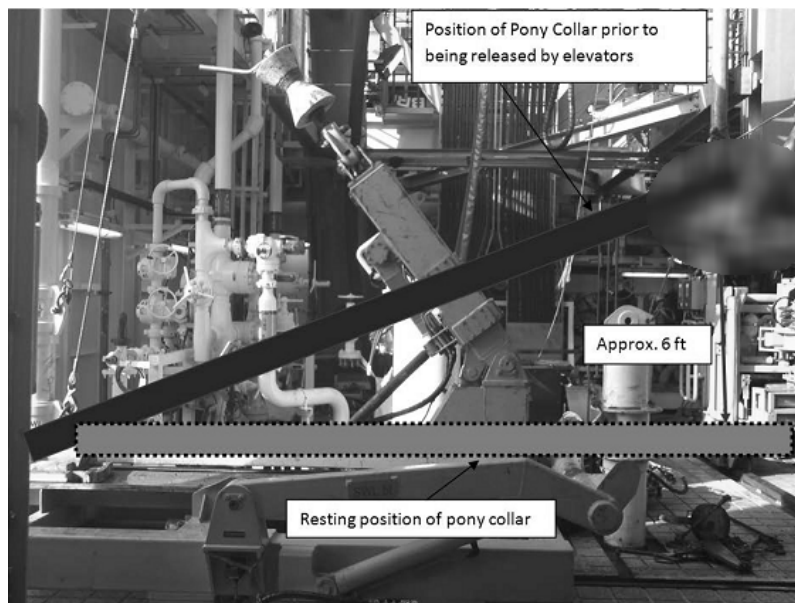
While laying down an approximately 16 foot x 10 inch (4.8m x 25cm) pony collar, weighing approximately 3400 pounds (1.5mt), the 500 ton (454mt) center-latch elevators opened inadvertently. The pony collar fell 6 feet (2m) and came to rest on the pipe skate. In the process of falling, the lift cap struck the stump, but there was no visible damage to the remaining BHA. No personnel were in the area.

- Defective and inadequate equipment: While being operated in accordance with the 2009 manual, the center-latch elevator failed and resulted in the dropped pony collar.

- Inadequate information/data: The 2009 version of the Manufacturer's Operator Manual was used as the reference manual. As far as the company and the drilling crew knew, the 2009 version WAS the latest version, but after the incident occurred the company found out from the Manufacturer/Equipment Provider there was a 2012 version. In the 2012 Operator Manual, which had not been sent by the Equipment Provider to the company, the use of the center-latch elevators is not allowed for this type of lift or lay down; instead, rotating elevators are required.

- Inadequate engineering/manufacturing: Design of the center-latch elevator is not compatible with laying down a pony collar.
- Inadequate maintenance of standards/procedures/work instructions: Unavailability onsite of the inserts for the rotating elevators led the crew to use the center-latch elevators as a substitute, which was noted as an acceptable substitution in the 2009 Operator Manual. It is not an acceptable substitution in the 2012 version.

- Inadequate communication: The process for communication of updated manufacturers' technical documents and manuals was not well defined.

- The company has decided to maintain sufficient spares of inserts onboard all rigs in the fleet to allow the use of rotating elevators at both rotary centers.
- The company has decided to review and update the process, as necessary, for ensuring that current revisions of Operator/Technical Manuals are received onboard.
- The company will utilize cascade/share the learning points from this incident with other company vessels.
- The company will ensure that a clause is inserted in the Terms and Conditions of agreements with Equipment Providers that requires them to provide documentation updates, product bulletins, etc. as they are released.
