Safety Alert

From the International Association of Drilling Contractors

ALERT 12 – 08

SUPPLY BOAT PULLS PLATFORM CRANE OVERBOARD

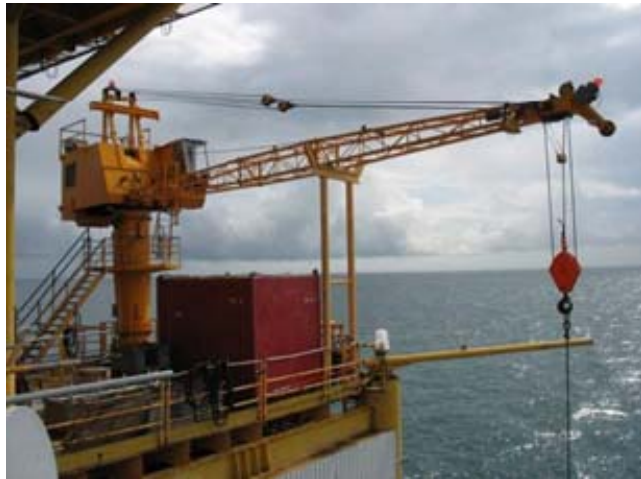
Crane before incident

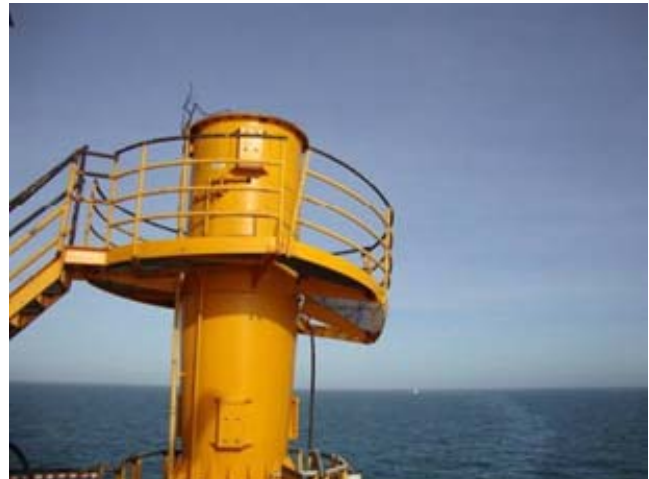
The vessel was still connected to the crane (now on the sea bed) as the hook and wire from the crane were connected to the cargo and hanging out over the stern of the vessel. Later the crane wire broke. Because of the potential risk to the vessel's crew members, the crane wire was not cut by the vessel's deck crew. The basket remained on the supply boat deck. As a result of the crane falling into the sea, a small oil spill was reported (0.6ltr). This incident is considered a high risk incident and relevant investigations have started up.

After Incident

- (Onshore) Emergency response team was mobilized;
- Relevant authorities were informed;
- First investigation on board by boat and platform crew;
- Started the investigation, focusing on ship/bridge activities, platform activities and crane maintenance;
- A similar type of crane was put out of operation for boat handling until relevant investigation results are known;
- Instructed transportation personnel to place transport baskets (low containers) off the side of the ship, in order to reduce the possibility of hooking in containers;
- The crane will be retrieved from the seabed as soon as weather conditions allow this.

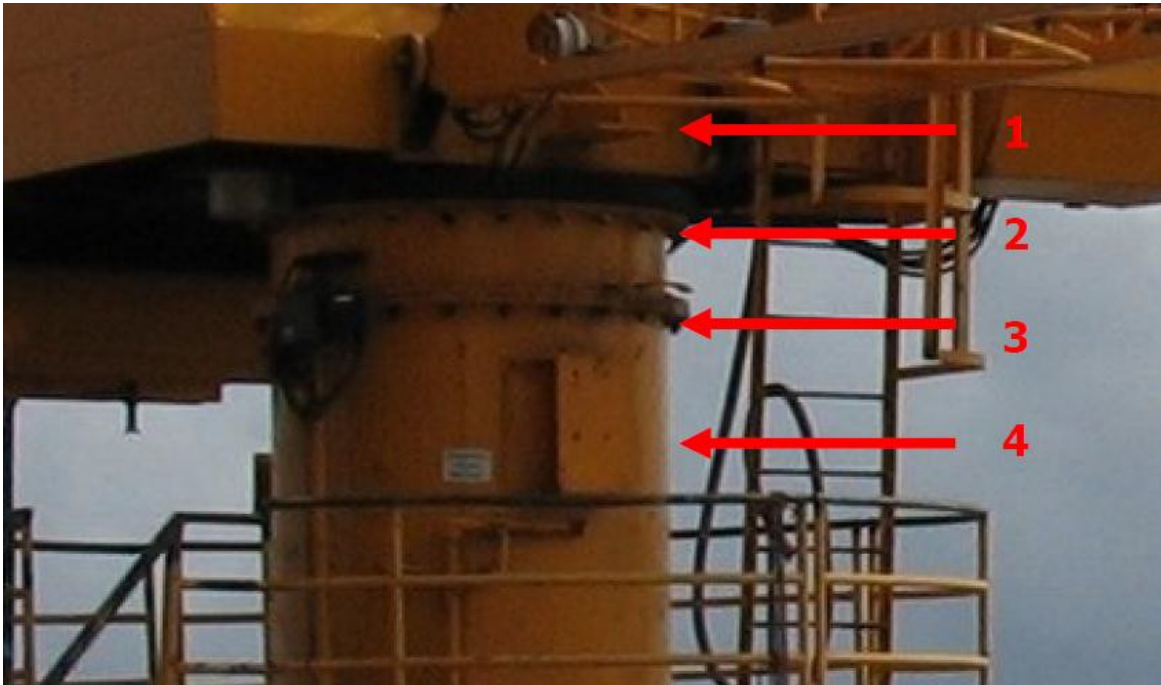
Detail of crane

1. Crane
2. Slewing bearing
3. Flange to connect entire crane to pedestal, broken bolts
4. Pedestal

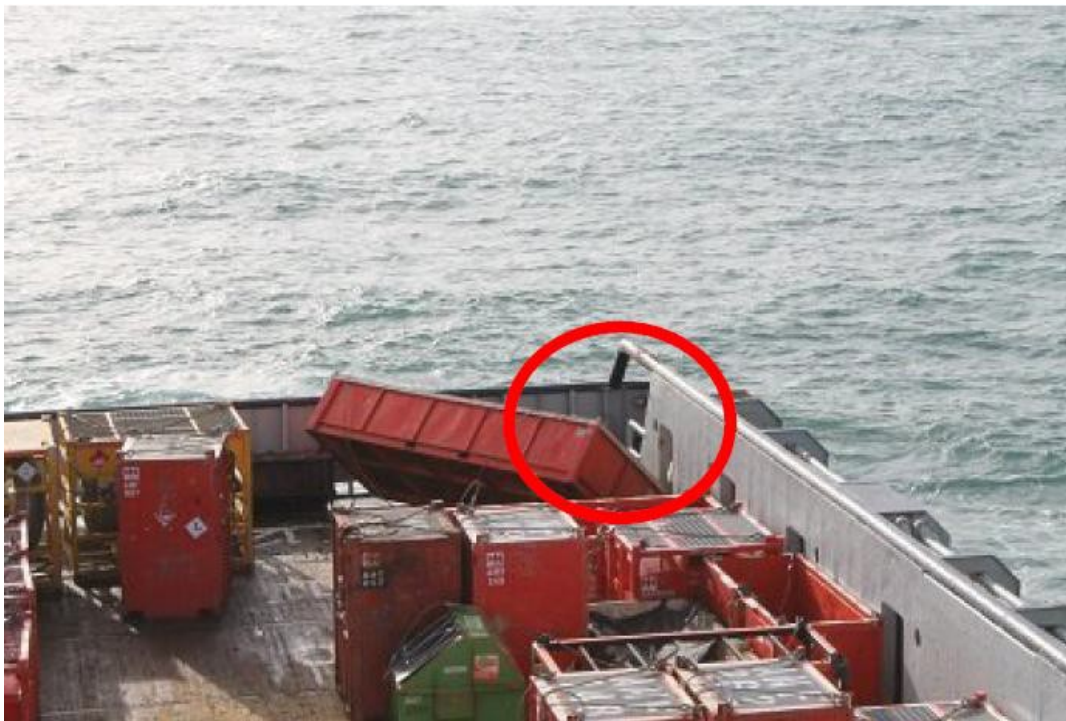
Note: The circle points out the location of the basket after the incident and the escape opening the basket was hooked in
