Safety Alert

ALERT 08 – 40

FAILURE OF BACK FLOW VALVE DURING NITROGEN FOAM FRAC RESULTS IN A FATALITY

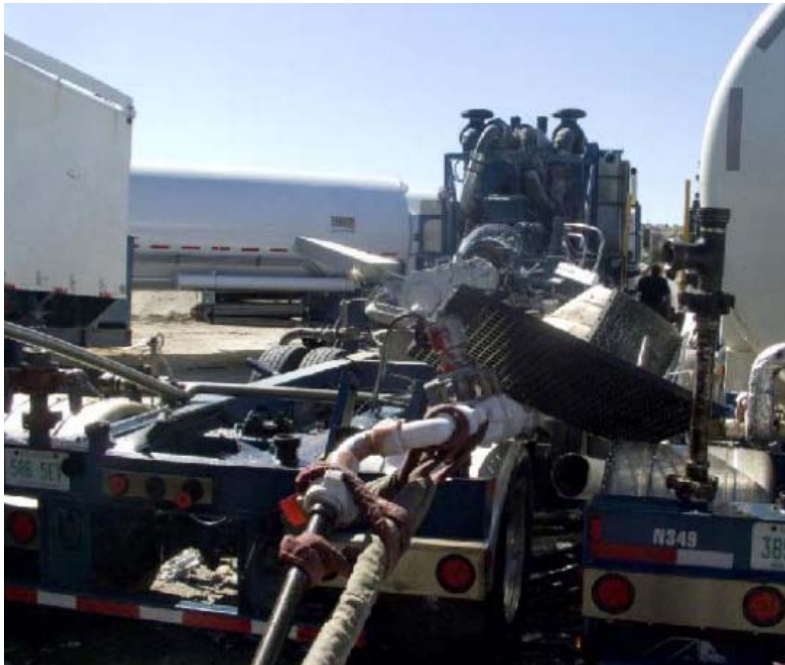
A fatality occurred when a service company was performing a two stage nitrogen foam frac treatment. The rig-up required four nitrogen pumps manifolded together. In the process of beginning the second stage, a nitrogen pump failed to maintain prime on the boost pump. While attempting to regain prime, gas from the remaining pumps back-flowed into the nitrogen pump's storage vessel. The relief system on the vessel was not capable of venting the volume of gas entering the vessel resulting in a catastrophic failure due to over-pressurization.

- A high pressure dart style check valve in the gas discharge line was modified for other than its intended use and did not prevent the back-flow of gas from three trucks online
- The pre-operation job site pressure test procedure utilized did not ensure integrity of the dart style check valve.

Post Incident – Storage Vessel Missing From Nitrogen Unit

- Ensure only engineered and inspected high pressure components are utilized for pressure pumping operations.
- Ensure equipment is in proper working condition prior to dispatching to job site.
- Install redundant dart style check valve in gas discharge line.
- Ensure pre-job pressure test procedure verifies the integrity of check valves.
