Safety Alert

ALERT 07 – 22

DROPPED OBJECT: FAST LINE GUIDE ROLLER

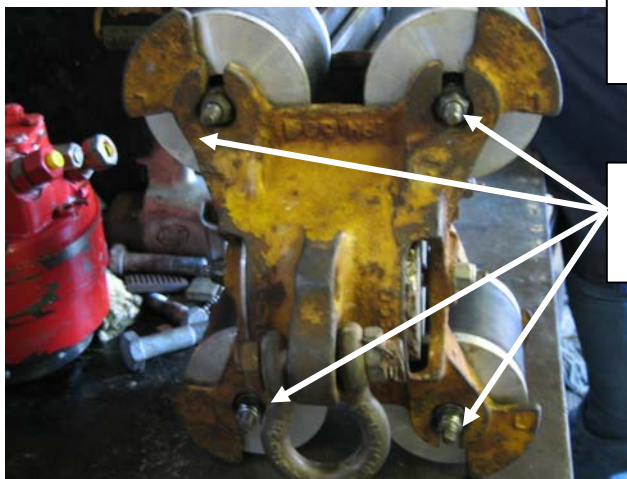
The locknut on the bottom outside roller had backed out allowing the roller to fall out. The stabilizer assembly had recently been rebuilt. Investigation revealed that some of the lock nuts had been loosened and re-tightened. All six rollers are seldom changed out at the same time, but it is necessary to loosen all lock nuts in order to re-install the assembly on the fast line. When a locknut is loosened and re-tightened, its break-out torque is reduced (and continues to be reduced further each time the nut is loosened and re-tightened.) To prevent this reduction in breakout torque, the lock nut must be replaced with a new one from the manufacturer and the old one discarded.

Fast Line Stabilizer Guide with 6 rollers.

Lock nuts to be torqued only once. Replace lock nuts if broken out.

Since the fast line stabilizer guide assembly is overhead and undergoes continuous rigorous vibration, it has high dropped-object potential. **Therefore, it is mandatory that each lock nut be used only once.**

1. All self-locking nuts on all rollers are to be replaced. Do not re-tighten a lock nut once it has been loosened. Discard all used lock nuts.
2. Do not torque up the nuts fully until the stabilizer assembly guide is squared on the fast line.
3. Ensure the assembly is inspected regularly (as well as subjected to Preventive Maintenance protocols).
4. Have a JSA for rebuilding, servicing or replacing one or more rollers in which the above points are specified.
