Safety Alert

ALERT 03 – 25

UNPROTECTED FLYWHEEL RESULTS IN A FATALITY

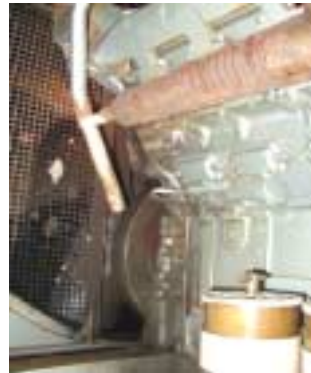
The investigation revealed that in preparation for the filter change, the injured person had partially removed his jacket, releasing his right arm first. The suction created by the fan pulled the free part of the jacket into the unguarded balance wheel pulley assembly. One of the main causes of the accident could be considered to be the improper guarding of the pulleys and belt.

- Performed a verification of all on board equipment and machinery in regards to Machinery Guarding or Machinery Protection of rotating and moving parts.

- Installed protective devices to the rotating parts on the generator and engine as necessary.
- All inspection operations beyond the control panel must have a stand-by person in attendance within the immediate area of the emergency stop and in a position to easily see the inspection operators.

- Installed protective devices for the hot surfaces (i.e. exhaust manifold) of the engine that may come into contact with operators.
- Installed safety signs at the entrance of the containers, such as “Authorized Person only”, “Hearing Protection required”, and the normal PPE requirements.
