# Safety Alert

ALERT 03 – 31

## FALL OVERBOARD RESULTS IN A FATALITY

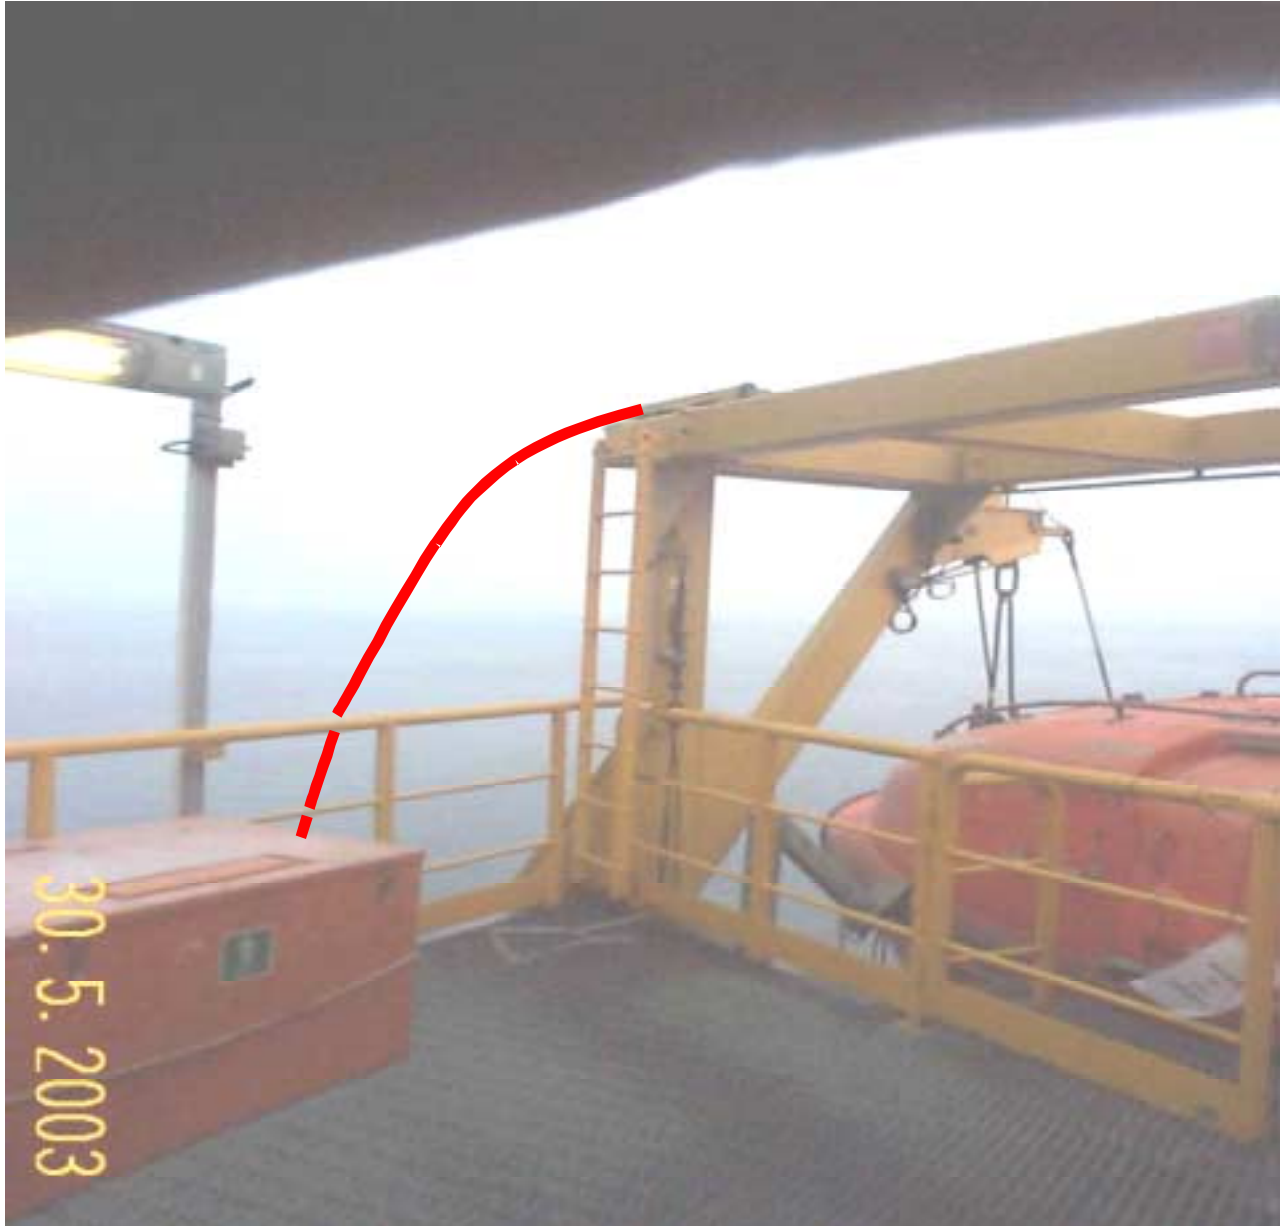
## Attachment 1

4. At approximately 18:50 hours, the deceased and his immediate supervisor started to dismantle the hose protecting No. 2 lifeboat (see attachment 1). A fire hose, supplied from a fire hydrant on the starboard helideck stairs was hung between the stairs and No. 2 lifeboat. The fire hose terminated with a nozzle connected to the hose by a positively latched coupling which requires the use of both hands to disconnect. The nozzle/hose arrangement was then connected to the davit by a long tie wrap (3 tie wraps looped together) fastened to the inboard box girder

5. The main body of the hose between the fire hydrant and the nozzle lay over open water and hung with a “belly” in the hose.
6. From this point onwards there are no eyewitnesses to the exact sequence of events who can say how or why the deceased fell overboard. His supervisor was the last person to see him at which time he had one foot on the rung of the vertical ladder at No. 2 lifeboat. The vertical ladder is adjacent to the handrails at the rig’s perimeter. The hose was found hanging from the fire hydrant and disconnected from the nozzle secured to the lifeboat davit.

No. 2 Lifeboat, showing the original position of the hose.

- Distributed and communicated this safety alert
- The risk of falling overboard is well recognized in the offshore industry. This incident highlights the need to remain ever vigilant.
- Conducted a review of all rigs/installations to identify areas where the potential for similar incidents exists.
