Safety Alert

ALERT 04 – 22

RIG CARRIER DRIVES OFF ACCIDENTALLY

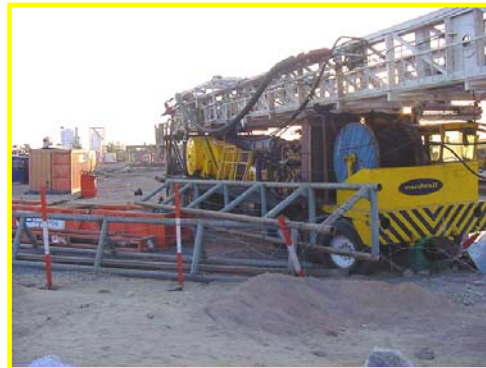
In the process of jacking up the parked Carrier rig on ground, the injured, a rig mechanic, was installing the 6th jack on the Carrier. As the Maintenance Supervisor shifted the Cotta Transmission lever from 'Road' to 'Hoist', the engine RPM suddenly increased and Carrier started to drive forward by itself. When the Rig Supervisor immediately shifted the lever back to 'Road', the Carrier drove further and finally halted after striking the gate hut.

- **Failure to Follow Procedure** / the Compound Gear Box was not kept in the "Disengage" position before shifting the Cotta Transmission.
- **Equipment Malfunctioning** / Cotta shifter movement to 'Hoist' position activated 'Road' mode of the Carrier mechanism.

- Compound Transmission must be disengaged before shifting the Cotta Transmission.
- Bypassing procedures can have serious consequence.

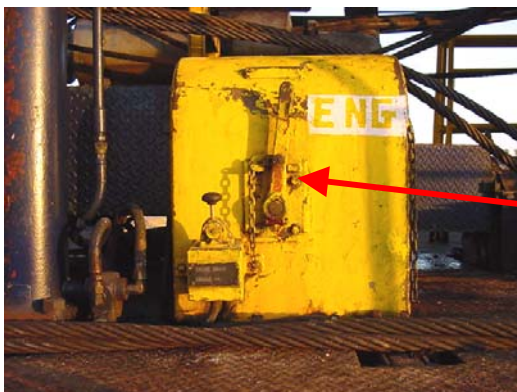
Compound Transmission must be disengaged before shifting the Cotta transmission.
