THE BUREAU OF OCEAN ENERGY MANAGEMENT,
REGULATION AND ENFORCEMENT

REPORT REGARDING THE CAUSES OF THE APRIL 20, 2010
MACONDO WELL BLOWOUT

September 14, 2011

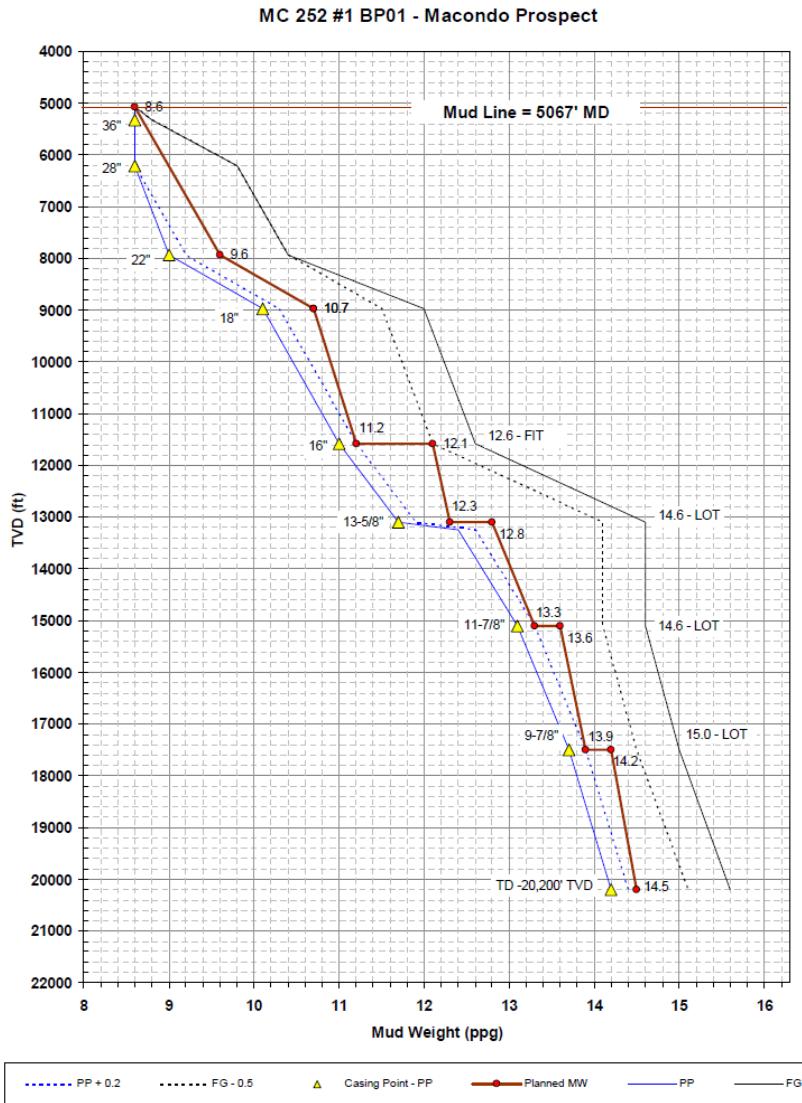
Figure 1 – Macondo Well Pore Pressure Fracture Gradient Plot⁶⁵

The final estimated Macondo well pore pressure, mud weight, and fracture gradient plot submitted to MMS on March 26 is shown at Figure 1. The vertical axis of Figure 1 shows the depth of the well. The horizontal axis shows the mud weight. The red line depicts BP’s planned mud weight, which was designed to be between the kick margin and the swab margin identified in Figure 1.

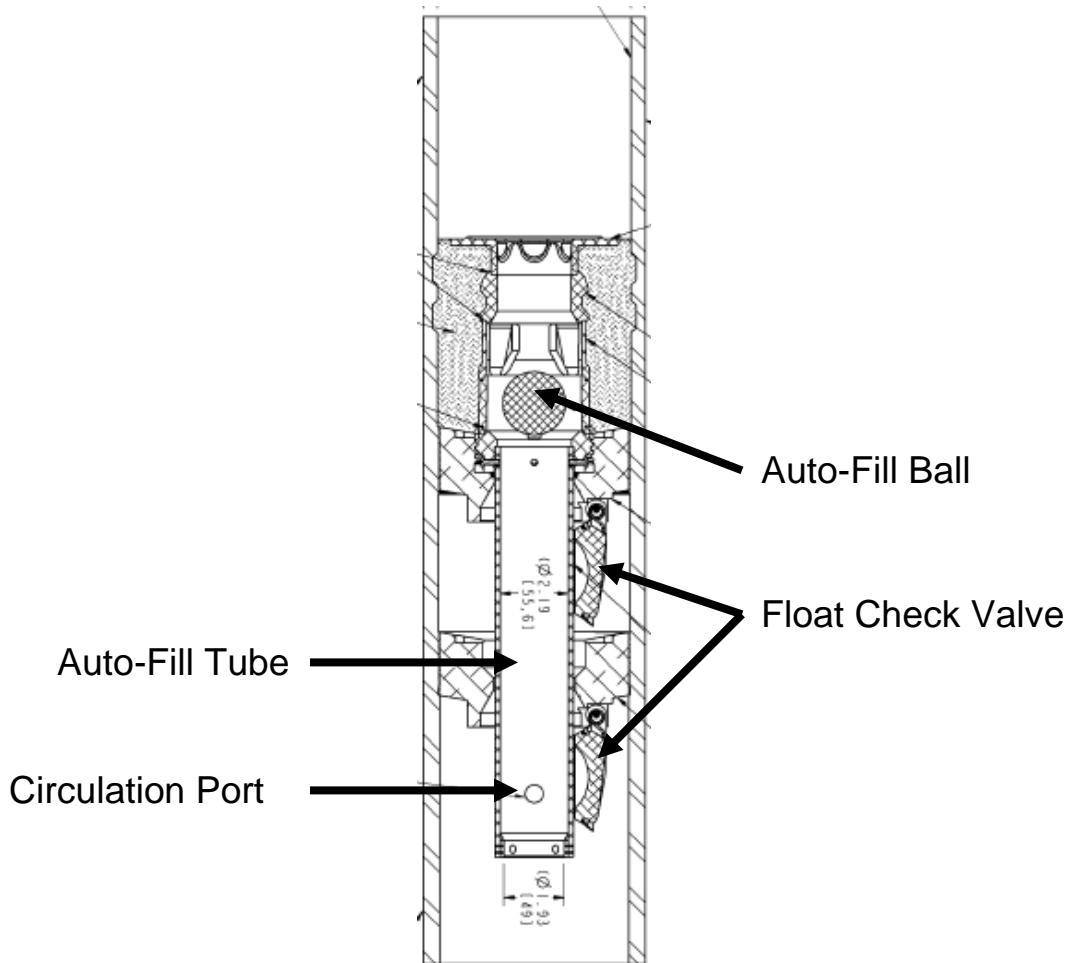
Figure 4 – Float Collar Utilized in the Macondo Well

As discussed above, the float collar was set at 18,115 feet measured depth, within the primary hydrocarbon reservoir sands (see Figure 2, above). Typically, an operator sets the float collar below the primary hydrocarbon sands to allow for perforation of the pay zone without the need to drill out the float equipment to get below the pay zone during the completion of the well. In addition, the lower primary sand was less than 100 feet from the bottom of the production casing shoe.¹¹⁶ Normally, an operator would set the production casing shoe 200 to 300 feet below the primary sand to improve the chances of proper isolation of the pay sand.

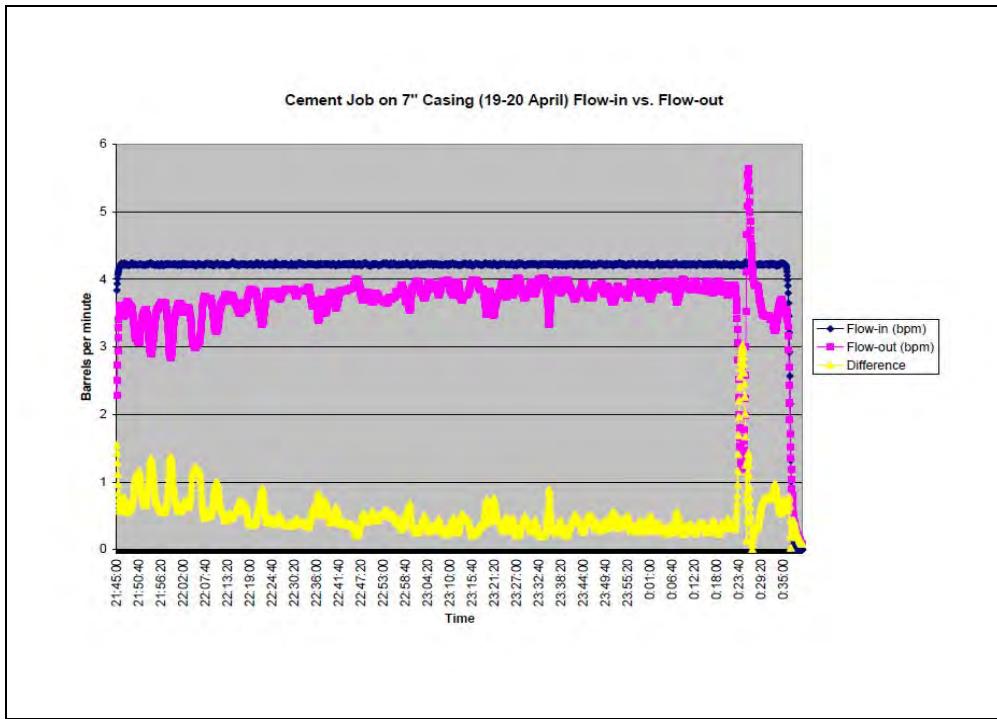
Figure 5 - Flow-out vs. Flow-in on the Production Casing Cement Job (Calculated by Panel)

This possible range of loss exceeded the entire volume of cement pumped during the production casing cement job. This could indicate that over-displacement of cement occurred in the shoe track. In other words, the cement could have been pumped into the well, past the shoe track, which would have left spacer and no cement in the shoe track to isolate the center of the production casing. If over-displacement occurred, it would have resulted in insufficient cement coverage in the shoe track.

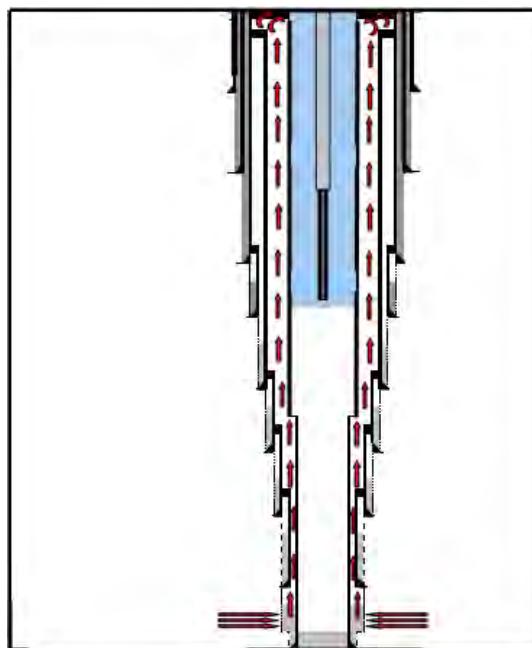
Figure 6 – Flow Up the Annulus and Through the Seal Assembly

Under this scenario, hydrocarbons would have flowed from the reservoir up the backside of the tapered casing string, and through the seal assembly into the riser. If this had occurred, the nitrified annular cement intended to isolate the hydrocarbon zone(s) at the production interval would have failed, the casing would have lifted or floated, and the seal assembly would have failed in conjunction with the casing lifting. This potential flow path is illustrated in Figure 6, below.

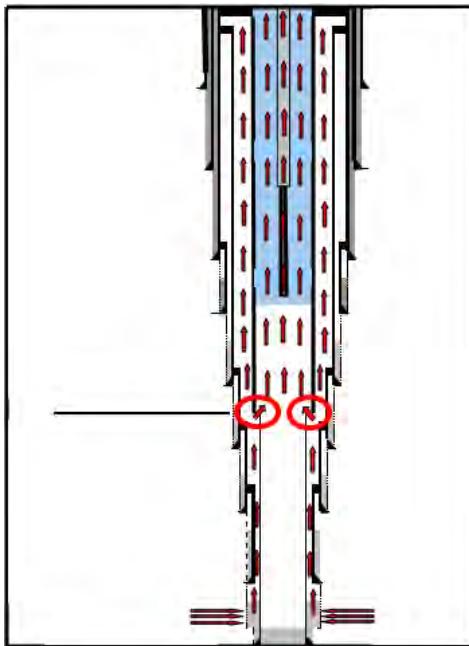
Figure 7 – Flow Up the Annulus and Through Production Casing Crossover Joint

Under this scenario, hydrocarbons would have flowed from the reservoir through the crossover joint of the tapered casing string, into the well and up the riser to the rig. The Panel considered the crossover point to be a possible source of flow because it was manufactured separately from the other tubular elements in the well. If hydrocarbons had flowed in this path, it would mean that the annular cement isolating the hydrocarbon zones at the production interval had failed and the casing had failed at the crossover joint. These failures would have resulted in hydrocarbon flow out of the well and up the riser. This scenario is depicted in Figure 7 below:

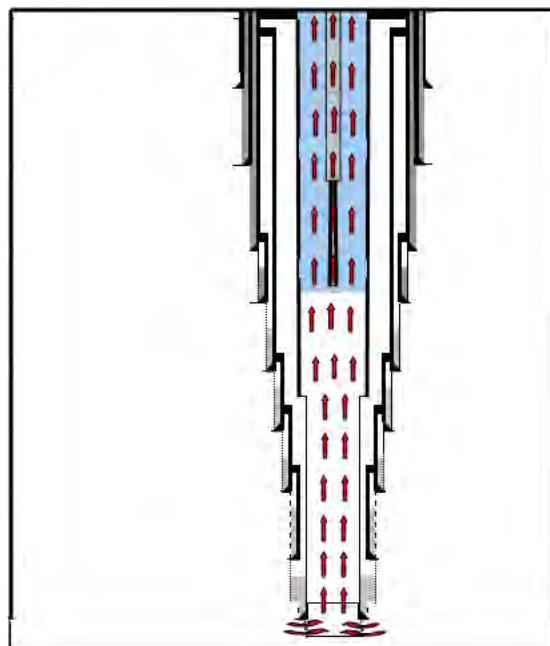
Figure 8 – Flow up the Production Casing Shoe Track

Under this scenario, hydrocarbons would have flowed from the reservoir through the casing shoe, into the well and up the riser to the rig. For this flow path to have occurred, the shoe track cement would have failed. A number of factors could have caused the shoe track cement to fail. First, mud in the wellbore could have contaminated the shoe track cement and caused the cement not to set properly. Second, the shoe track cement might have swapped out with the lighter drilling fluid in the rat hole. Third, some of the shoe track cement could have been lost into the formation. Finally, the failure of the shoe track could have resulted from a combination of these factors. This scenario is represented in Figure 8 below.

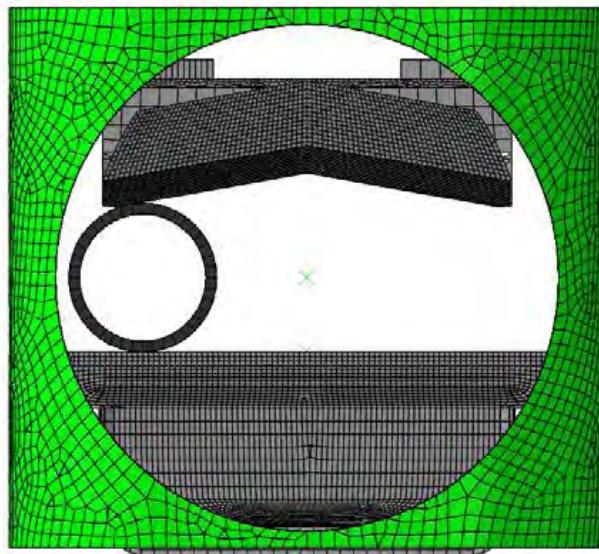
A forensic examination of the BOP stack revealed that elastic buckling of the drill pipe had forced the drill pipe up against the side of the wellbore and outside the cutting surface of the BSR blades. As a result, the BSR did not completely shear the drill pipe and did not seal the well. The buckling of the drill pipe, which likely occurred at or near the time when control of the well was lost, was caused by the force of the hydrocarbons blowing out of the well; by the weight of the 5,000 feet of drill pipe located in the riser above the BOP forcing the drill pipe down into the BOP stack; or by a combination of both. As a result of the failure of the BSR to completely cut the drill pipe and seal the well, hydrocarbons continued to flow after the blowout.

Figure 12 – Off-center drill pipe (Source: DNV)
