## Macondo Well Deepwater Horizon Blowout: Lessons for Improving Offshore Drilling Safety

# Macondo Well *Deepwater Horizon* Blowout

LESSONS FOR IMPROVING  
OFFSHORE DRILLING SAFETY

Committee on the Analysis of Causes of the  
*Deepwater Horizon* Explosion, Fire, and Oil Spill to  
Identify Measures to Prevent Similar Accidents in the Future

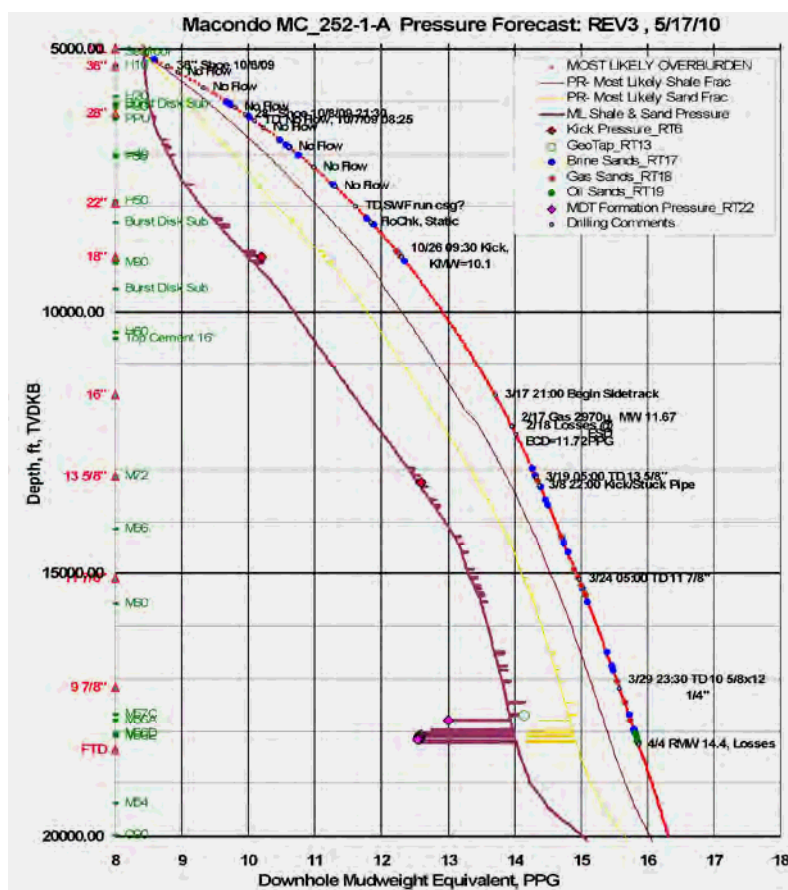
2. In the course of drilling at 13,250 feet, a kick occurred, and the lower annular blowout preventer (BOP) was closed in response. During well control operations, the drill string became stuck and was severed at 12,147 feet. The drill string and hole below 12,147 feet were abandoned, and subsequent well drilling deviated slightly to go around the abandoned materials left in the original hole. The  $13\frac{5}{8}$ -inch liner was run at 13,145 feet, which was shallower than planned, to allow the well to be drilled safely past the higher-pressure reservoir that had been encountered. The  $11\frac{7}{8}$ -inch liner was used at 15,103 feet to seal the reservoir and allow for the use of higher mud weights than had been anticipated. Mud weight was to be kept between the curves for pore pressure and fracture pressure, as shown in Figure 2-3.

**FIGURE 2-3** The four curves (moving from right to left) represent overburden stress, fracture gradients in the shale and sands, and pore pressure in the Macondo well. Depth and diameter values on the y-axis correspond to the final well bore architecture shown in Figure 2-2. The equivalent mud weight (EMW), expressed in pounds per gallon (ppg), must be higher than the pore pressure to avoid flow from the well and lower than the fracture gradient to prevent accidental hydraulic fracturing. Note the small separation between the values at depths below 18,000 feet. Source: BP unpublished report, July 26, 2010.<sup>3</sup> Reprinted with permission, BP.

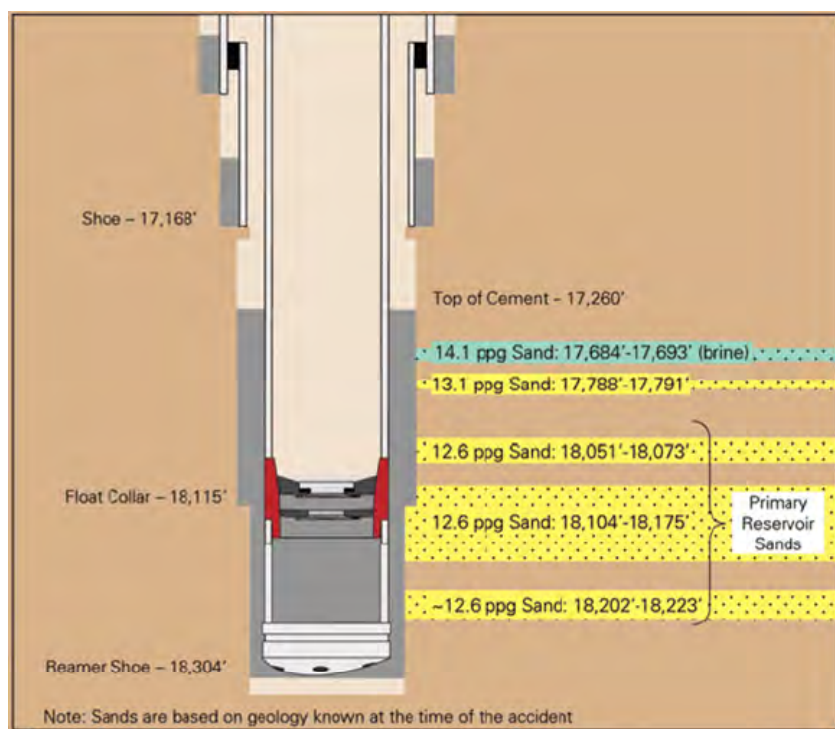
tion report, the well analysis indicated that there were in fact several reservoirs open in the wellbore with decreasing pore pressure with depth, as shown in Figure 2-4. The hydrocarbon reservoirs had pore pressures equivalent to a range of 12.6 to 13.1 ppg. A reservoir containing salt water that had a pore pressure equivalent to 14.1 ppg was also exposed in the wellbore. As discussed below, the difference between the mud weight needed to prevent flow of salt water and the mud weight above which reservoir fracture could occur was only 0.2 ppg. Recent reports in the press have indicated that a thin gas sand was present above the salt water bearing zone shown in Figure 2-4 and have questioned the possible contribution of this sand to the blowout. The committee has seen no evidence indicating that flow occurred upwards in the annulus between the production casing and the reservoirs (see discussion below). Also, the presence of the high-pressure salt water sand created the same completion problem referenced above as would have been created by the presence of a high-pressure gas sand. Therefore, the presence or absence of the gas sand is expected to have had no material effect on the cause of the blowout.

**FIGURE 2-4** Variation of pore pressure in the open hole section of the Macondo well expressed in pounds per gallon. Source: BP 2010, p. 54. Reprinted with permission; copyright 2010, BP.

To continue drilling to the planned final depth of 19,650 feet, the reservoirs that had been discovered with decreasing pore and fracture pressures with depth (Figure 2-4) were to be sealed with the  $9\frac{7}{8}$ - × 7-inch combination casing string and cement. However, because the hole diameter that could be drilled below the 7-inch casing was considered too small to be practical, the well was terminated at 18,360 feet.

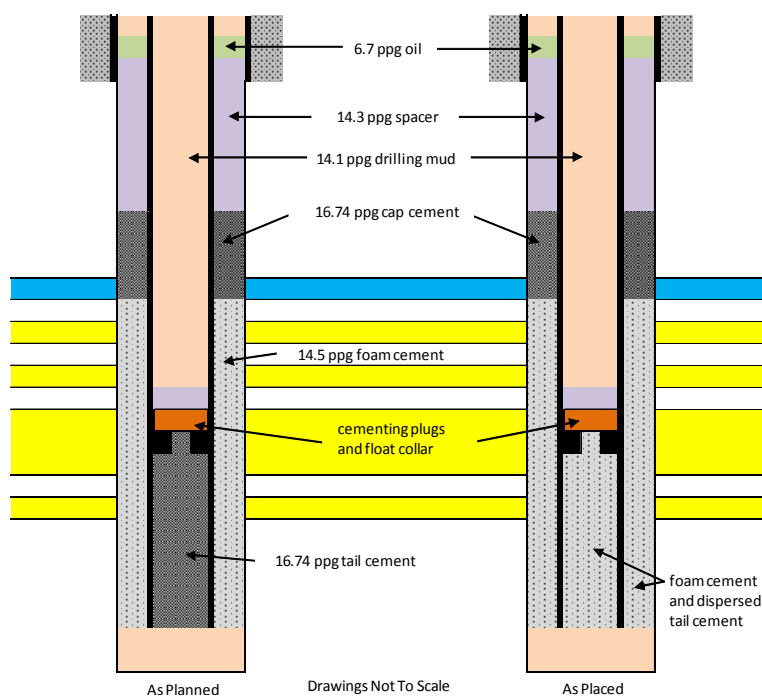
**FIGURE 2-5** Planned cement location and likely cement location after pumping. Source: Committee.

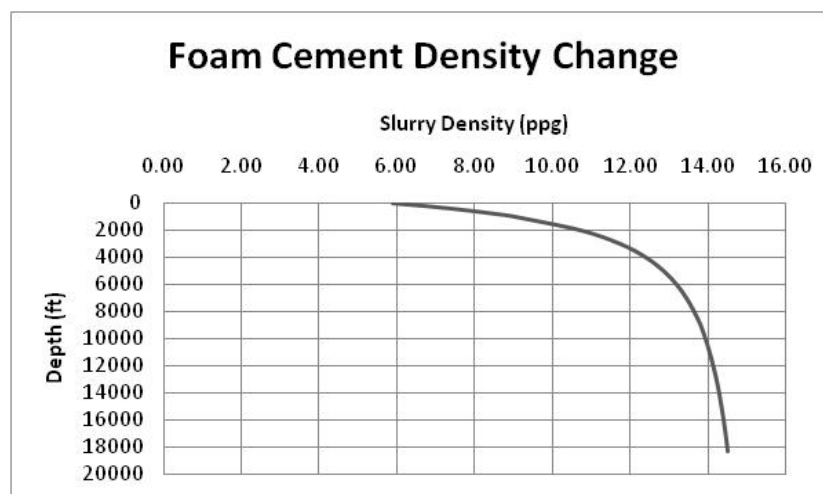
To make a foamed cement slurry that has a density of 14.5 ppg at the bottom of the well, the foam quality<sup>7</sup> had to be 17.4 percent at bottom hole conditions of 245°F and 13,321 psi (see Appendix D for the calculations).<sup>8</sup> At the surface, where the conditions in the mixer were about 600 psi and 60°F, the foam quality had to be 66 percent, producing a foamed slurry of about 6 ppg, to allow for the substantial compression and heating that were to occur as the foam was pumped to the bottom of the well. (For reference, freshwater has a density of 8.33 ppg.) Figure 2-6 shows the calculated foam density versus depth.

**FIGURE 2-6** Calculated foam density versus depth during pumping. Source: Committee.

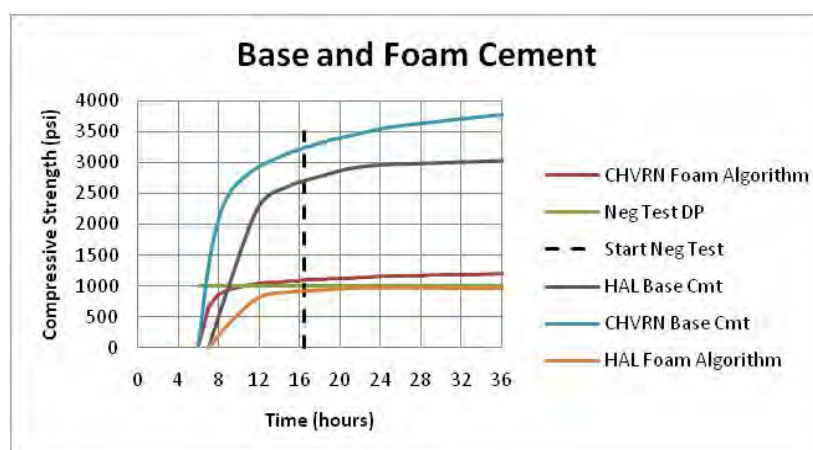
**FIGURE 2-7** Uncontaminated cement compressive strength tests (DP = differential pressure). Source: Committee.

The curves for the two foamed cements are not from direct measurement but assume that the foamed cement compressive strength is reduced according to the foam protocol used in the Chevron test software (by a factor of approximately 35 percent).

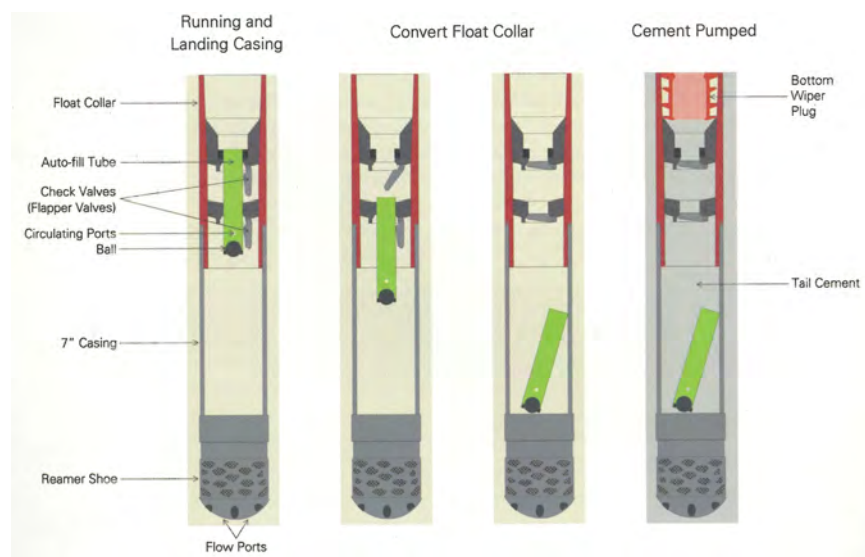
**FIGURE 2-8** Float collar with flapper valves and differential fill tube. Source: BP 2010, p. 71. Reprinted with permission; copyright 2010, BP.

Once the casing was in place in the Macondo well, initial circulation could not be established until 3,142 psi of pump pressure was applied. This suggests that the shoe track was plugged with foreign material when it was run into the well. The practice of allowing mud to fill the casing by flowing up through the differential fill tube is a time-saving step that would not be needed if the casing were filled with mud from the top as it is run, a much slower process but one that reduces the possibility of debris entering the casing.

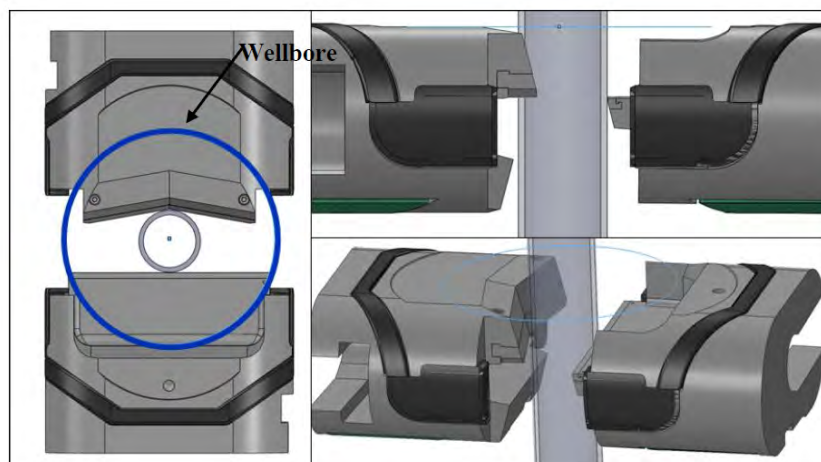
The BSR was the uppermost of the five rams of the BOP stack and is shown for nominal operation in Figure 3-2. A BSR is like a massive metal scissors with two opposing blades that are designed to slice through the drill pipe as the blades pass by each other, as shown in Figure 3-3, and seal the well. The design intent was that, when the two blades of the “scissors” passed by each other and fully penetrated into the “side packers” on the other side, the seal

across the BOP bore was to be effected and thus seal off the entire throat of the BOP. The BSR was, by design, a device of last resort in a hierarchy of well control strategies: when all else failed, the BSR was to slice the drill pipe and seal the well. Even if no drill pipe was present in the BOP system, the BSR was designed to seal the well when the “scissor blades” passed by each other and into the side packers.

**FIGURE 3-2** Sketch of intended nominal operation of BSR in the Macondo well. Source: DNV 2011a, I, p. 155. Reprinted with permission; copyright 2011, DNV.

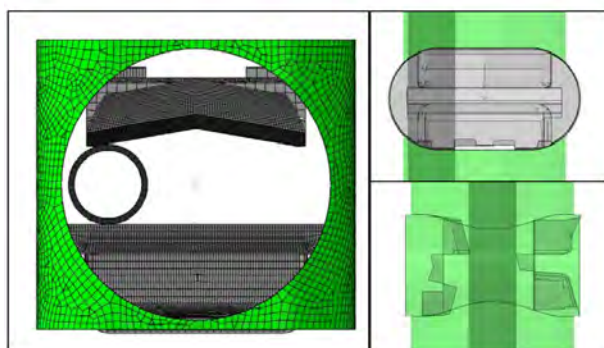
**FIGURE 3-5** Finite element analysis model of BSR blade surfaces and off-center drill pipe. Source: DNV 2011b, p. 15. Reprinted with permission; copyright 2011, DNV.

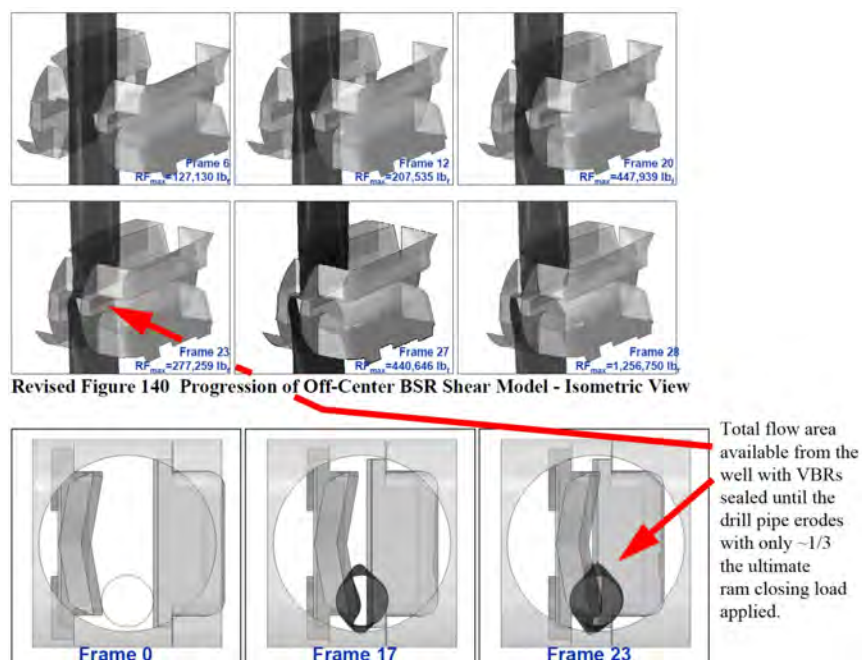
**FIGURE 3-6** Progression of off-center BSR shear model, isometric view (*top*) and top view showing deformation of drill pipe outside of shearing blade surfaces (*bottom*). Source: DNV 2011b, p. 17. Reprinted with permission; copyright 2011, DNV.
