## CATASTROPHIC FAILURE OF MUD CENTRIFUGE

**ALERT 5-20**

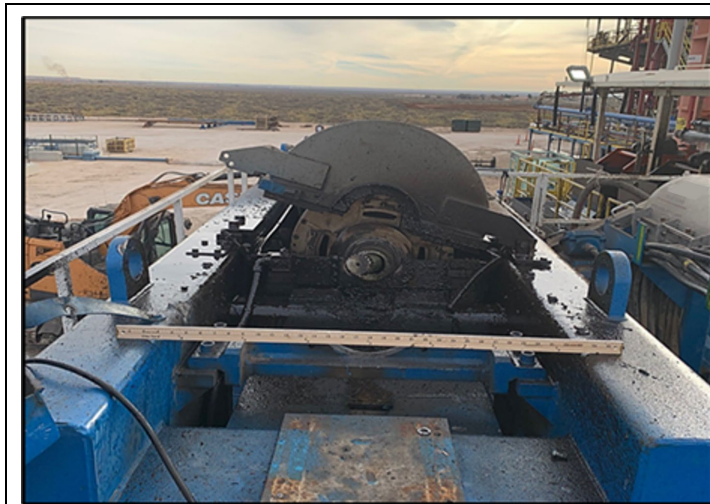
Fig. 1 - Failed Centrifuge

While processing drilling fluids, a mud centrifuge (Fig. 1) experienced a catastrophic failure resulting in the ejection of the pillow block bearing assembly. The 65 lb. assembly traveled approximately 190 ft before striking the steps of a living quarter trailer (Fig. 2). The gearbox, back drive electric motor, coupler and associated components were also dislodged from the frame but remained within the confines of the centrifuge platform.

- Inadequate maintenance at third-party facility
  - Three of twelve gearbox adaptor flange bolts installed at a third-party maintenance facility were found to be of insufficient length
  - Fit between hub and gearbox flange that had been incorporated into this machine to reduce torque on the flange bolts had been machined out, without consultation with OEM
- Vibration sensor on unit was non-operational
- Protocols for verifying and maintaining bolt torques were inadequate
- The gearbox restraint system was inadequate and did not prevent dislocation of the gearbox from the confines of the frame

- Functional verification of safety critical sensors should be conducted before utilizing any piece of machinery
- Implement torque verification protocols during routine maintenance
- Consider installation and verification of effectiveness of secondary restraints on exposed rotating components
