# SAFETY ALERT

## WORK PLATFORM DROPPED INTO SEA

ALERT 8-20

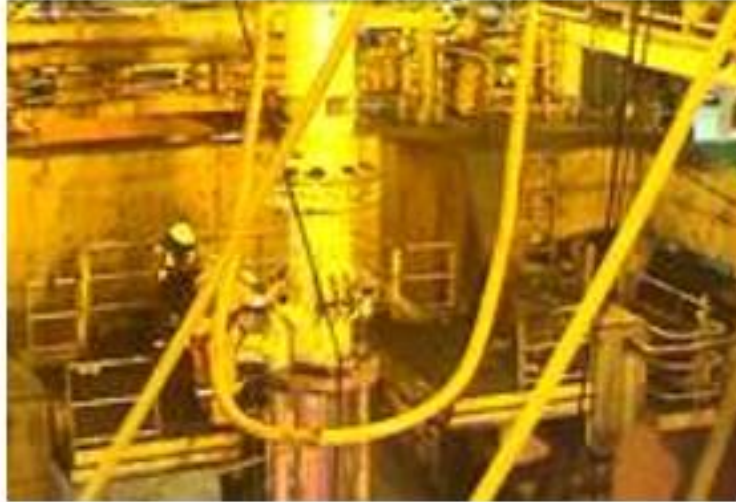
While maneuvering the BOP trolley work platform, the platform operator intended to move the platform closer to the riser, but inadvertently activated the wrong lever on the control panel. This action released the work platform securing pins, dropping the platform into the sea. Two personnel were on the platform when it was accidentally released and were restrained by their Self Retracting Lifelines (SRLs) and retrieved without injury. *(Images on Pages 2, 3)*

**Work area immediately before event**

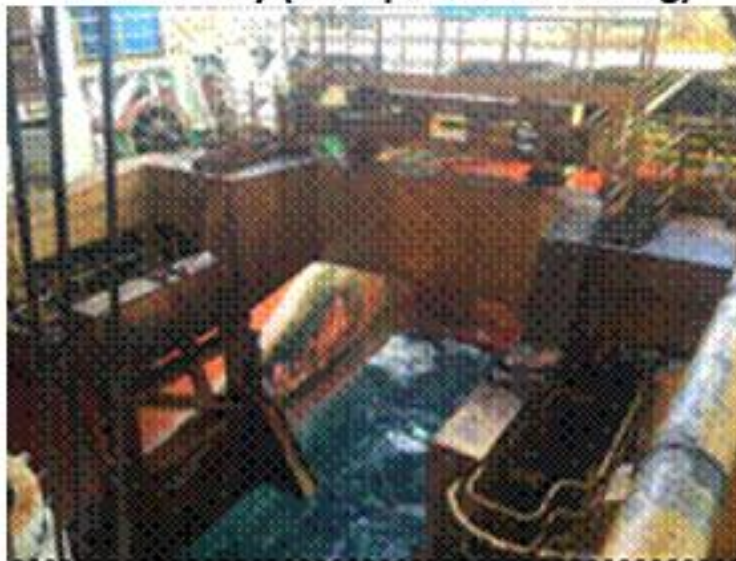
**BOP Trolley (with platform missing)**

Following this incident, an engineering solution has been designed that prevents the trolley platform from falling in the event the platform securing pins are inadvertently released. It is recommended that all members review support mechanism on any similar platforms to ensure the design is such that accidental release of pins will not result in an uncontrolled drop of the platform.

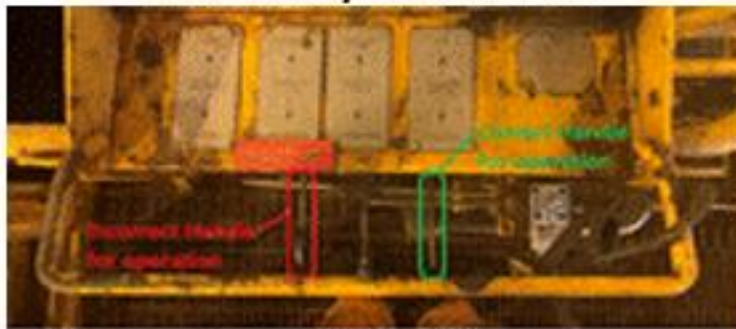
The control panel is of poor ergonomic design, with the securing pin retraction and trolley travel control levers being of similar look, size and design and housed together in a bank of levers. In addition, the orientation of the panel is such that the operator is facing the opposite direction (to the controls) when looking at the work area. To sum, the design of the working platform did not eliminate the risk of platform dropping to sea, thus prevention measures were reliant on operational procedures.

**BOP Trolley Control Panel**

Until engineered solutions have been implemented across the fleet, rigs are recommended to review procedures, work plans, work tempo and task-based risk assessments to ensure sufficient risk controls are in place. Simple interim measures should include the installation of a manually operated isolation valve, capable of being locked out, to prevent inadvertent functioning of the platform securing pins.
