SAFETY ALERT

MARINE RISER DROPS TO DRILL FLOOR

ALERT 21-1

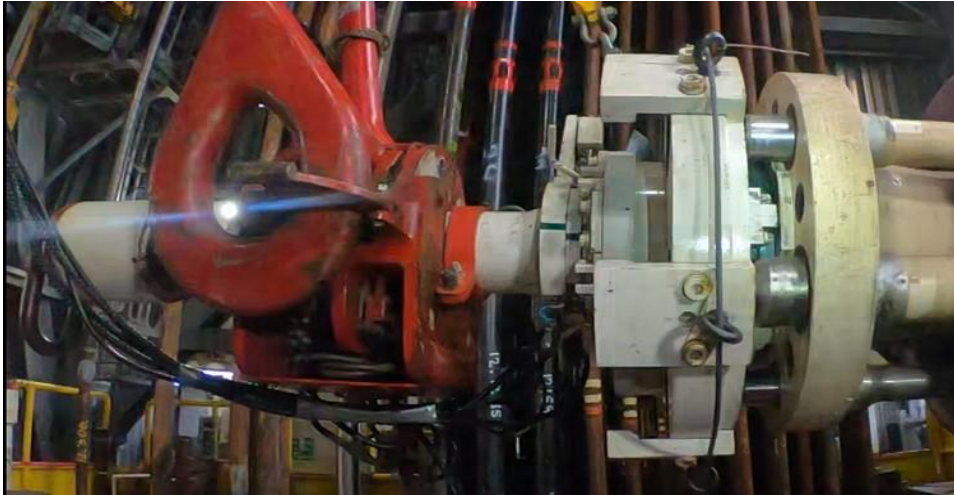
When installing the RRT, it was inserted with an angle into the riser and the RRT didn't engage properly into the riser. This gap was not detected by the rig crew involved. The procedures did not provide detail on **how** the RRT was to be verified as locked, only that it should be verified. During the planning up-front, the important task of lock verification wasn't discussed.

Figure 1 RRT stabbed onto the riser

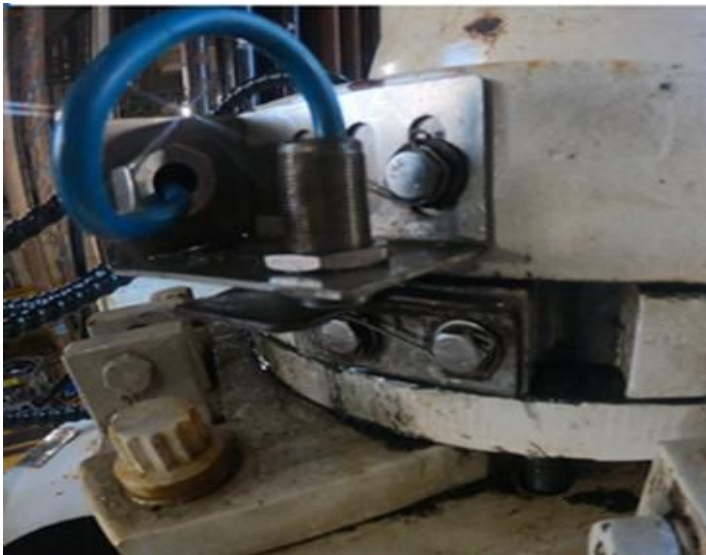
The RRT in this event is hydraulically operated to a locked position, and then secured with a hydraulically operated secondary locking ring which mechanically ensures that the primary lock is in position and cannot unlock. The lock ring in use is further secured with a locking pin which requires manual intervention to install. The RRT in this event was not equipped with this pin, but was equipped with a proximity switch to indicate RRT lock status to the driller when the secondary lock was rotated into lock position. In this event, it was verified by review of equipment logs that the proximity switch transmitted the signal to the driller's control panel indicating the RRT was locked before the joint could be lifted. It was also found in the investigation that the proximity switch could be activated in some conditions in which the secondary lock was not fully engaged.

In this event two verification methods failed, a visual verification and electro-mechanic verification.

Figure 2 Proxy Switch giving signal to driller when the RRT is locked

Following this incident, the design has been improved to replace the proximity switch with a contact switch which lowers the probability of the switch falsely indicating a locked RRT. It is recommended that all members review their riser running system for risks – with a special focus on mechanisms used to both lock and verify the RRT is locked.

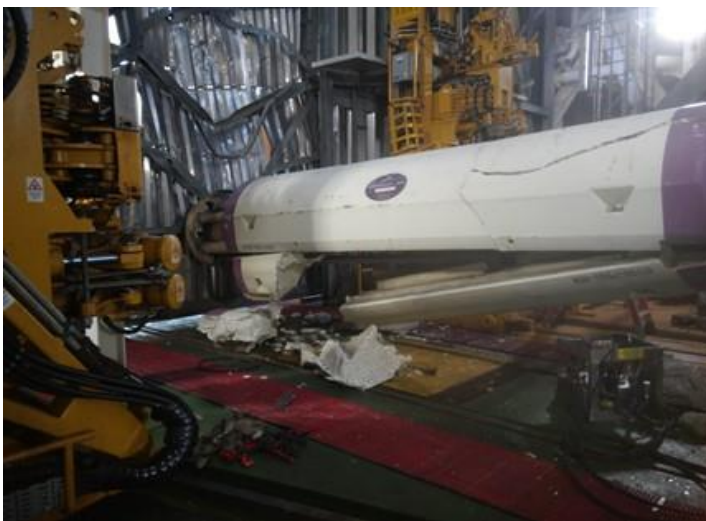
While transporting the first riser joint to the drill floor, the joint slipped out of the Running Riser Tool (RRT) and dropped on to the drill floor. Before lifting the RRT, it had been visually inspected by drill floor crew and verified as locked. In addition, a positive indication from the tool's proximity switch was given to the drilling control, that the tool was locked and ready to lift. There were no personnel in the red zone. *(Images on Pages 2)*

Figure 3 The dropped marine riser hitting the V-door
