# SAFETY ALERT

*Two LTI's result from dropped object while preparing to run BOP*

*ALERT 2-21*

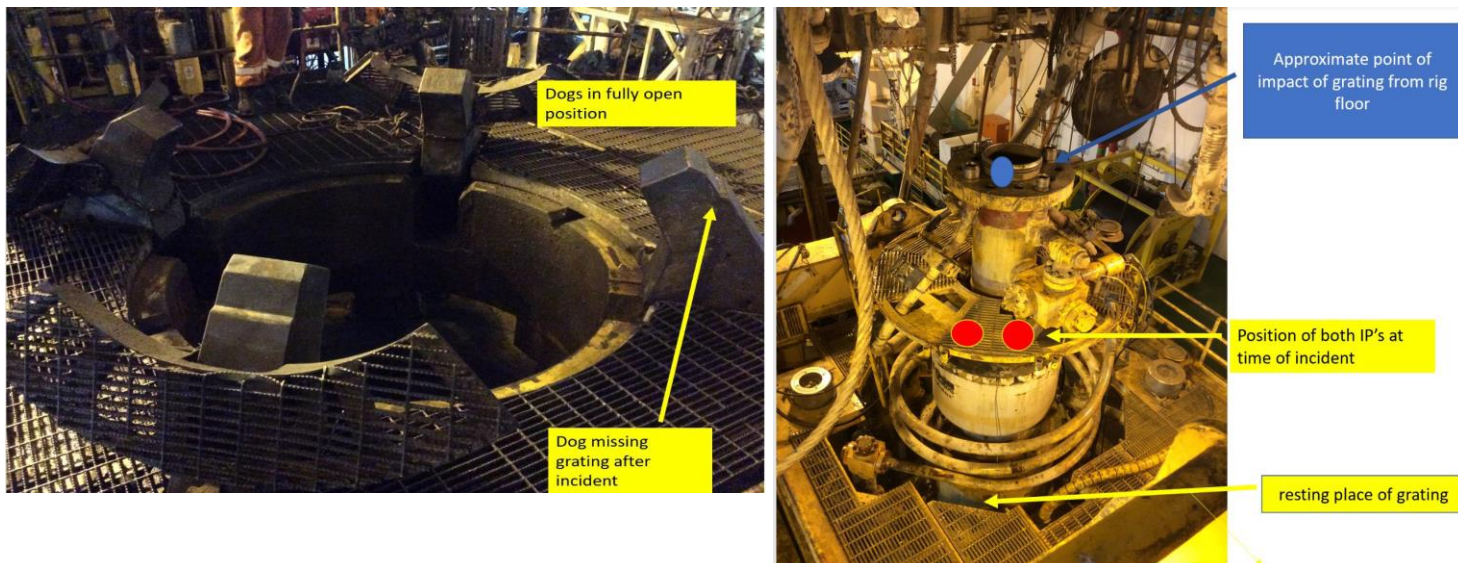
After repairing the Blind Shear Rams, the BOP was being prepared to run back on the well. A 90' slick joint of riser had been picked up in preparation to begin deployment of the BOP. While functioning the spider dogs into the open position to lower the joint through the spider and rotary, the grating attached to one of the support dogs dislodged and fell through the rotary table to the top of the BOP. The grating impacted the BOP riser adapter, then deflected and hit two personnel who were positioned around the riser adapter preparing to make up the first riser joint. Both workers sustained injuries and lost time from work.

- **Inadequate Safety Securing** –The safety securing chain kept the grating from falling backward onto the work platform, but not forwards and down through the rotary.
- **Personnel present in moonpool below rotary table** – Poor communication between drill floor and moonpool.
- **Moonpool Area not identified as red zone in risk assessment** –Risk assessment did not consider personnel on the BOP, thus putting them in the line of fire.
- **Lack of Procedural Discipline** –Company procedure for this operation was not followed.
- **Management of Change (MOC)** – A similar event had occurred in the past on another rig in the fleet. The MOC process risk assessment recognized the potential for the grating to fall backward onto the work platform but failed to identify the potential for the grating to fall forwards and down through the rotary.

- Review spiders in use across fleet and grating and safety securing system to prevent grating falling into the rotary.
- Focused plan to improve procedural discipline in operations required to ensure procedures are followed.

- Focus on Risk Assessment, effective Red Zone management, and ensuring clear communication between adjacent work areas. Planning of work requires site visits, particularly in areas where there is potential for personnel to be working adjacent to, above, or below an area with high-risk activity, potential dropped objects, or where work in one area can impact another. Risk assessments and work plans must clearly identify how these risks are to be managed. This includes identification of extended red zones and clear scheduling of activities in tasks to ensure personnel are not in the line of fire.

- Improved communication across fleet to highlight issue of spider and grating safety securing for this design of spider.
