SAFETY ALERT

Uncontrolled release of Hydraulic Gooseneck Ring

ALERT 6-21

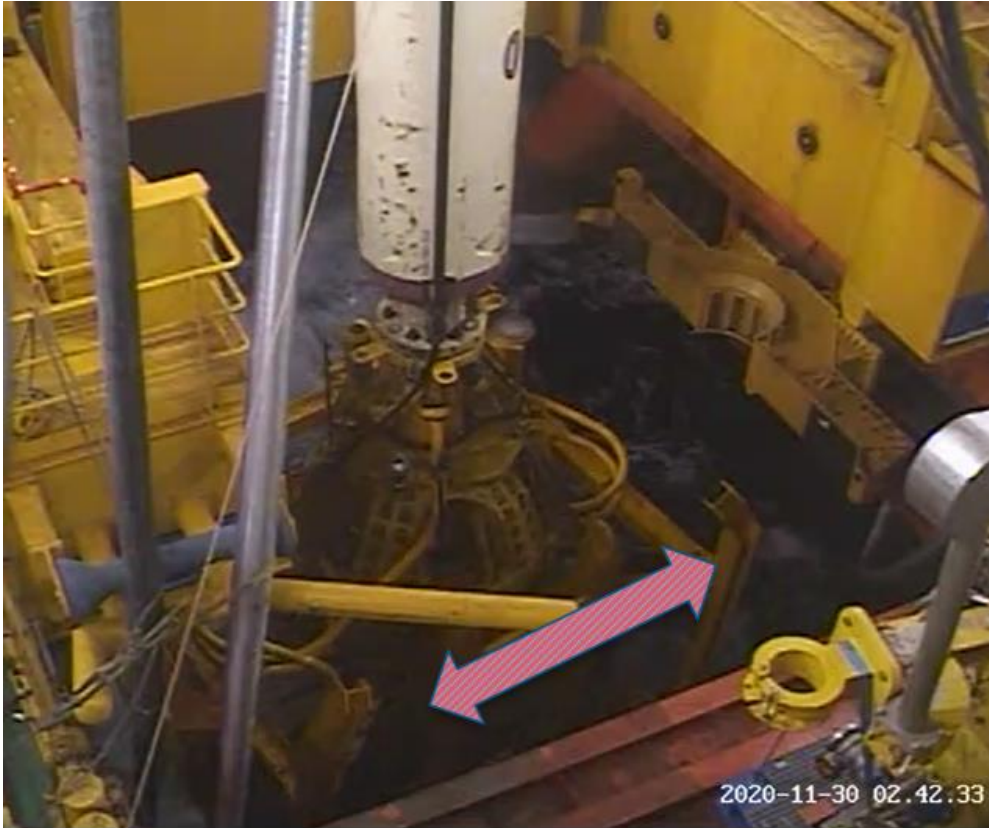
The gooseneck ring experienced lateral motion from the riser when the BOP went through the splash zone.

Fig-1: Screenshot from CCTV. Prior to gooseneck ring drop. The riser and BOP can be seen swinging from side to side when BOP is in the splash zone

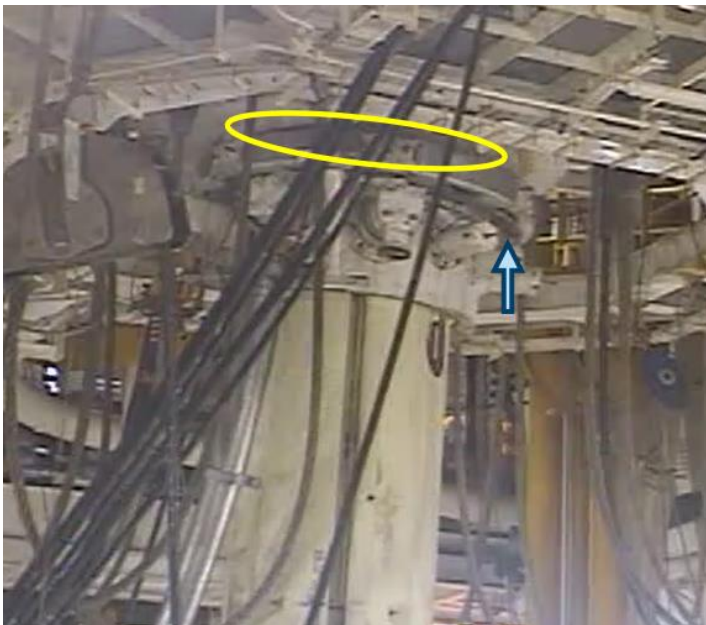
Hydraulic pressure to the storage dogs and locking mechanism was not maintained during pulling of the BOP and riser. It is likely that the gooseneck ring would not have dropped if hydraulic pressure had been maintained. The locking ring would have been in the upper position and the blocks would have kept the storage dogs extended. However, a leakage or hose rupture in the hydraulic connection to the gooseneck ring during pulling of the BOP and riser could have led to the same outcome as this event.

Fig-2: Screenshot from CCTV. During pulling of the BOP through the splash zone a gap between tension and gooseneck ring emerged, as indicated by yellow circle

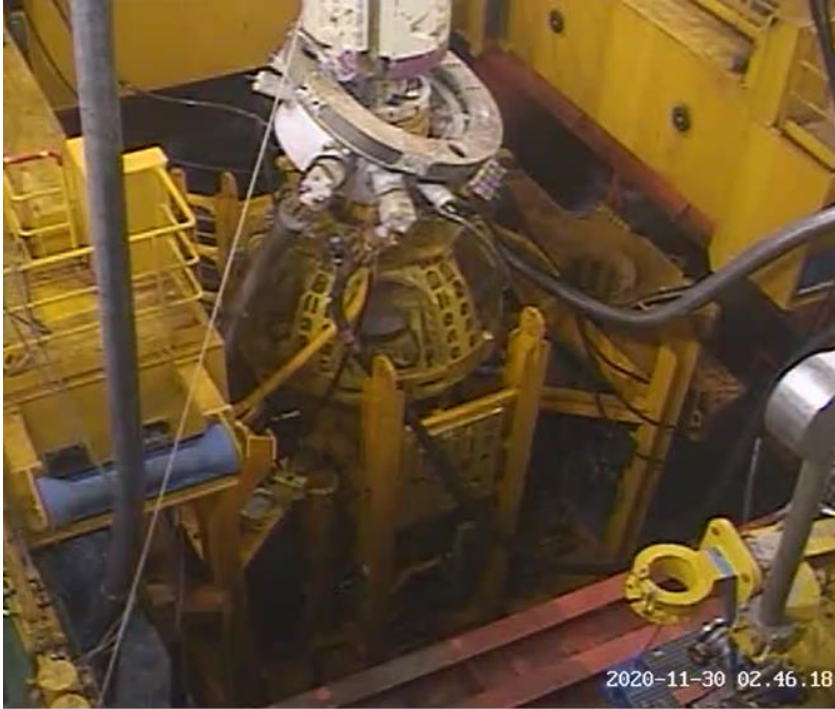
During pulling of the BOP, the gooseneck ring dropped from its storing position on the tension ring and landed on the flex joint. When the BOP entered the splash zone, it experienced less resistance from the air compared to the sea. This, combined with some rig movement, created a pendulum effect when the BOP was almost out of the splash zone, resulting in the riser colliding with the gooseneck ring, and the gooseneck ring dropping onto the flex joint. Immediately after the gooseneck ring dropped, the BOP was raised clear of the splash zone and secured in the under-hull guides. The dropped gooseneck ring affected the integrity of the storage dogs and storage dog locking mechanism and resulted in downtime.

The gooseneck locking ring had no mechanical lock or interlock mechanism to keep it in stored place on the tension ring during the BOP pull. The OEM had not identified that this could happen during FMECA (Failure Mode, Effects & Criticality Analysis).

Fig-3: Photo taken after Gooseneck ring had dropped

- OEM to find a permanent solution for securing the gooseneck locking ring, to review and update FMECA, and to review and update the equipment manual for the riser system.
- Design requirements for locking systems for overhead rings within the marine riser system currently do not exist so a task group is being set up to draft specification requirements.

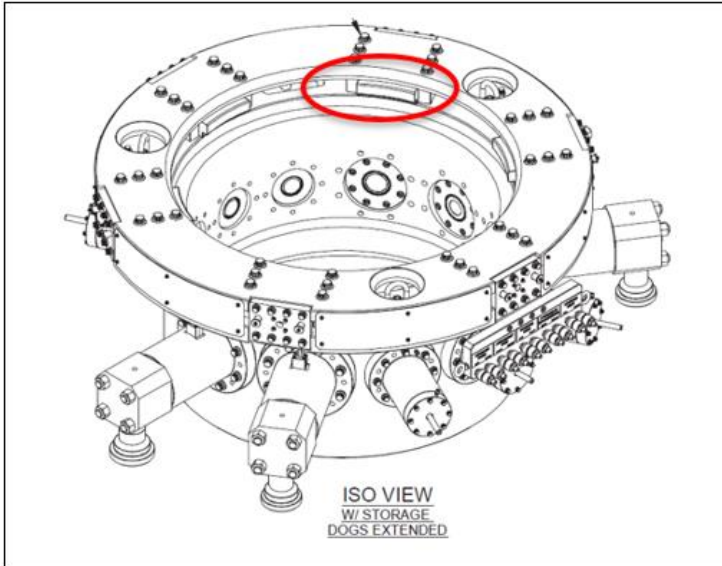
Fig-5: Gooseneck Ring. Red circle shows one of the six extendable storage dogs

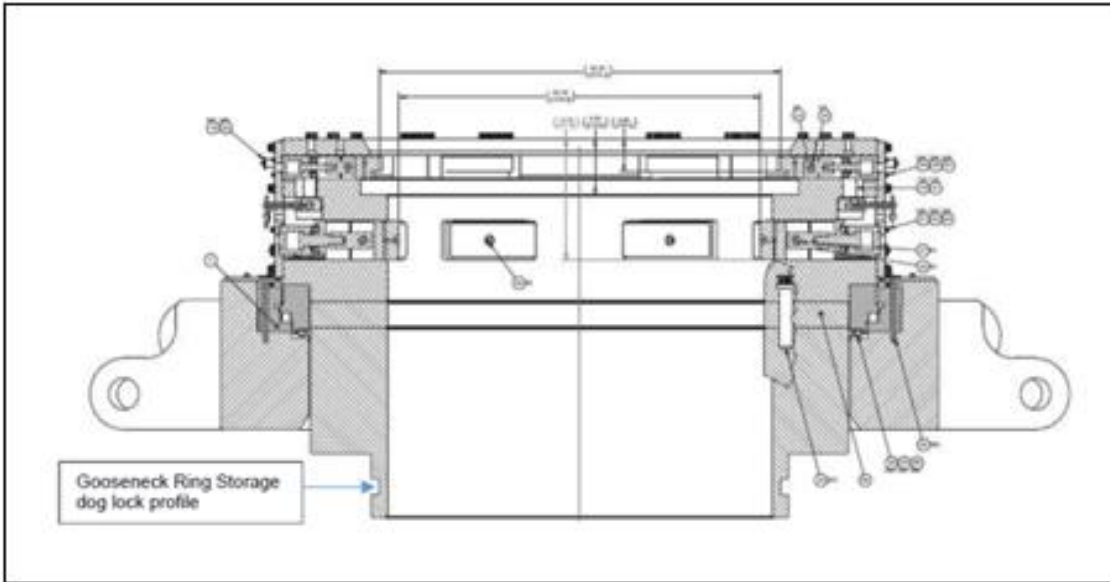
Fig-6: Tension Ring. The gooseneck ring is stored onto the tension ring by extending all storage dogs into a profile on the tension ring.
