# SAFETY ALERT

## MUX Cables and Hotline Hose Damage results in BOP Control Pods Losing Power and Communications

Alert 4-22

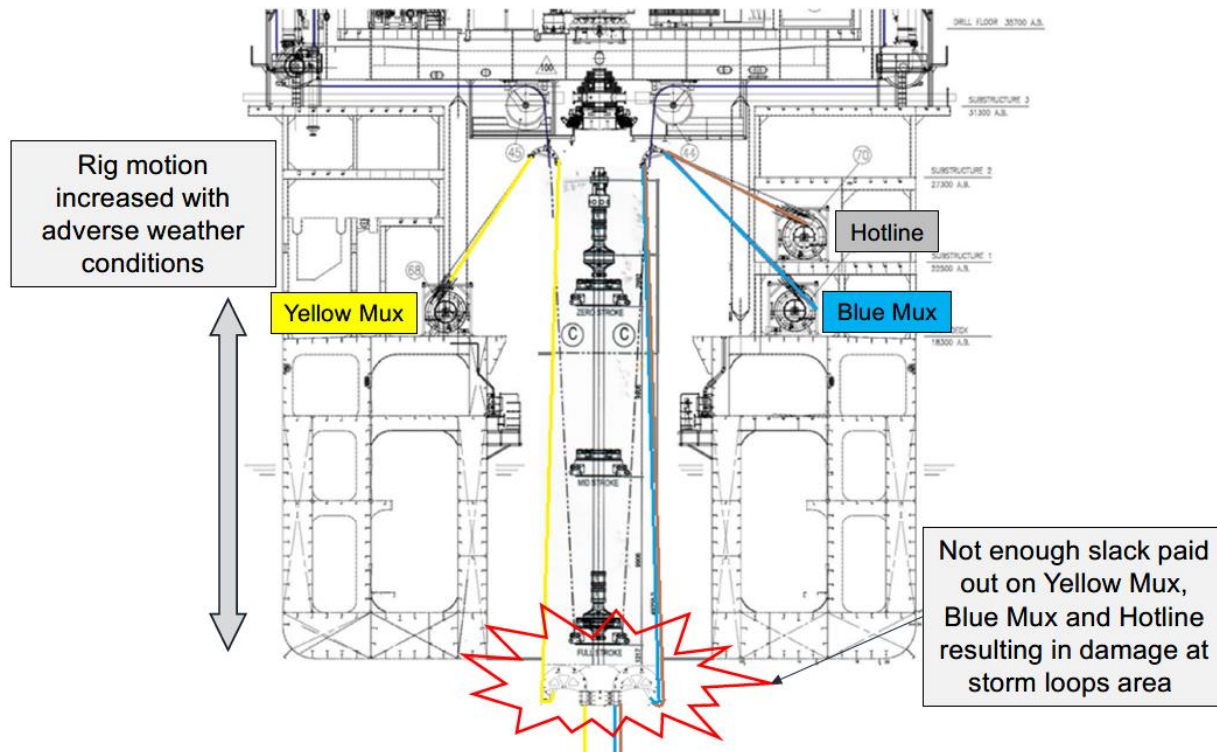
Subsea Blow Out Preventer (BOP) loses partial communications while latched to a well. The hotline hose, the yellow pod and blue pod multiplexed communication (MUX) cables were damaged due to excessive tension during harsh weather and extreme heave conditions. Control and operability of the BOP were maintained through the Acoustic Pod and subsea Remotely Operative Vehicle (ROV) panel.

- **Design Difficulty** - During BOP deployment, the length of Mux cables and Hot Line hose paid out between reels and storm loops was insufficient to accommodate the maximum anticipated heave amplitude under local environmental conditions.
- **Sea Conditions** – Deterioration of weather conditions rapidly increased heave amplitude beyond what the system as deployed could tolerate with insufficient time for the crew to make necessary adjustments.

- Implement formal process for independent review and validation of the amount of slack paid out during BOP deployment (Mux cables, Hot line, other control lines as applicable) to accommodate the full stroke of the Telescopic Joint (TJ), plus an adequate safety factor.
- Depending on Rig design, perform an ROV inspection of the storm loop area after any weather conditions where heaving amplitude approached the maximum TJ stroke.
