WHAT HAPPENED:

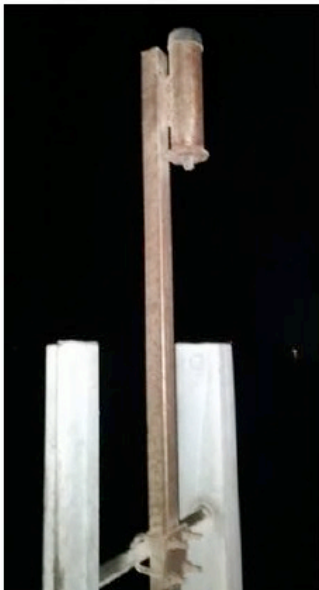
Parted Point between carrier lug and carrier cable

Damaged vertical ladder fall arrest carrier cable could not be identified during external visual inspections.

OEM for vertical ladder fall arrest system does not specify to inspect internal components.

Utilize the Certified 3rd Party Inspectors to conduct an inspection of vertical ladder fall arrest system and replace failed systems identified during the inspection (if any).

Develop planned inspection/maintenance of internal components that can not be inspected by external only inspections.

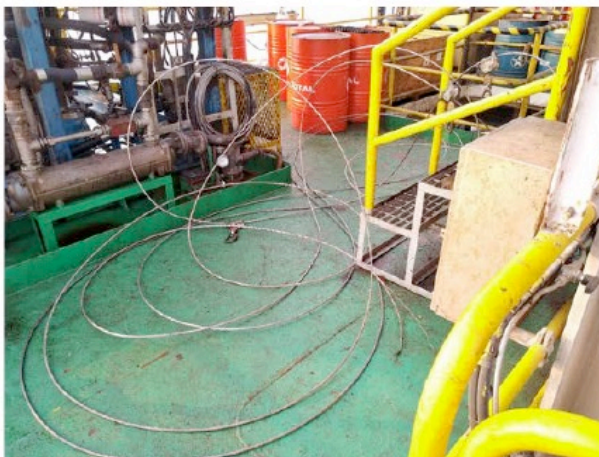
The hissing sound of the carrier cable dragging onto the derrick ladder back scratcher was heard by the drilling team working on the rotary table. The Team went to investigate and found the carrier cable descended through the fall arrest sleeve, within the confines of the back scratcher, and came to rest on the drawworks roof.

Carrier cable coiled on drawwork roof
