## WHAT HAPPENED:

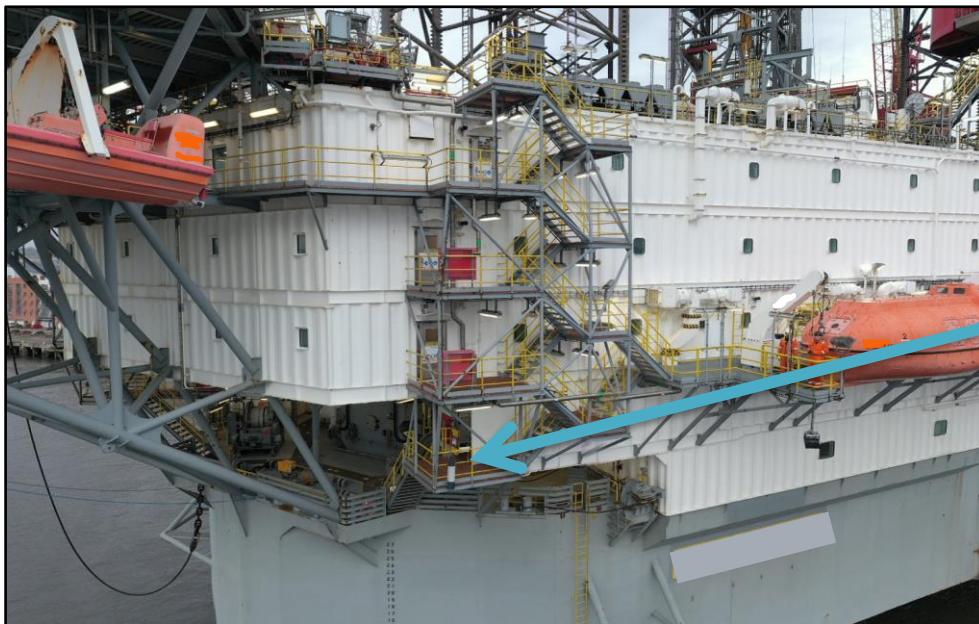
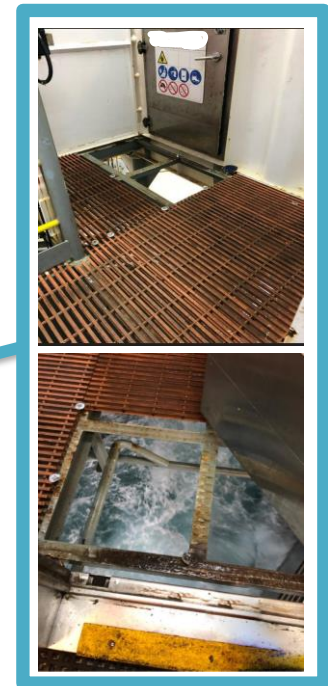
While a jackup rig was being wet towed, a section of deck grating located immediately outside an egress point from the Living Quarters was found to have been dislodged under the action of the waves being forced up the side of the hull. The dislodged grating was part of a platform located directly over water, more than 20 ft. above the rig's floating draft. The sea state recorded at the time showed 8-10 ft. significant wave height.

Design – Since the original design and construction of the rig, the GRP (glass fiber reinforced plastic) grating, and fasteners used in this area were not expected to be subject to wave action. While the dislodged section of grating was found essentially intact, it had been evidently forced up from its fasteners by the wave run-up.

1. The company undertook a review of all similar grated platforms across its jackup fleet and decided to replace all GRP grating and fasteners in areas directly over water and located at an elevation below the rig's life boat platforms. The GRP grating was replaced with steel grating and fasteners with specification and quantities to resist wave action.
2. Also, the company is collaborating with the competent authorities to determine whether construction standards for this type of structure need to be revised.
