## WHAT HAPPENED:

# Safety ALERT

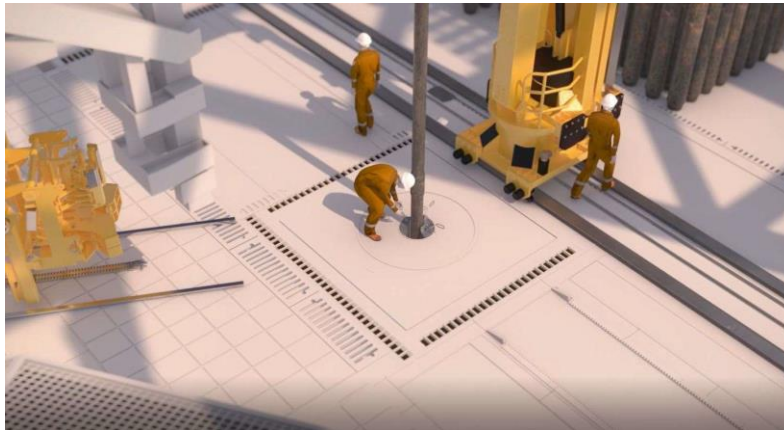
The photos on the following page are taken from a video reconstruction of the incident. They show (1) the IP tying slips while the remaining crew move out of red zone as per procedure, (2) the view from the drillers chair, with hydratong and hydrarackers being able to be moved at the same time with different joysticks, and (3) the IP caught between casing and hydratong.

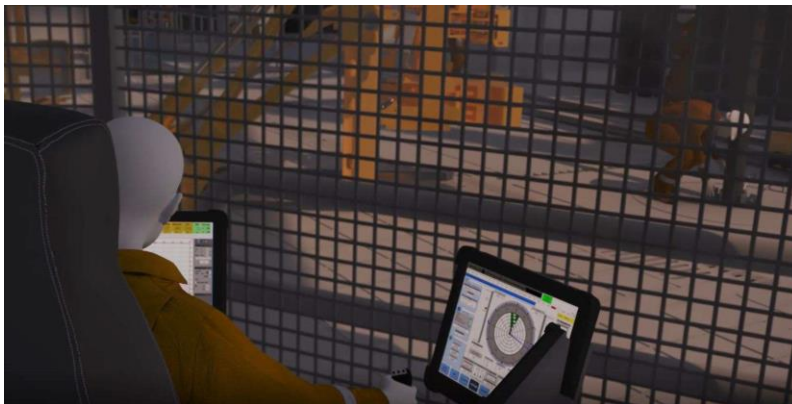
- Engineering design allowed for multiple pieces of equipment to be operated at the same time
- Complex task dependent on human performance
- Personnel in red zone while hydratong was moving to well center
- No proximity sensors or alarms to indicate, or stop equipment, if personnel are in the line of fire
- A significant change to the existing process/method of work had not been adequately assessed.

1. All procedures and Job Safety Analysis (JSA's) were reviewed to ensure that safe locations for personnel are identified prior to moving equipment.
2. Evaluation into the practicality of installing audible or flashing alarm to indicate travelling equipment is moving to be performed.
3. Review of practices for tying slips in line with industry best practice to be performed.
  4. Commissioned the OEM to develop a software change that includes an engineered stop in the hydrating travel (1 meter from well center) requiring a confirmation from the Operator prior to proceeding.
5. Investigate automated red zone management systems for future installation.

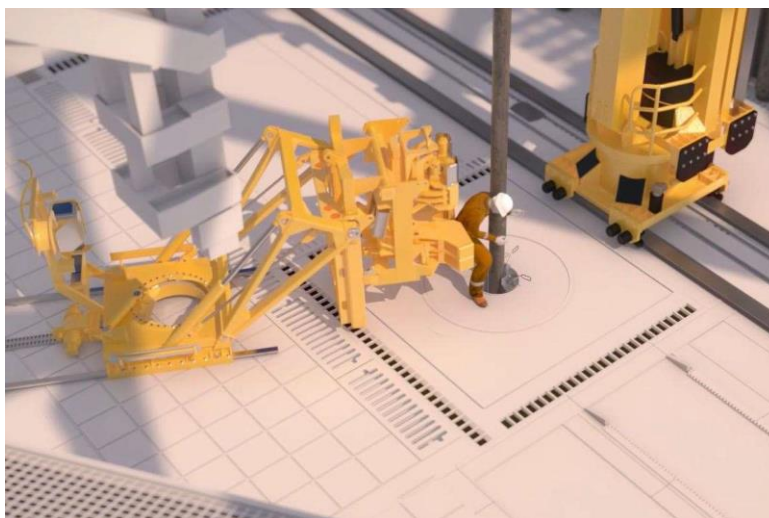
During tripping operations, a member of the drill crew - while tying slips - was caught between a moving hydratong and a pipe stump in the rotary. The IP sustained only minor injuries, however, there was significant potential for much greater serious injury, or fatality (SIF).
