## WHAT HAPPENED:

Electrical shock to rig personnel from third party rotating head hydraulic unit.

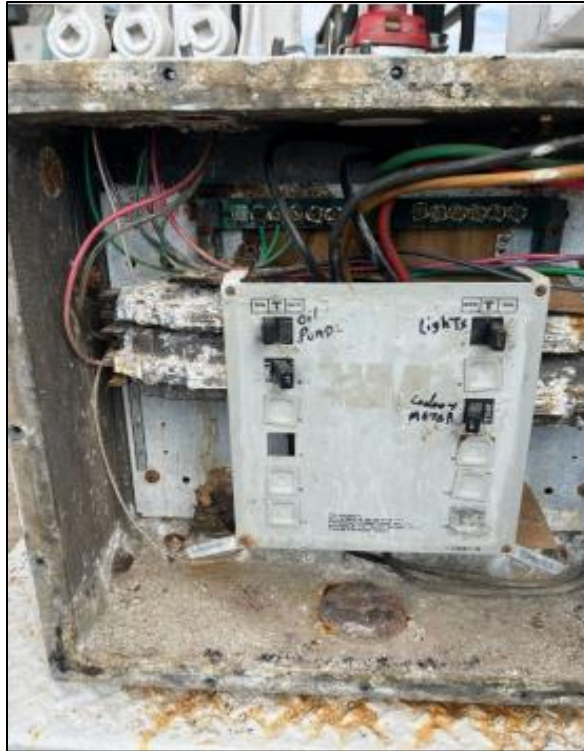
1. Upon inspection the equipment owner's electricians observed a burnt breaker on their oiler unit.
2. They also found the circuit breaker panel (all 110v circuits) on the oiler unit had water inside.
3. The water had most likely entered from a broken conduit entering the top of the panel.
4. The oiler unit was also found to not be grounded.

Showing breaker panels inside unit.

1. If the third-party rotating head hydraulic unit is not properly sealed and grounded, there is a potential for failure which can result in a serious injury or fatality.
2. Notify third parties when damaged equipment is identified to get the equipment changed out or the issues corrected.
3. Ensure that repaired equipment is in good working order before returning to service.
4. Thoroughly visually inspect third party equipment to ensure it appears to be in good working order upon arrival at location and periodically thereafter.

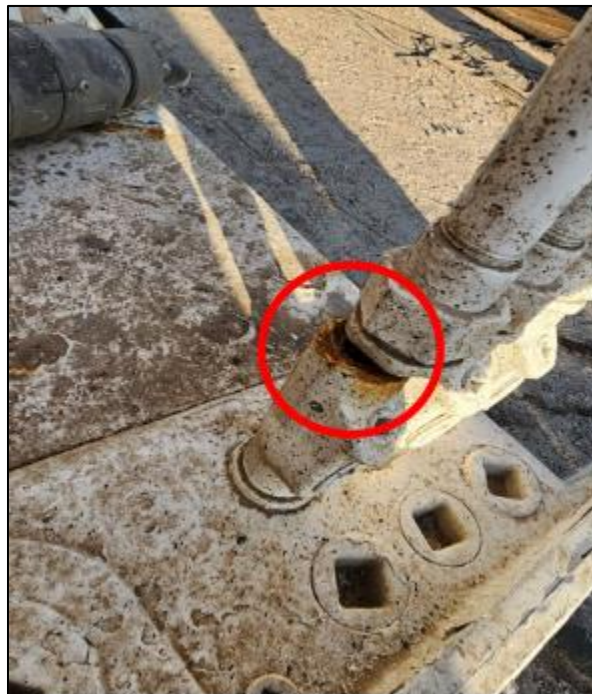
Area of damage to the unit allowing moisture inside once the silicone was removed from this area.
