WHAT HAPPENED:

A rubber bumper stopper for the derrick elevator (offshore) detached from its original mounting bracket and fell 20m landing on the Hydraracker Upper Level of the derrick. The bumper stopper weighed 600g, with the outcome of the DROPS calculator deemed to be a potential fatality. There were no personnel in the area and no injuries to personnel.

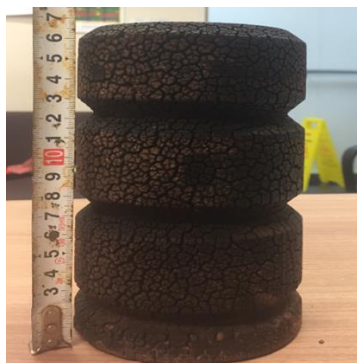
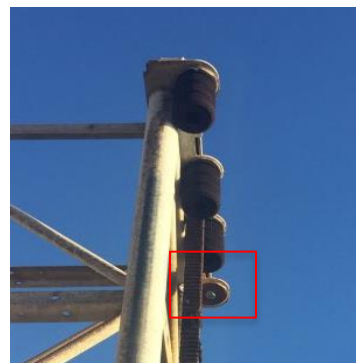
- Derrick structure and fixed overhead equipment failure.
- Independent OEM inspections and lack of shared lessons learned from similar incidents within the industry resulted in a failure to recognize or communicate the drops potential of the bumper stoppers.
- The primary securing method of the bumper stoppers was inadequate by current DROPS recommended practice, and the incumbent drops process did not fully address the associated risk.
- A new design of rubber bumper stopper was not highlighted or prioritized for change out.
- Deviation from agreed independent drops inspection criteria.

1. Review independent drops inspection criteria and verify that inspections are being completed in line with the agreed scope of work.
2. Consult elevator provider to ensure most up to date rubber bumper stops are installed that conform with current DROPS recommended practice.
3. Ensure that bumper stoppers are included in drops inspections.
