Safety ALERT

Lifting Incident on Pipe Deck

Alert 24-7

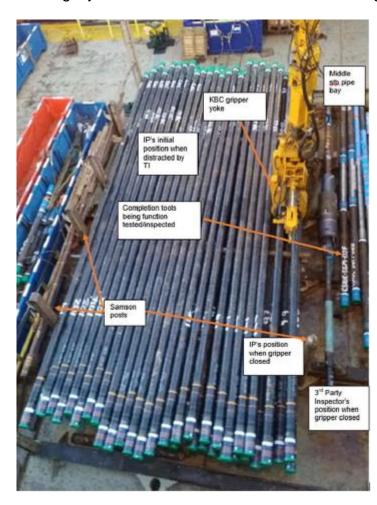
As the Banksman positioned the gripper yoke to pick up the 4th joint, the 3rd Party Inspector shouted to the Banksman. The Banksman radioed the Knuckle Boom Crane (KBC) Operator and proceeded to walk towards the 3rd Party Inspector. In doing so the Banksman placed a foot between two casing joints. The KBC operator closed the gripper yoke which was misaligned over the target joint which struck the Banksman resulting in several bone fractures.

- The Banksman was not aware the 3rd Party Inspector was working within the barrier.
- The Banksman was not suitably positioned to enable visibility of the area and the lifting team.
- The gripper yoke was misaligned when the gripper was activated to close.

- Radio instructions were not confirmed between Banksman and KBC Operator
- A Tool Box Talk (TBT) had not been performed prior to recommencing the activity
- The Task Risk Assessment (TRA) & lift plan in use were generic and not specific to the activity
- The activity was not recognized as a blind lift or controlled by a permit

- All work stopped and a safety stand-down conducted with all personnel onboard
- Job specific lift plan and TRA developed
- Activity controlled by permit
- Launched incident investigation
