Safety

ALERT

Dropped Object – Mud Hose Lifting Collar Insert

Alert 24-8

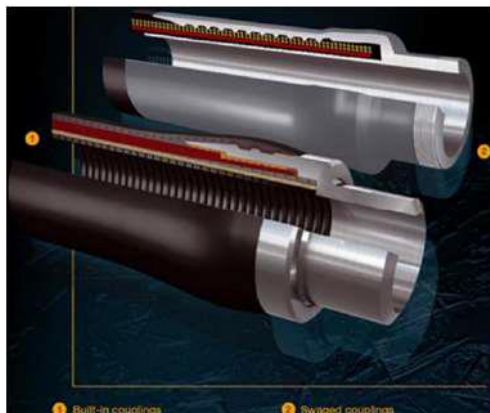
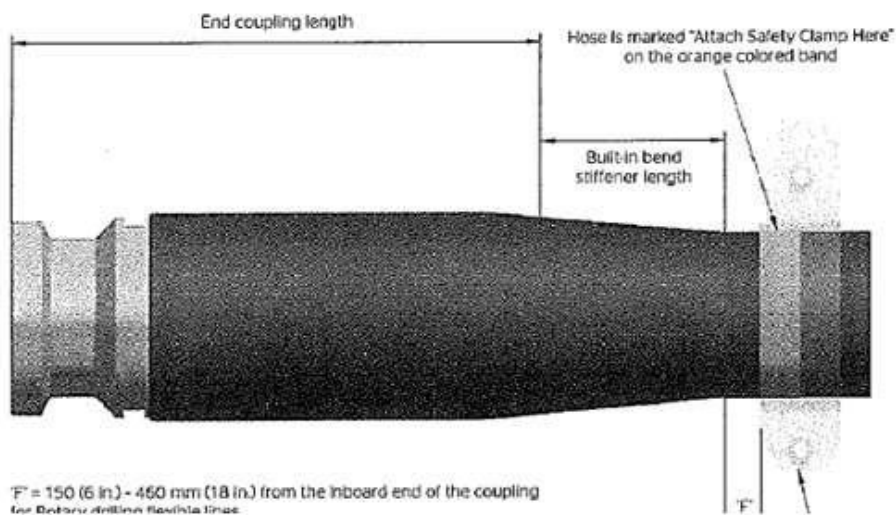
A new mud (Kelly, Rotary) hose assembly was installed in the derrick during Special Periodic Survey (SPS). During the yard stay multiple Dropped Object Prevention Scheme (DROPS) inspections were performed in the derrick by rig crew & a 3rd Party rope access team. The rig sailed to location and completed three off 17-1/2" top hole sections. During drilling of the top hole sections, multiple DROPS inspections were performed by the rig crew. On commencement of casing running in the first hole, one half of the hose lifting collar insert (ref Fig 2) detached from the hose assembly end connected to the top drive and fell to drill floor landing within the red zone.

Insert weight = 3.1kg Drop height = 16m Energy = 486 Joules

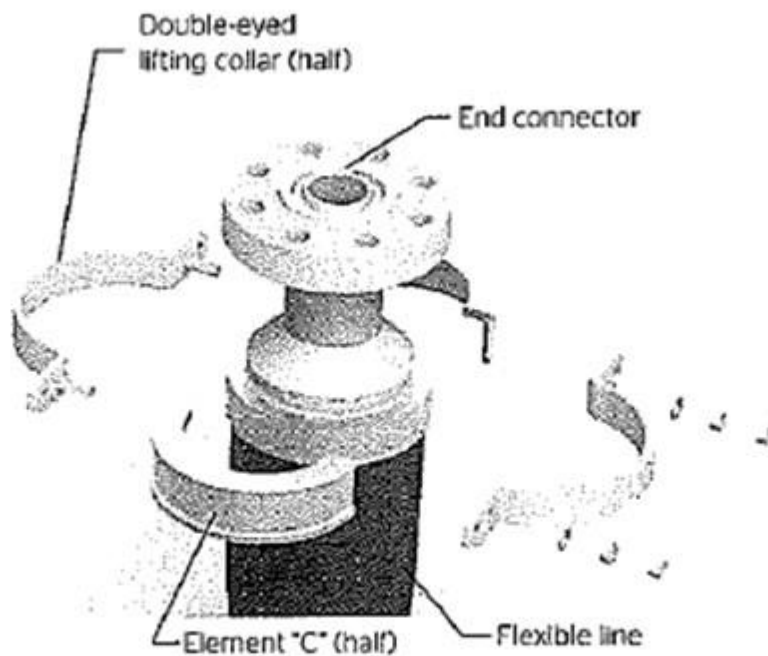
When the new hose assembly was connected to the top drive, the lifting collar inserts remained attached to the hose end nearest the top drive. The hose assembly had been in storage for 5 years with the lifting collar assembly attached. The new hose assembly was a different design. All personnel (rig crew and 3rd party rope access team) involved in installation of the new hose assembly and performing DROPS inspections, believed the attached lifting collar inserts were an integral metal collar. The new hose design incorporated a space between the hose end and the coupling for installation of the lifting collar inserts. Removal of the old mud hose assembly and installation of the new hose assembly was performed by multiple parties. The rig crew were not involved with removal of the lifting collar and therefore did not recognize the lifting collar assembly comprised of 4 component parts.

Fig. 16 Lifting the line from the crate using the lifting collar

- Equipment pre-installation inspection to identify design changes.
- Identify single discipline responsible for quality control of full scope of work.
- Raise awareness within industry on this event resulting from hose end connection design.
