# Safety ALERT

## Lifeboat Unexpectedly Descends

Alert 25-2

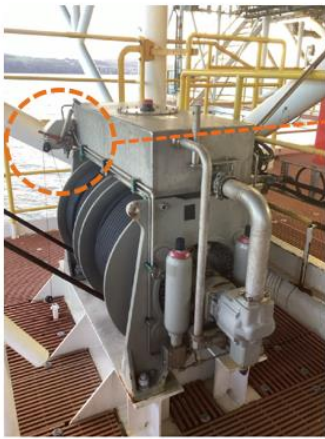
Figure 1 - VIKING Norsafe davit winches NW-150-NO

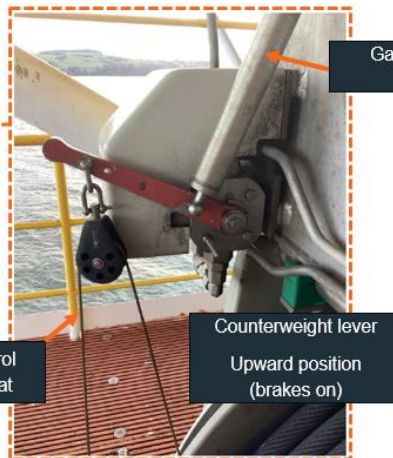
Figure 2 - Counterweight lever in the upward position (brakes on)

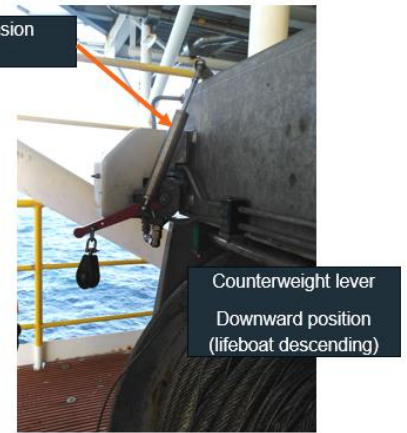
Figure 3 - Counterweight lever in the downward position (lifeboat descending)

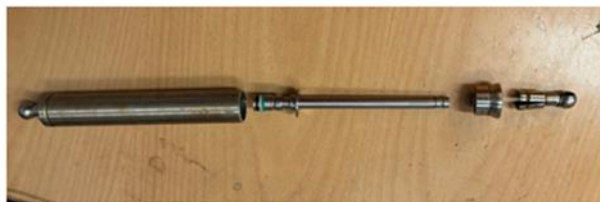
Disassembly of the lifeboat davit gas strut showing corrosion

This incident was a result of several contributing factors. The gas strut, a critical component of the winch system, suffered from corrosion, leading to a loss of pressure and failure. Upon removal and closer examination of this failed component, it was determined that the surface of the piston rod had corroded to the point that the cylinder's integrity was compromised causing the pressurized gas to escape and rendering the strut inoperable. The material used for the gas strut was not suitable for marine environments, making it more susceptible to degradation. Maintenance practices lacked clear guidelines for inspection and replacement of the subject component, which contributed to the failure going undetected. Furthermore, the design of the system relied heavily on the gas strut, making it a single point of failure without redundancy.

Regular inspections of lifeboat components, particularly gas struts and other critical parts, are essential to prevent unexpected failures. Equipment used in marine environments must be made from corrosion-resistant materials to ensure longevity and reliability. Maintenance manuals should provide clear guidelines on inspection intervals and replacement schedules to prevent oversight. Finally, lifeboat systems should be designed with redundancy in mind to prevent single points of failure from compromising safety.
