Nitrogen Cylinder Rupture

Alert 25-3

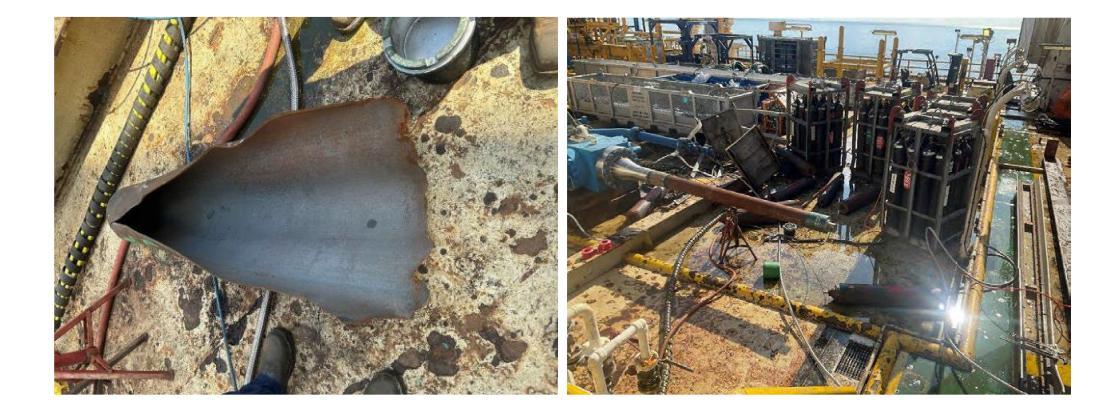
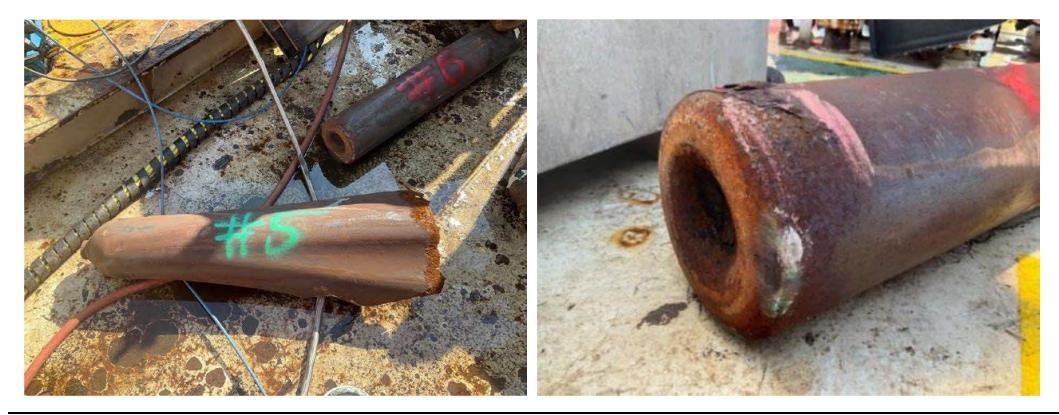
Rig crews had just finalized positioning a rack of nitrogen cylinders/bottles nitrogen to begin the pre-charge process of the accumulator cylinders with nitrogen. One nitrogen cylinder, charged to 2,400psi, in a rack that was not connected to charge the accumulator suffered a rupture to the bottom of the cylinder. This rupture scattered the rack, debris, and the remaining 11 cylinders around the immediate area and port aft area of the rig.

Initial findings indicate the cylinder rupture was the result of exterior wall loss. Investigation is ongoing and results will be shared upon completion.

- The base of the cylinder that ruptured was heavily corroded.
- Other cylinders in the quad had evidence of similar but less severe corrosion.
- Despite compliance with the Department of Transportation (DOT) special permit regulations, deficiencies in the design and material of the racks contributed to this event. This exposed the limitations of current inspection protocols and the susceptibility of cylinder integrity to the marine environment.

- Visual pre-fill inspections were conducted prior to mobilization offshore, but the rack was <u>not</u> disassembled for a thorough inspection of the individual cylinders or manifold components. This type of inspection did <u>not</u> allow for the bottom of the cylinders to be inspected for corrosion.

- The nitrogen cylinder rack is designed to securely hold multiple nitrogen cylinders in place, ensuring safety and preventing accidents during storage and handling. However, the absence of a material barrier between the cylinders and the rack presents several significant safety concerns. This can include dents, scratches, or other forms of wear that may compromise the integrity of the cylinder, potentially leading to leaks or failures.

- The rack design does <u>not</u> allow for proper drainage, which caused prolonged exposure of the cylinders to corrosive elements.

The cylinders were nine (9) years into their 10-year hydrotest cycle. The cylinders had been visually inspected by the supplier in accordance with Compressed Gas Association guidance for re-filling three months before the incident, prior to being loaded out to the rig. However, the severe corrosion that caused the rupture was not spotted during this inspection.

The cylinder that ruptured was located in the middle of the quad and therefore not easy to thoroughly inspect without disassembly of the quad.

- Are the cylinders on your facility certified and in good condition?
- Are you able to see the condition of all cylinders in every rack?
- Are all cylinders located on a free draining base to minimize corrosion?
- Do you know what level of visual inspection of cylinders/quads is provided by your supplier?
- Are all cylinders on your facility stored and located in accordance with the relevant industry regulations?
- Can adding corrosion barrier materials (i.e., non-metallic, coatings, etc.) between the base of the cylinders and racks help to mitigate corrosion?
