Current hardbanding techniques protect pipe, casing

John G Mobley, Arnco Technology Trust Ltd

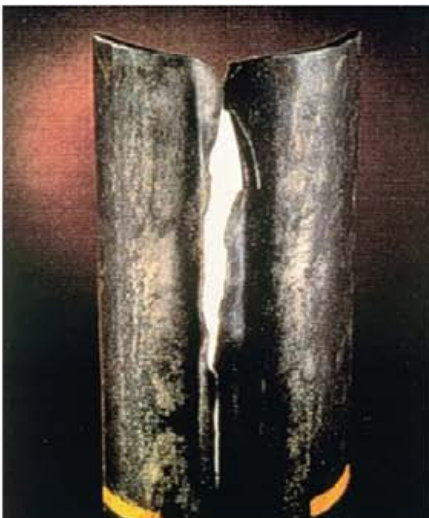
This photo illustrates the amount of casing damage that can occur from the drill pipe tool joint when older hardbanding techniques are used, such as tungsten carbide particles applied to the pipe in a raised condition.

The major problem was that, in this raised condition, it caused severe casing wear, therefore resulting in many casing failures. If there was a type of hardbanding that could be utilized in this same raised condition without causing the severe casing wear, then the industry would have solved one of their most pressing problems.

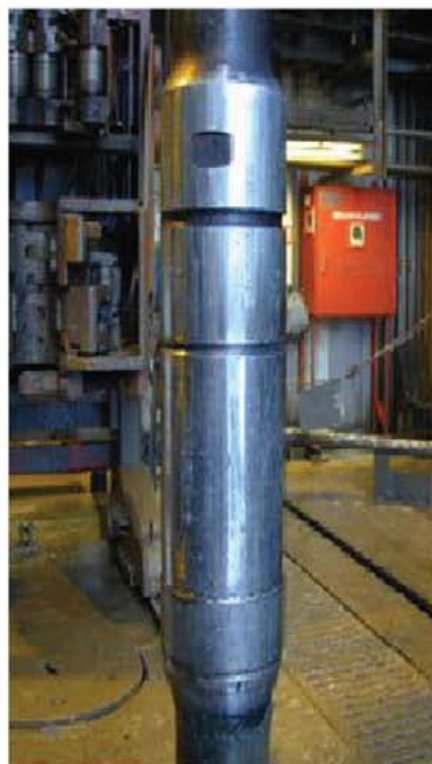
This tool joint has wear-resistant hardbanding applied to reduce wear to the drill pipe and joint as well as reducing wear and damage to casing.

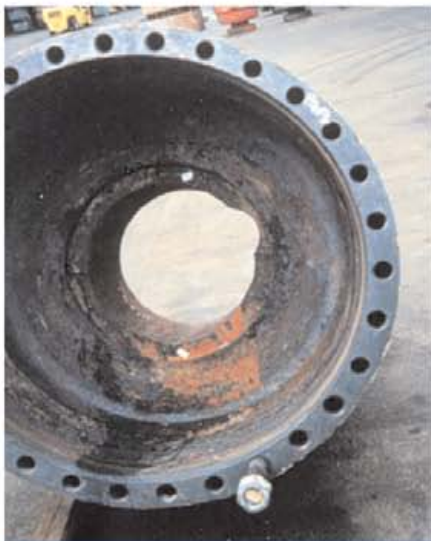
Present hardbanding materials and techniques have eliminated damage to casing. Damage to marine risers like that in the above photo has also been virtually eliminated due to modern hardbanding techniques.
