# Safety Alert

ALERT 05 – 06

## SAFETY HOOK FAILURE - CHEMICAL CORROSION

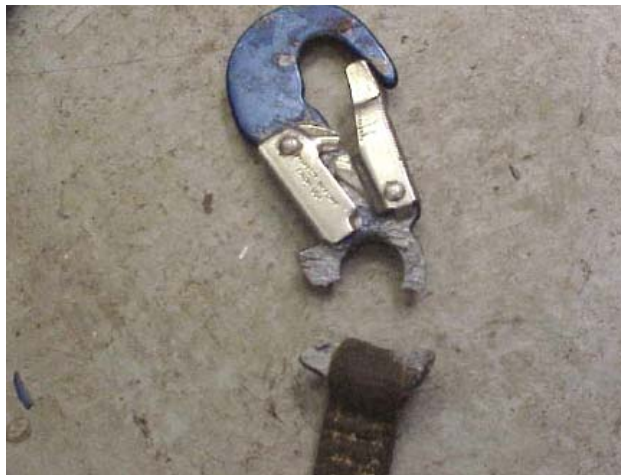
While cleaning and inspecting the tethered toolbox, a Floorman noticed corrosion on one of the safety hooks attached to the lanyard. After further investigation it was found that several safety hooks had swollen to twice the normal size and deteriorated enough to break by hand.

The safety hooks were sent to a lab for testing. The results showed the corrosion was caused by calcium chloride. The calcium chloride was used by the rig for a completion job several hitches prior to noticing the damage.

1. Instructed rig personnel to inspect all tethered tools immediately and remove from service any tools that may be damaged.

1. In the event any tools have to be replaced now or in the future ensure they are equipped with stainless steel safety hooks.
2. Keep aluminum tools and hooks away from calcium chloride. If safety hooks or tools contact the chemical, wash with a mild detergent immediately and rinse thoroughly.
3. Inspect tethered tools, safety lanyards, and safety hooks at regular intervals.
