Safety Alert

ALERT 05 – 14

MATERIAL HANDLING (DRILL PIPE) RESULTS IN AN LTI

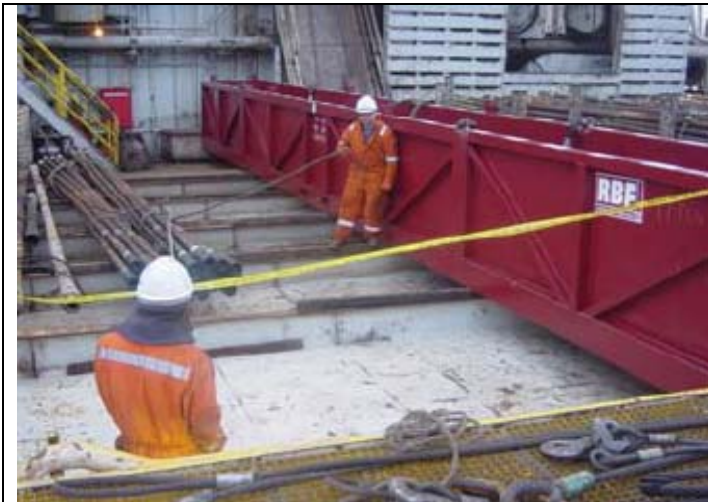
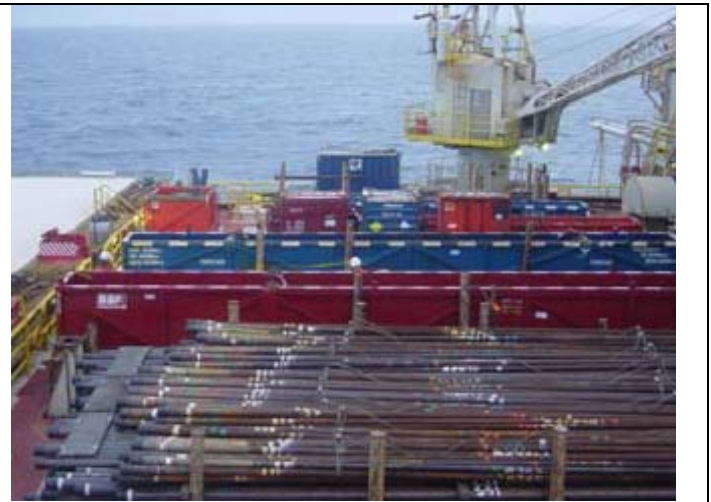
A incident occurred during the routine task of offloading tubulars from a work boat that resulted in a Roustabout sustaining a fractured arm. As the preliminary incident investigation has confirmed this incident was no accident but once again a series of events which were not effectively managed and collectively produced an unacceptable result. The operation was offloading bundles of 3-1/2" drill pipe from a supply vessel. **Events involved in this incident include:** 1. The Assistant Crane Operator was attempting to spot the first bundle in the starboard pipe rack with one Roustabout flagging (Banksman) and the other Roustabout standing adjacent to the pipe rack on a walkway. 2. The Assistant Crane Operator's view of the landing area was restricted by a tool basket. 3. During the lowering of the load the Injured Roustabout left his position of safety and entered the area of pipe rack bay. 4. The load appeared to have struck a Sampson Post and recoiled towards the injured party who had taken a position between the load and the tool basket, a blind spot. 5. As the load swung towards the Roustabout he raised his arms across his chest to protect himself and the load struck his right arm causing the fracture.

- Failure to conduct proper Job Risk Assessment (JRA) and identify and manage known hazards.
- Failure to implement effective Management of Change.
- Crane Operator had gone to the galley leaving the Assistant in charge.
- The injured party had never worked offshore previously and his appointed Safety Partner was also in the galley at the time of the incident.
- The Banksman (Signalman) was relatively inexperienced this being only his second hitch.

CORRECTIVE ACTIONS: To address this incident, this company instructed its rig personnel to do the following:

Discuss as a team what went wrong and consider the following:

- Leadership / Supervision
- Short Service Employee (SSE) Safety Partner Responsibilities
- Team Work
- Varying levels of inexperience
- Blind spots and body positions
- Time Out
