From the International Association of Drilling Contractors

ALERT 12 – 18

## LOOSE MACHINE GUARDING RESULTS IN MINOR INJURY

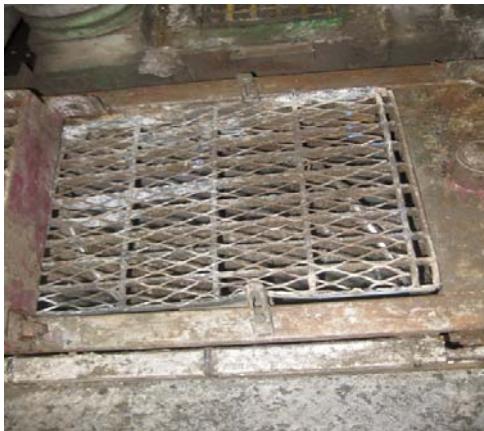
While working in the shaker house, an employee stepped onto a grating that was covering an auger. The grating gave way and fell onto the auger, which was rotating at the time of the incident. The employee's foot did not make contact with the auger and the emergency stop was immediately activated. The employee sustained a slight bruising to his heel. This incident had the potential for serious injury had the person's foot come in contact with the auger.

- The fixing clips that were holding the grate in place had worked loose and were insufficient for a weight bearing load.

Auger Cover Grating

- All employees were reminded to be aware at all times when working around rotating equipment.
- It was stressed to employees to ensure that all necessary covers and/or guards are secure.
- The crew inspected the entire auger area and any questionable areas were replaced with solid plates and non-slip paint was applied.

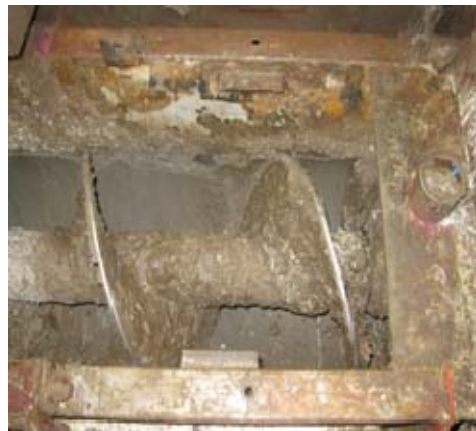
Auger without Cover

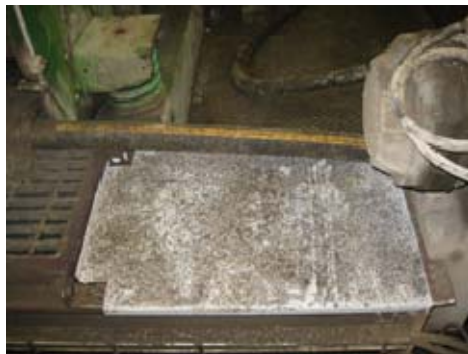
Replacement Solid Plate
