# Safety Alert

ALERT 08 – 04

## FAILURE OF COUNTER BALANCED LIDS FOR WASTE STORAGE AREAS RESULT IN INJURIES

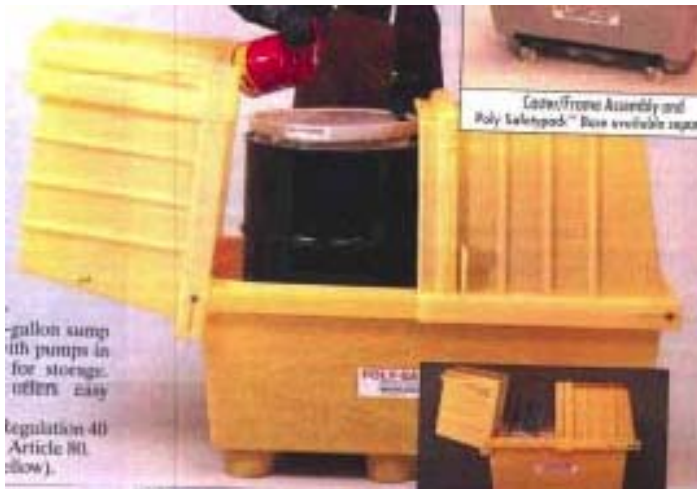
There have been several incidents when personnel have tried to lift the counter weighted lids on these storage areas which resulted in:

- The weight coming off;
- Not enough weight to hold the lid up;
- The cable breaking due to wear or corrosion;
- The wind blowing the lid down;
- Someone lifting the lid without enough weight to assist in opening the lid or;
- No locking devices to keep the lid open while personnel are working in the storage area.

- Eliminate these types of storage areas and replace with 100% polyethylene constructed storage containers that meet the requirements in 40 CFR 264.175 (Containment), and Uniform Fire Code Article 80 (or equivalent local standard).
- To prevent the lids from accidentally closing or falling shut while personnel are working in these storage areas until they can be replaced rig personnel are to temporarily place safety bars or support legs on these lids that can be pinned to hold the lids in place.
- See the picture of the recommended storage areas to use.
