Safety Alert

From the International Association of Drilling Contractors

ALERT 02 – 08

IMPROPER RIGGING RESULTS IN LOST CARGO

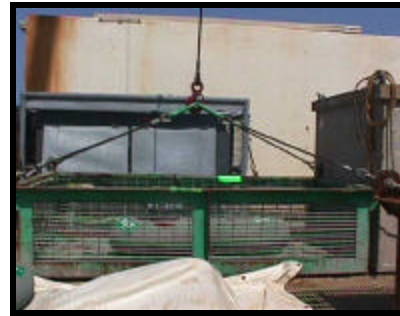
While making a lift from a boat to the platform, the operator picked up a cargo basket and proceeded to swing away from the boat. While swinging the basket, the cargo suddenly shifted causing the O-ring on the latch side of the hook to pull through the latch. When the O-ring pulled through the latch, the two part sling came unhooked from the stinger and the basket dropped on one side resulting in dropping some of the cargo into the water. No injuries, but some of the cargo was lost.

Figure 1: Similar cargo basket with incorrect sling angle.

- Utilize two-part slings when lifting similar cargo baskets.
- Crane operators and riggers should always maintain a minimum angle of 60 degrees between the sling and the load.
- Supervisors must reinforce the necessity of stopping the job when proper rigging is not being used.
- Supervisors should review this communication with all crane operators and riggers during a safety meeting.
- Use the same number of pickup slings as the number of o-rings on the load rigging.
- Each sling leg should be at least equal distance between the load pickup points (forming an equilateral triangle) regardless of whether using a single stinger or two-legged hookup. This will always give the preferred 60-degree sling angle.

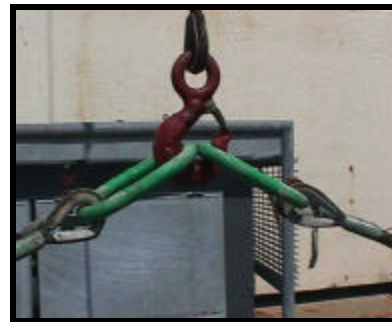
- 1.) The cargo basket slings were too short to be utilized with a single point hookup causing an unstable load and one ring to pull through the hook.
- 2.) The minimum recommended sling angle (60 degrees) between the sling and the load was not maintained. Actual angle was about 35 degrees.
- 3.) The riggers on the boat failed to stop the job and used a poor rigging technique (single line stinger hook).
- 4.) The crane operator failed to observe the rigging techniques prior to starting the lift.

Figure 2: Similar hook point with incorrect sling angle = hazard.
