# Safety Alert

From the International Association of Drilling Contractors

ALERT 02 – 36

## HAND GRINDER INCIDENT RESULTS IN ARM LACERATION

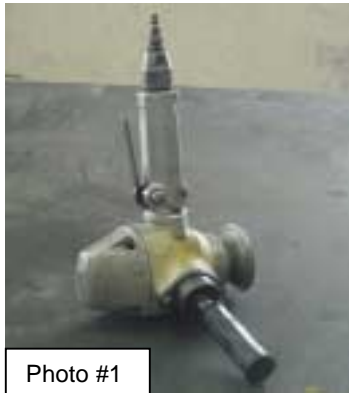
An employee was using a hand held pneumatic grinder to polish a metal table. (Photo # 1) and the grinding wheel got stuck in a joint of the table and broke off. (Photo # 2). The employee was struck in the forearm and lacerated by the broken wheel. (Photo # 3).

- Ensure that the correct grinder guards and work rests are in place, used and inspected before each use. The guard for this type of grinder would have a maximum exposure angle of 180 degrees and be located between the operator and the wheel. This would deflect pieces away from the operator

- Inspect grinding wheels. This includes but is not limited to:
  - Visual inspections for cracks, chips, gouges and other damage.
  - Verifying that the rated wheel speed is greater than that of the grinder.

- Checking that the grinding wheel hole fits the arbor correctly.
- Ensure that the grinding wheels used are the correct ones for the application.
- Require personal protective equipment when grinding. As a minimum, use safety glasses with side shields and a face shield. Use gloves only when they will not get caught in the grinder. Hearing protection and goggles could be used when the conditions warrant.

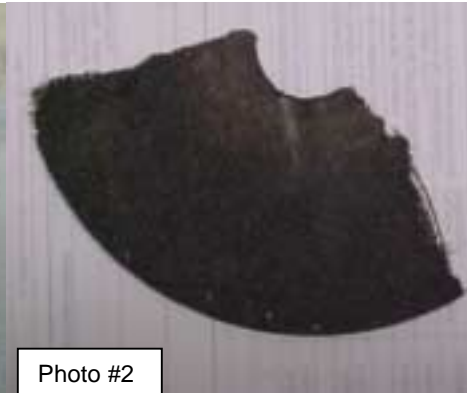
- The grinder did not have a guard on it at the time of the injury and no PPE was in use.
- Upon investigation it was discovered that the grinding wheel was not the right one for the task being performed.
