Safety Alert

From the International Association of Drilling Contractors

ALERT 03 – 34

PREVENTING CROWN COLLISIONS

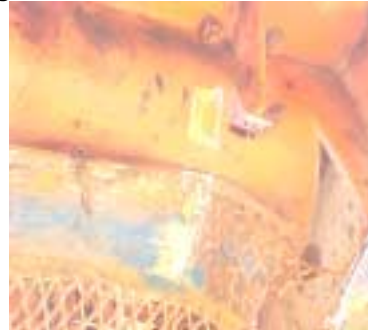
The crown saver device toggle was contacted and engaged however due to speed, the blocks hit the crown. Sheared bolts and other hardware fell from crown bumper. The crown was undamaged but dropped objects posed a hazard to derrickman and crew.

Note damage to the crown beam.

Common threads to all the above accidents: Due to distraction and/or loss of focus and concentration, the driller lost count of tool joints. Losing count resulted in the driller's failure to reduce traveling block speed in time. Additionally, the improperly set and/or untested crown saver device. In most of the above cases, damage was mitigated by a crown saver bumper block system. It is a common practice to envelop wooden blocks in wire mesh to prevent fragments from falling upon collision.

1. The driller should stop and secure the blocks if someone needs to speak with him either by phone or in person. Distraction is the primary factor that causes crown collisions.

2. Operate blocks at a controllable speed. Avoid rushing.
3. As a backup to the driller's attention, everyone on the floor should count the tool joints coming through the rotary.

4. Test the crown saver device by slowly pulling into the crown saver device toggle with the top layer of line on the drum and do not use a "broom handle" to activate it. Ensure the derrickman is monitoring distance between blocks and crown and can signal the driller when the crown saver device is being tested or set.

5. The crown saver device should be checked with the drilling line as soon as practicable by each driller coming on tour, before each trip, and after each slip and cut. This check should be noted on the daily drilling report. (IADC APGR 3.17.N, API RP54 9.4.8)
