Casing Elevators not latched properly result in a dropped joint of casing ALERT 3-20

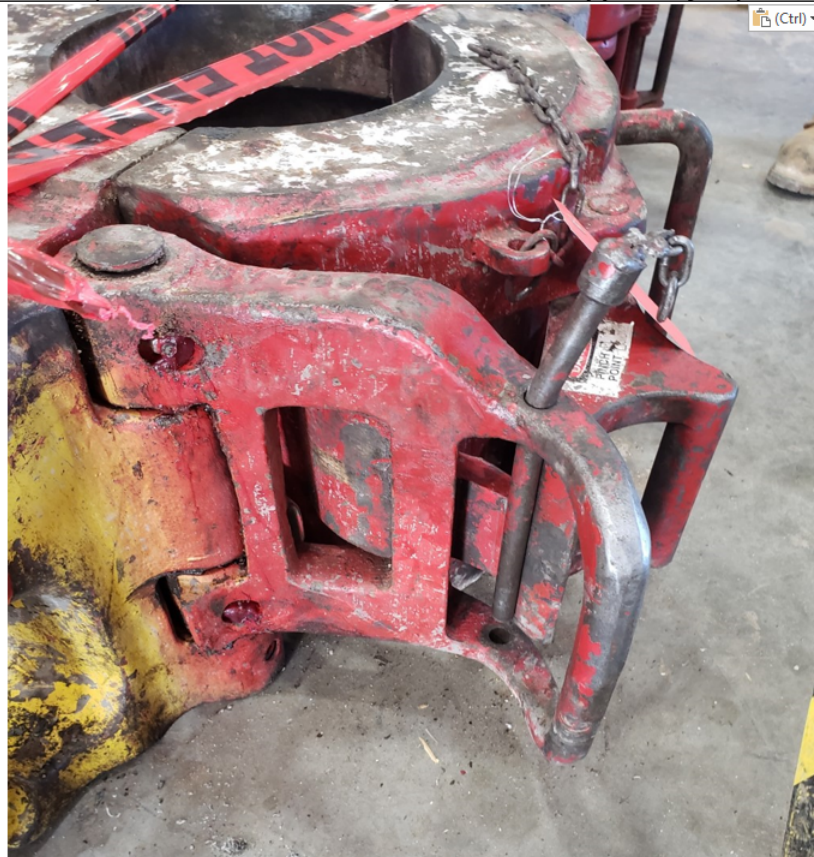
While running casing, the pin in the Casing Elevators was incorrectly inserted before the latch was fully closed. This allowed the elevators to inadvertently open as a joint of 9-5/8" casing was hoisted out of the tubular handling trough. The joint bounced in the trough and fell on to the gull wings next to the catwalk. No one was injured, however the potential for serious injury and/or equipment damage was very high.

**Incorrect pin placement
(note: pin was not bent prior to the dropped object)**

1. Casing crew employee was not aware that improperly latched elevators allowed the pin to be installed and door still come open

1. This design of casing elevators allows the pin to be inserted w/o the elevators being latched.
2. Confirm that latch is completely closed before installing pin.
3. Familiarize employees with the manufacture's operating procedures and warnings.

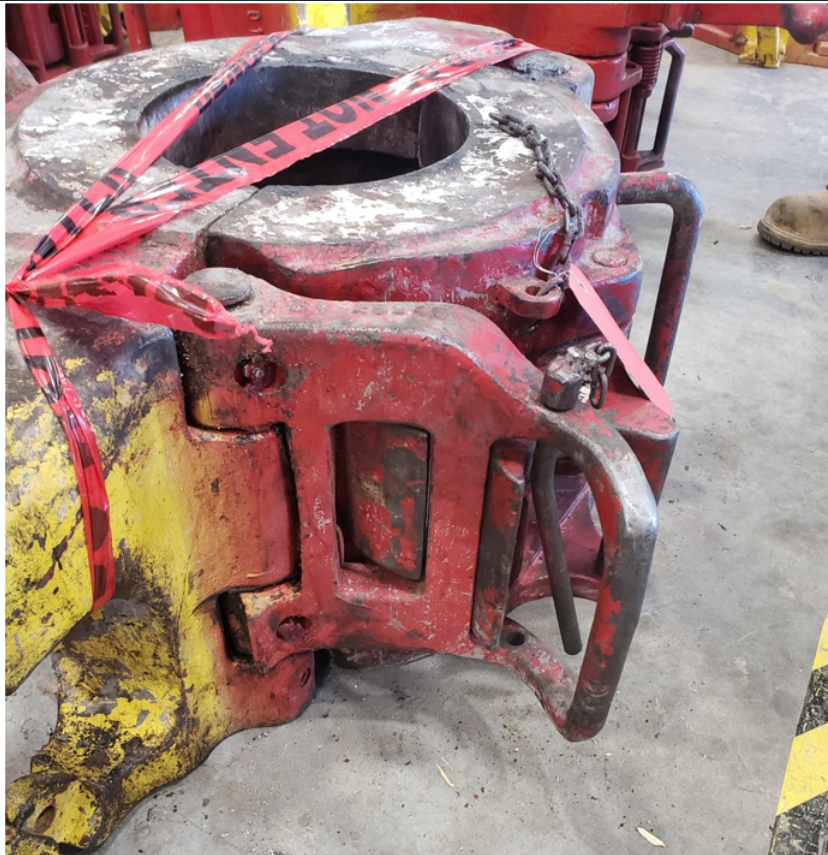
Correct pin placement
(note: pin was not bent prior to the dropped object)
