SAFETY ALERT

CRUSHED BY/CAUGHT BETWEEN FATALITY

ALERT 3-21

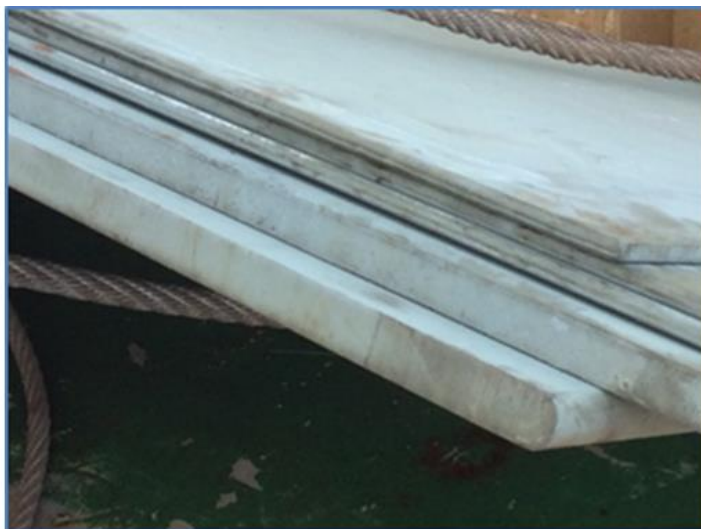
The plates were all 4 x 8 feet; three were 3/8" thickness and the other two were 1" thickness (see Figure 2).

Figure #2: The 5 metal plates, combined weight of approximately 2 T

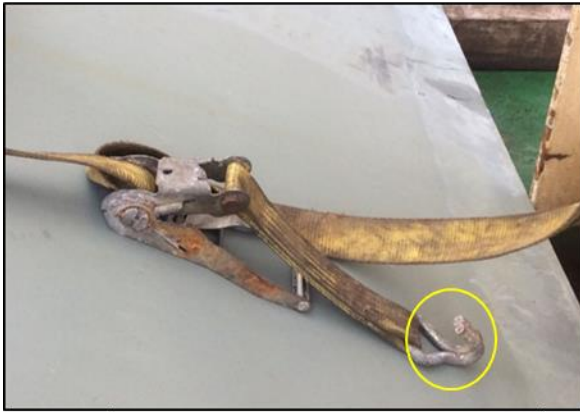
Figure #3: illustration of the ratchet strap hook that came free from the stanchion

- Are there sufficient measures in place to prevent unauthorized manipulation of sea-fastenings? Service provider personnel may not recognize cargo straps as sea fastenings when a rig is in operation. Procedures, including the use of warning tags, should be reviewed to ensure it is clear what needs authorization to release or manipulate

- Review housekeeping and sea-fastening – are materials around the rig stored safely and has the potential for gravitational energy to be released been minimized as far as practical (e.g. if a strap comes loose, will the stored material fall or tip over?) Can this be mitigated by storing in an alternative location or an alternative orientation (e.g., by lying flat)?

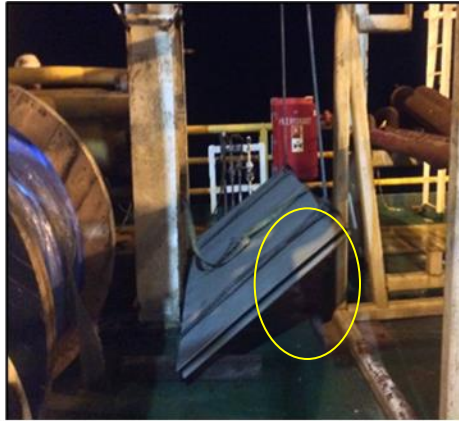
The inspection team leader then leaned his back against the plates; The reason for this is unknown, but it is assumed the intention was to keep the plates in their standing position when the ratchet strap was loosened. When he was standing in this position, directly in front of him was a framework for the drilling bail rack. When the ratchet strap was manipulated by the assistant, the hook (ratchet strap) released, (see Figure #3), allowing the plates to free fall forward (away from the stanchion) under their own weight, fatally trapping the inspection team leader between the plates and the framework of the drilling bail rack (see Figure #4).

Figure #4: The position of the inspection team leader

The weight of the falling metal plates, overwhelmed the lead inspector, who was caught in the line of fire and pinned between the plates and the solid frame. First responders arrived at the scene and attempted to manually remove the plates but were unable due to their weight.

- Line of fire awareness – reinforce with all personnel the importance of avoiding body positioning in the line of fire, including avoiding getting between loads and structures
