Safety ALERT

Alert 24-1

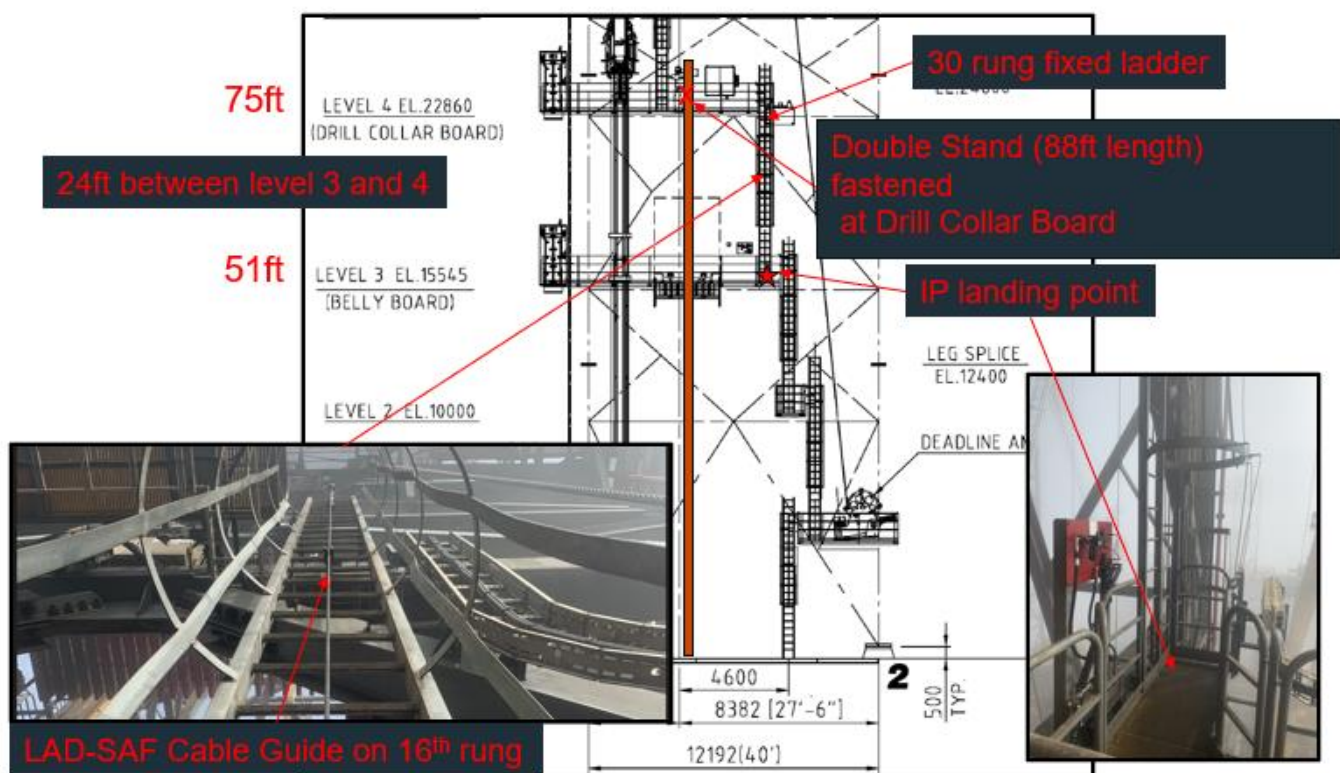
Injured person (IP) had just completed untying a double stand of drill pipe that was lashed to the derrick. IP connected full body harness to the cable sleeve of the fall-arrest system and started to descend the derrick ladder when his foot slipped on a rung, causing him to fall 6-7 ft. (approx. 2 m) to the intermediary platform below.

The installed fall-arrest system failed to stop IP's fall over a 6-7ft. distance.

The fall-arrest manufacturer's technical specifications indicate that it may not stop a fall immediately and that a minimum clearance of 7ft. (2m) is required between the user's feet and the surface below for the system to stop the fall of an average person.

The company reinforced to its employees to always maintain three points of contact (with hands and feet) while ascending or descending a ladder and to follow the manufacturer's instructions for the use, inspection and maintenance of fall protection equipment.
