Crate lid dislodged overboard

Alert 25-1

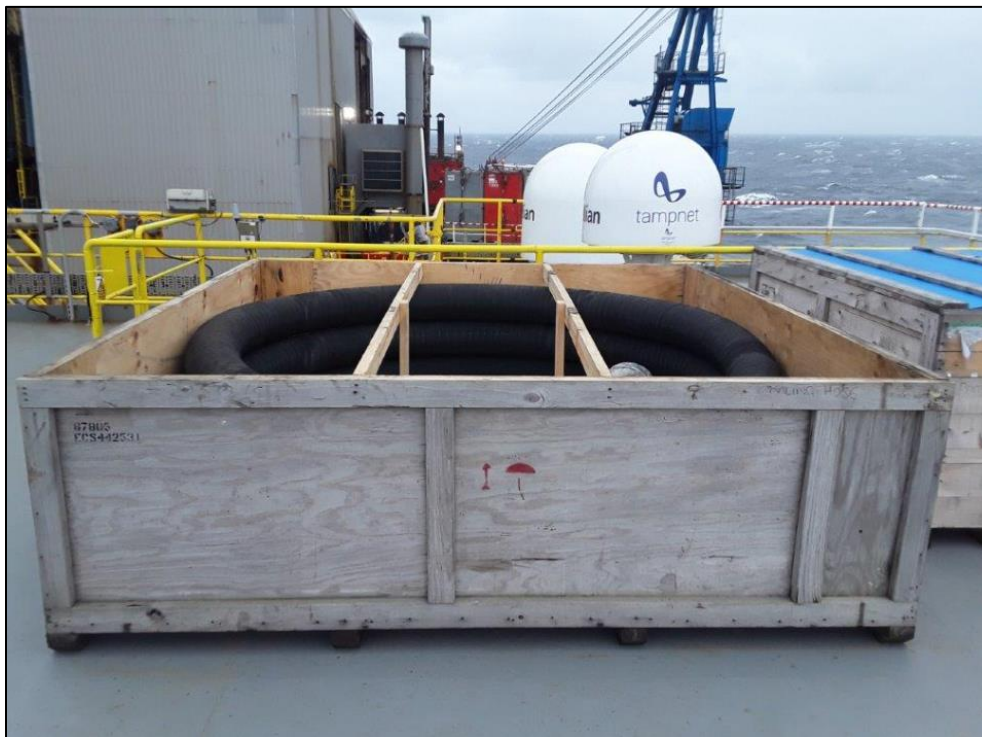
During helicopter operations on a drilling rig located on the UK Continental Shelf, a 3mx3m (9.8 ft x 9.8 ft) wooden crate lid, weighing approximately 40kg (88 lb), dislodged from a hose transport crate and blew overboard. While no personnel were in the area, the event highlights the risks associated with storage near helidecks.

Securing Mechanisms Matter: Factory-installed plastic banding and screws, originally intended for transport, can degrade over time due to environmental exposure, making them inadequate to withstand wind and helicopter downdrafts.

Environmental Forces: Weather, wind, and rotor downwash amplify the risk of unsecured items becoming Foreign Object Debris.

Storage and Security: Evaluate storage areas near the helideck for suitability, ensuring they are used only for essential items. Relocate non-essentials elsewhere and secure any necessary items with approved mechanisms to withstand environmental and helicopter induced loads.

Regular Inspections: Conduct routine checks of these securing systems, to identify and address potential risks.

Increase Awareness: Identify hidden Foreign Object Debris risks by raising awareness about items or equipment that might not typically be recognized as a potential hazard.
