# IADC maintenance meeting

NOV TDS-11 and TDX-1250

April 2, 2025

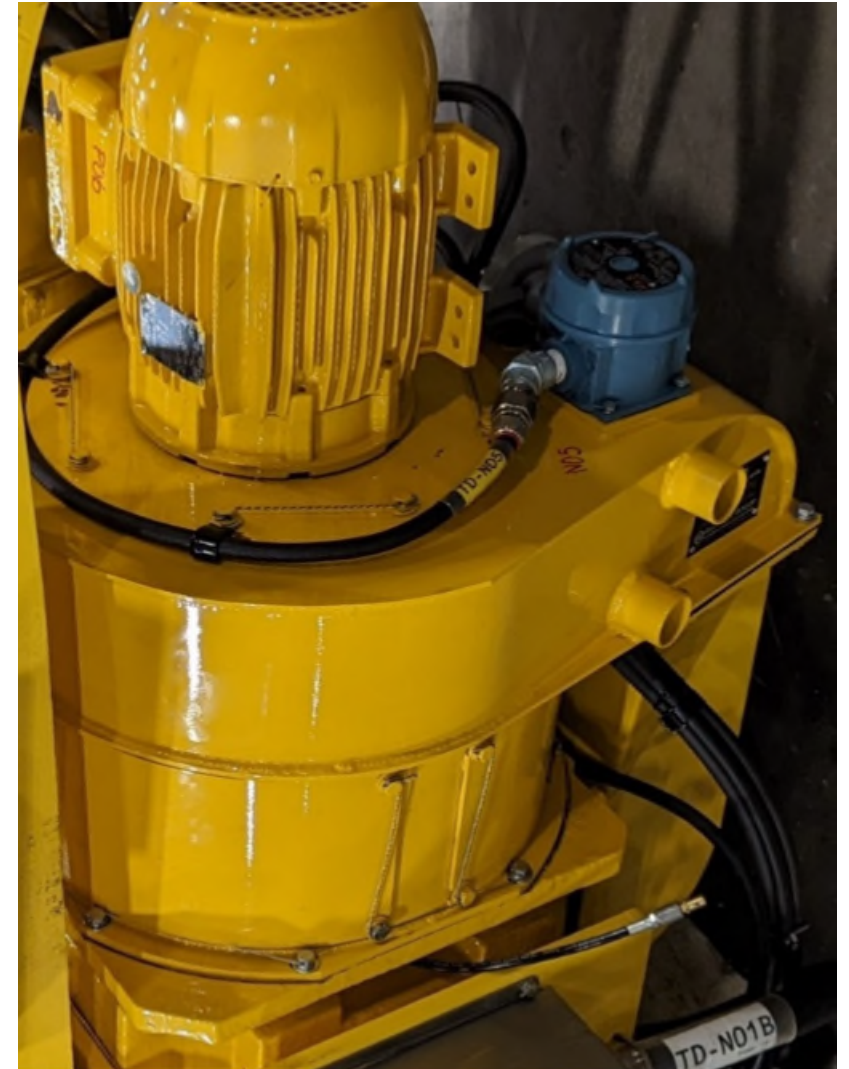
Introduction of a cleaning blower upgrade for 400 hp drilling motors.

Cleaning Blower Upgrade on a TDS-11SA

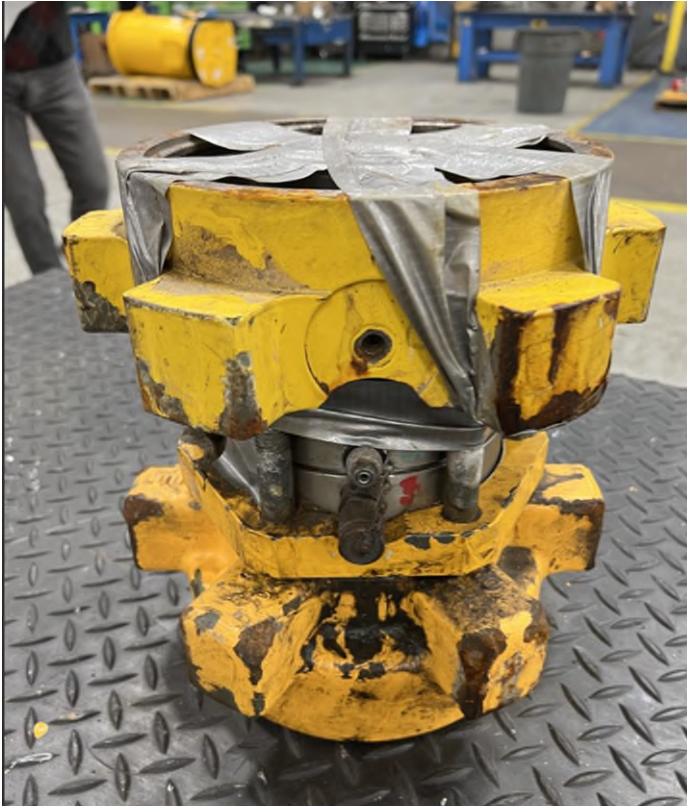
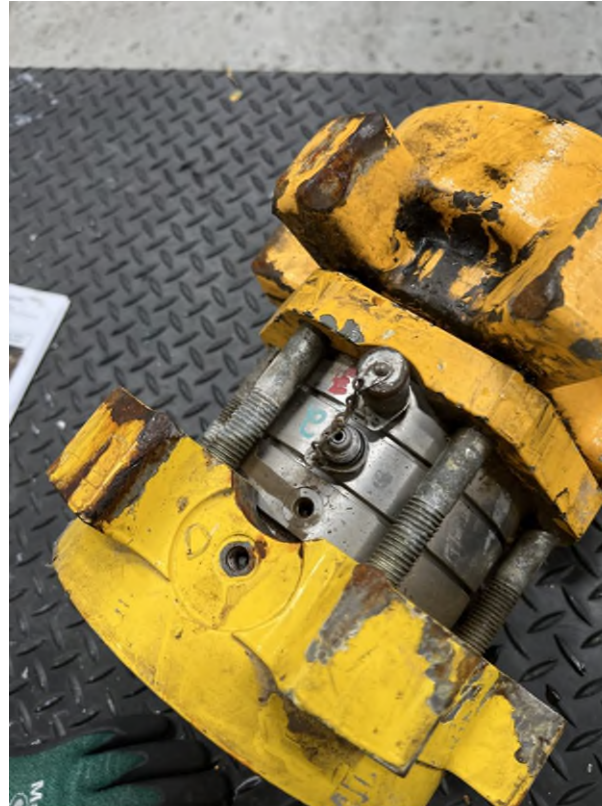
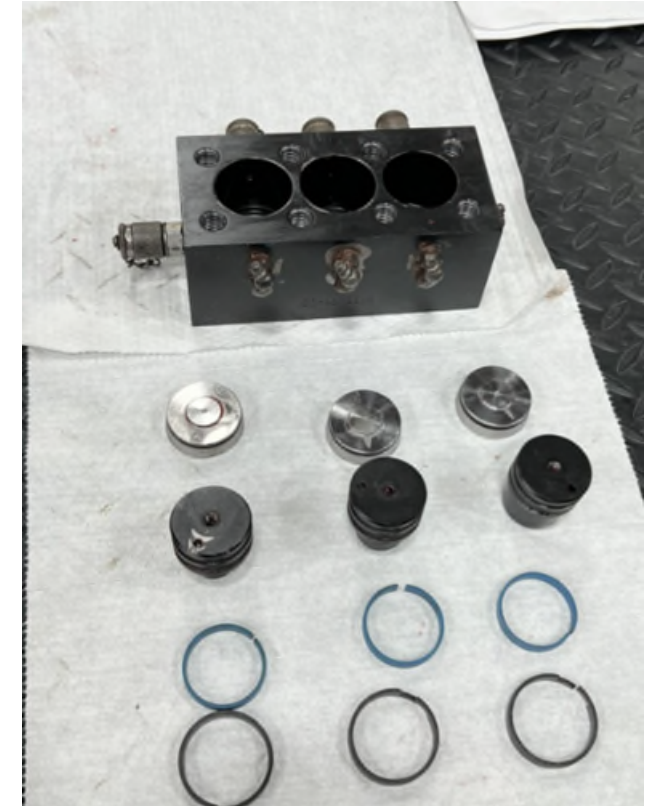
# Divided Pressure Washpipe

New Developments – Field Trial
