# Safety Alert

ALERT 13 – 27

## PIPE DROPPED FROM SIDE DOOR ELEVATOR

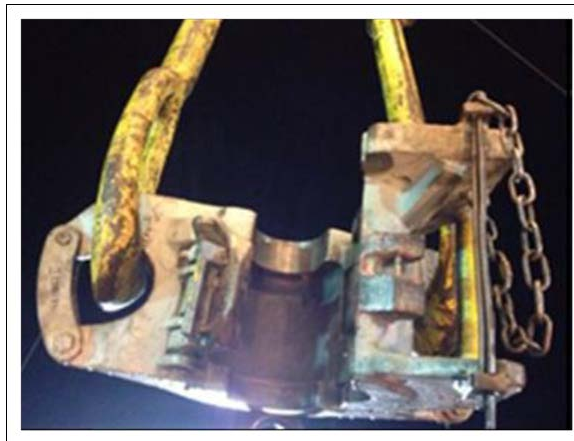
While pulling and laying down 4 1/2" (11cm) tubulars, a crew member closed and secured the elevators with the verification pin and the Driller hoisted the tubing up to the next connection to be broken. Once the connection was landed in the slips, the tongs were engaged and the connection was backed out. A crew member grabbed the tubing and began to guide it to the lay-down machine. He was in the process of asking the Driller to hoist the tubing up when it fell down to the stabbing mat and came to rest against the rig floor. The rig crew members observed that the elevator was open with the verification pin still in the hole in which it had been placed.

- Workers were able to install the verification pin even though the elevator was not fully latched.
- The latch on the elevator was either not fully engaged prior to hoisting the tubing or it came open under load during the hoisting operation.
- A non-OEM modification had been previously made to the elevator.

- Company management reminded all employees that operating manuals for equipment are available. Supplier provided training is also available and should be utilized to increase crew member awareness when operating manual elevators that they are properly latched and secure prior to hoisting.
- The company agreed to prepare safety alerts to communicate this incident with all parties involved on a global basis.
- The company required all rig managers to review all side door and single joint elevators in their inventory for proper installation and functioning of the safety latch verification pin.
