Deepwater Horizon

**Mississippi Canyon Block 252
Macondo Well**

BP internal investigation

BP has published its internal investigation team's report into the accident on the Deepwater Horizon rig in the Gulf of Mexico on 20 April 2010.

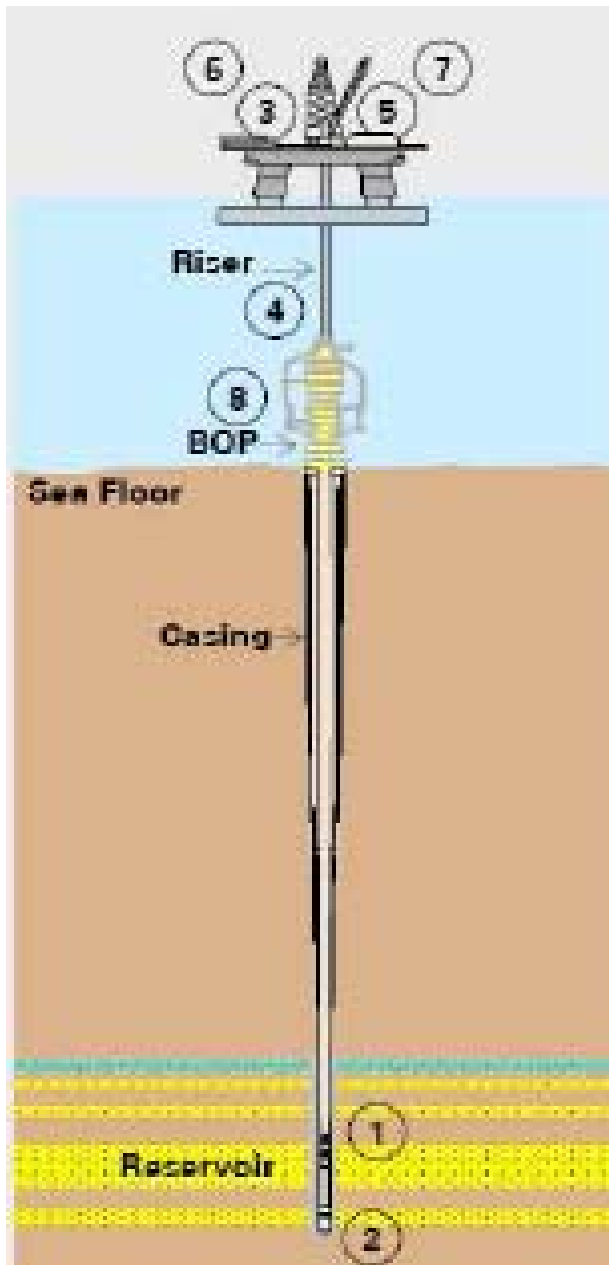
Eight barriers were breached

- Well integrity was not established or failed
 1. Annulus cement barrier did not isolate hydrocarbons
 2. Shoe track barriers did not isolate hydrocarbons
- Hydrocarbons entered the well undetected and well control was lost
 3. Negative pressure test was accepted although well integrity had not been established
 4. Influx was not recognized until hydrocarbons were in riser
 5. Well control response actions failed to regain control of well
- Hydrocarbons ignited on the Deepwater horizon
 6. Diversion to mud gas separator resulted in gas venting onto rig
 7. Fire and gas system did not prevent hydrocarbon ignition
- Blowout preventer did not seal the well
 8. Blowout preventer (BOP) emergency mode did not seal well

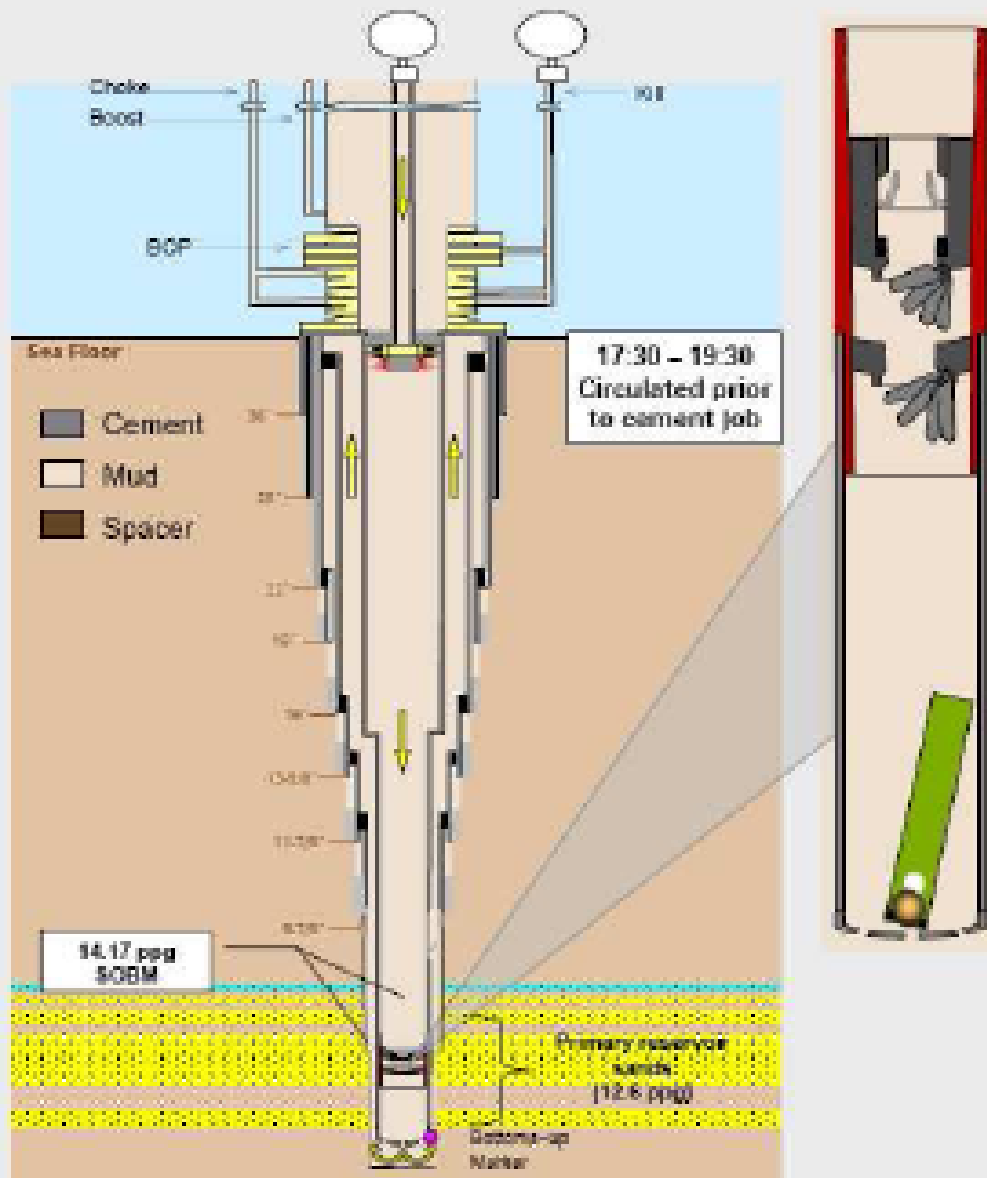
Production Casing Installation

After drilling to total depth, casing is run to bottom in preparation for the cement job. A double valve float collar is used to prevent backflow or ingress of fluids through the shoe track until the cement hardens and creates a permanent barrier.

- Long string design robust, consistent with similar wells in the area
- 9 attempts made to establish circulation to convert float valves
- Circulate ~6 times open hole volume, limited circulation due to concerns over creating losses and hole washout
- No evidence that hydrocarbons entered the wellbore prior to the cementing operation

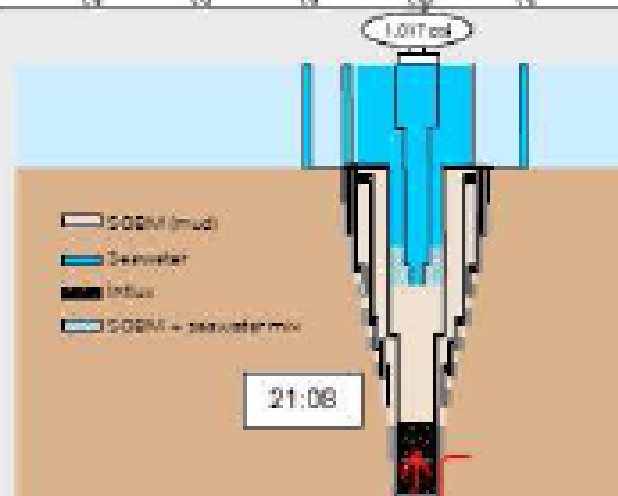
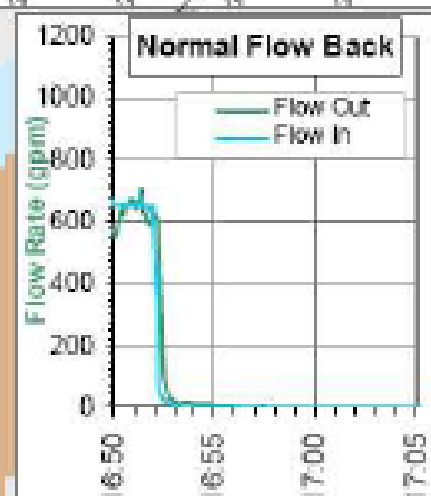
Key Finding #5

The influx was not recognized until hydrocarbons were in the riser

- #1: Drill pipe pressure increased by 100 psi, (expected decreased); ~39 bbl gain from 20:58 to 21:08
- #2: Drill pipe pressure increased by 246 psi with pumps off
 - Flow out does not immediately drop after shutting down pump
- #3: Drill pipe pressure increased by 556 psi with pumps off; ~300 bbl gain
- No well control actions taken

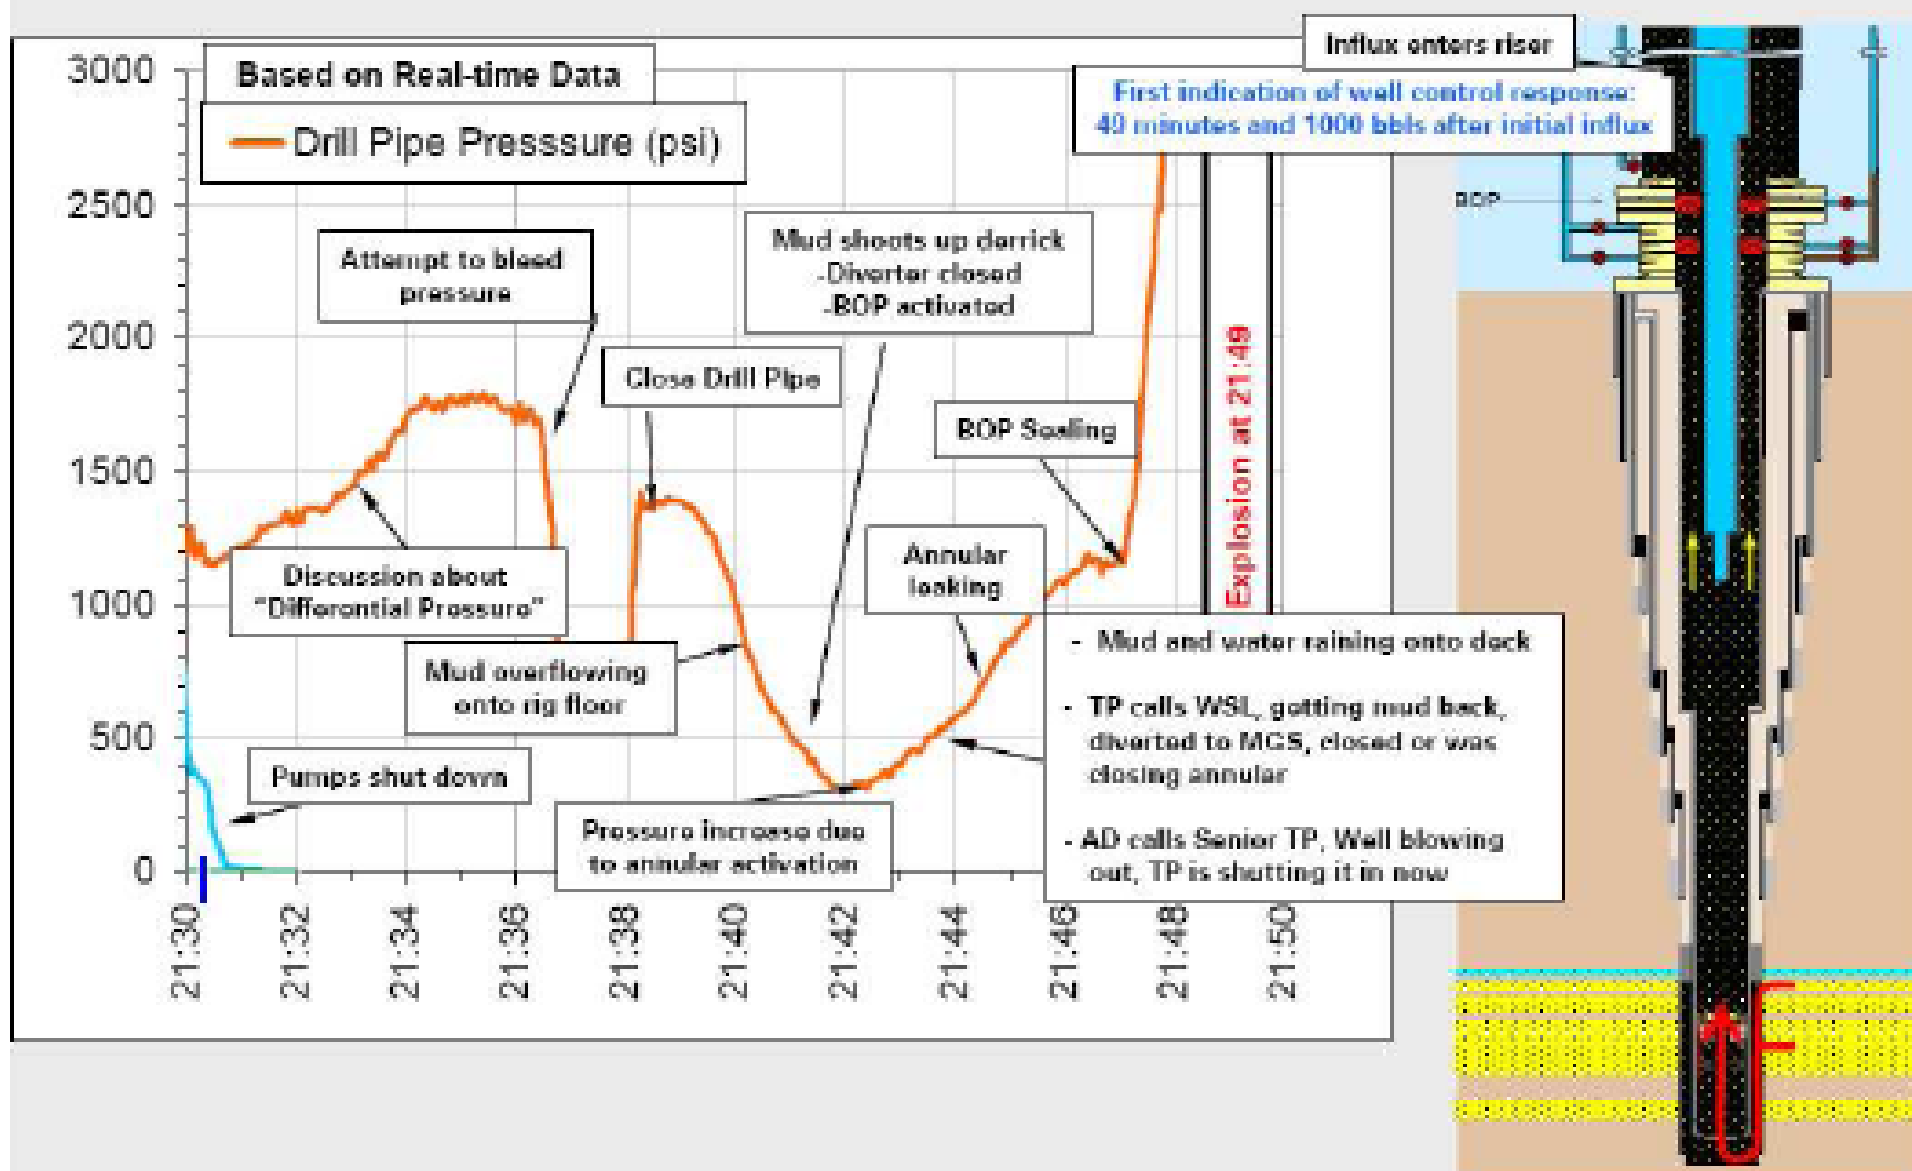
Well control response actions failed to regain control of the well

Diverting to the Mud Gas Separator at about 21:42

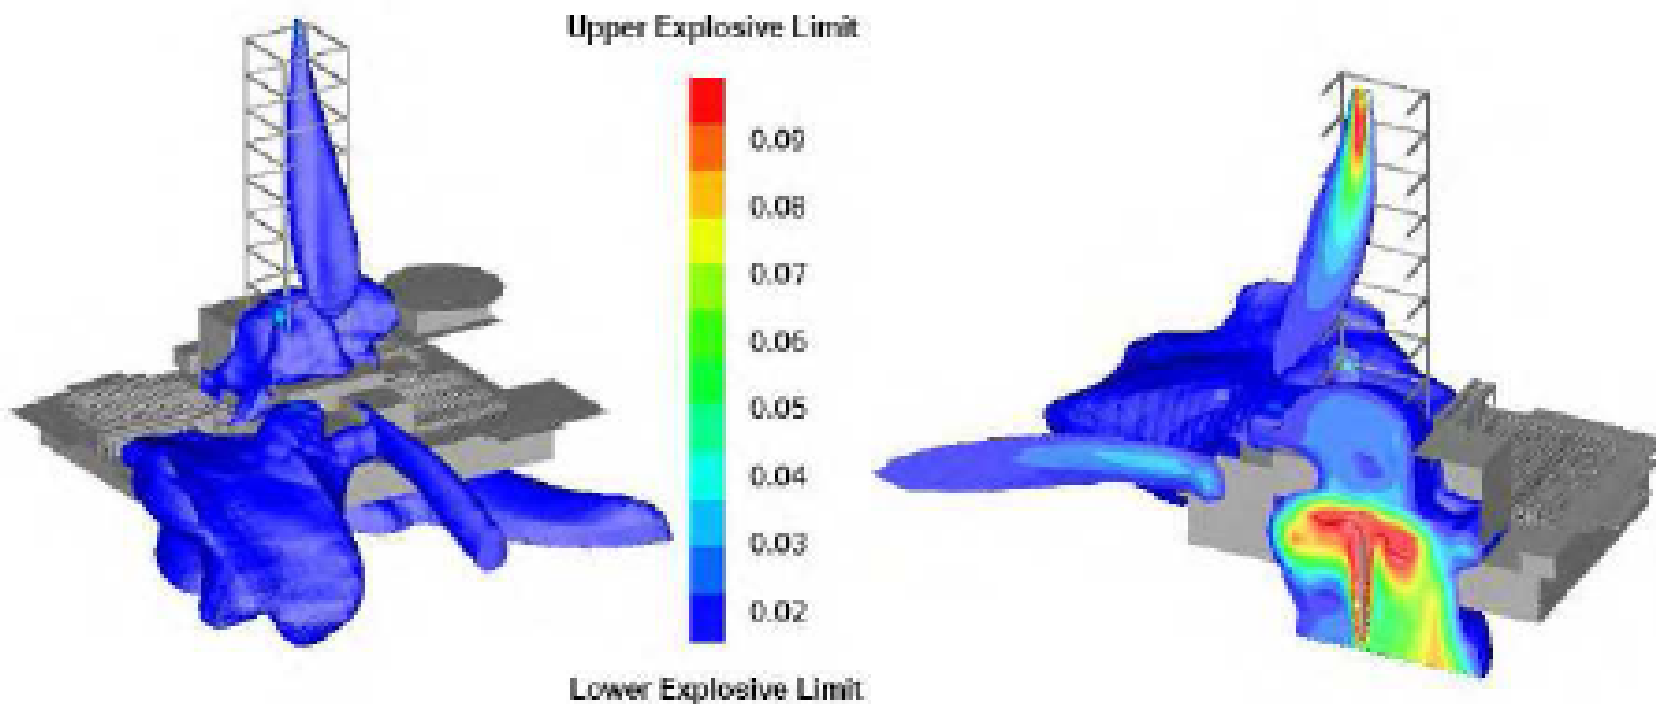
Gas Dispersion across the Deepwater Horizon 21:46 to 21:50 hrs

- Instantaneous gas rates reached 165 mmscfd
- Pressures exceeded operating ratings (above 100 psi)
- Gas would probably have vented from:
 - Slip joint packer into the moon pool
 - 12" MGS "gooseneck" vent
 - 6" MGS vacuum breaker vent
 - 6" overboard line through burst disk
 - 10" mud line under the main deck

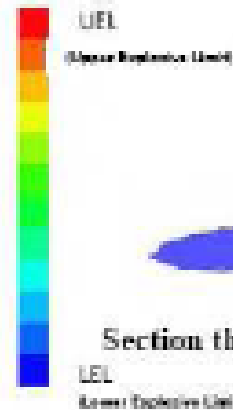
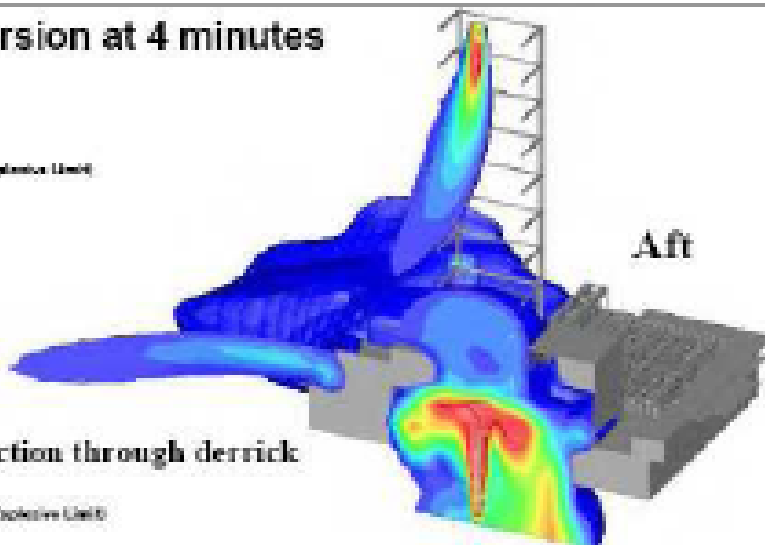
Gas Dispersion at 4 minutes

The fire and gas system did not prevent hydrocarbon ignition

- Gas dispersion beyond electrically classified areas
- Gas ingress into engine rooms via main deck air intakes
- The on-line engines were one potential source of ignition

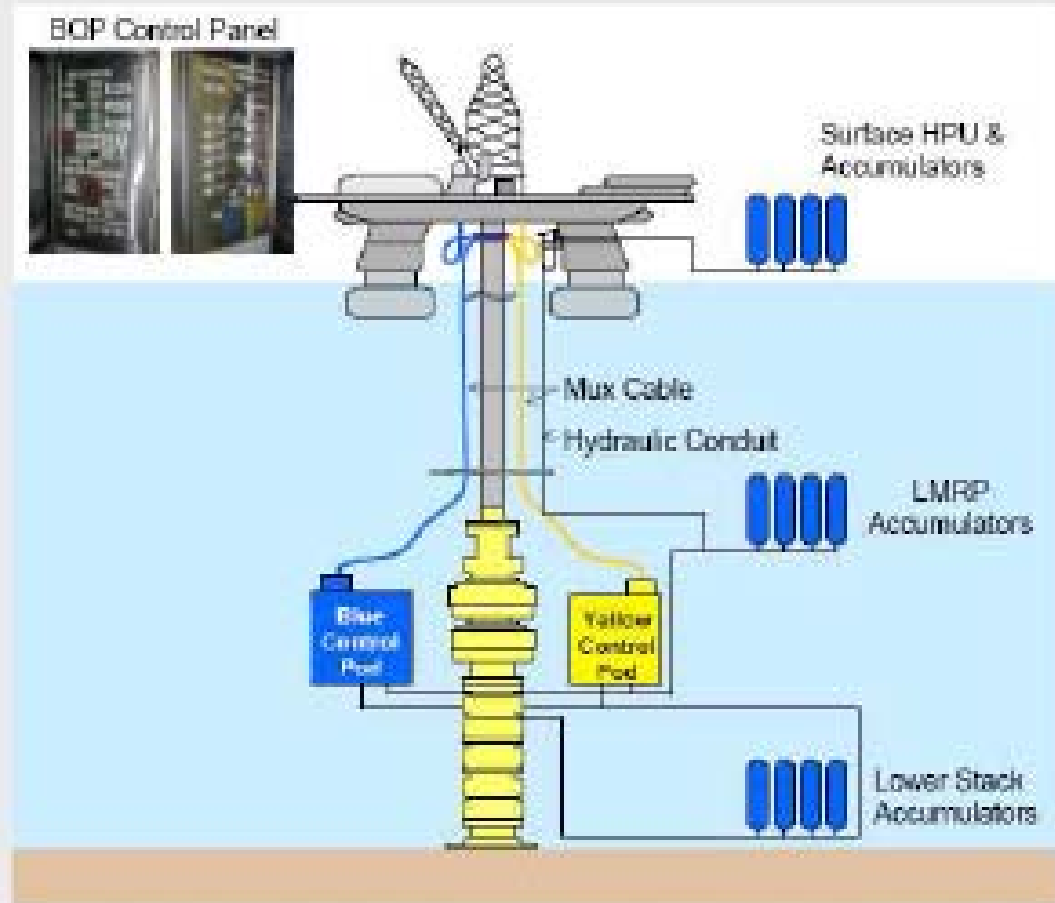
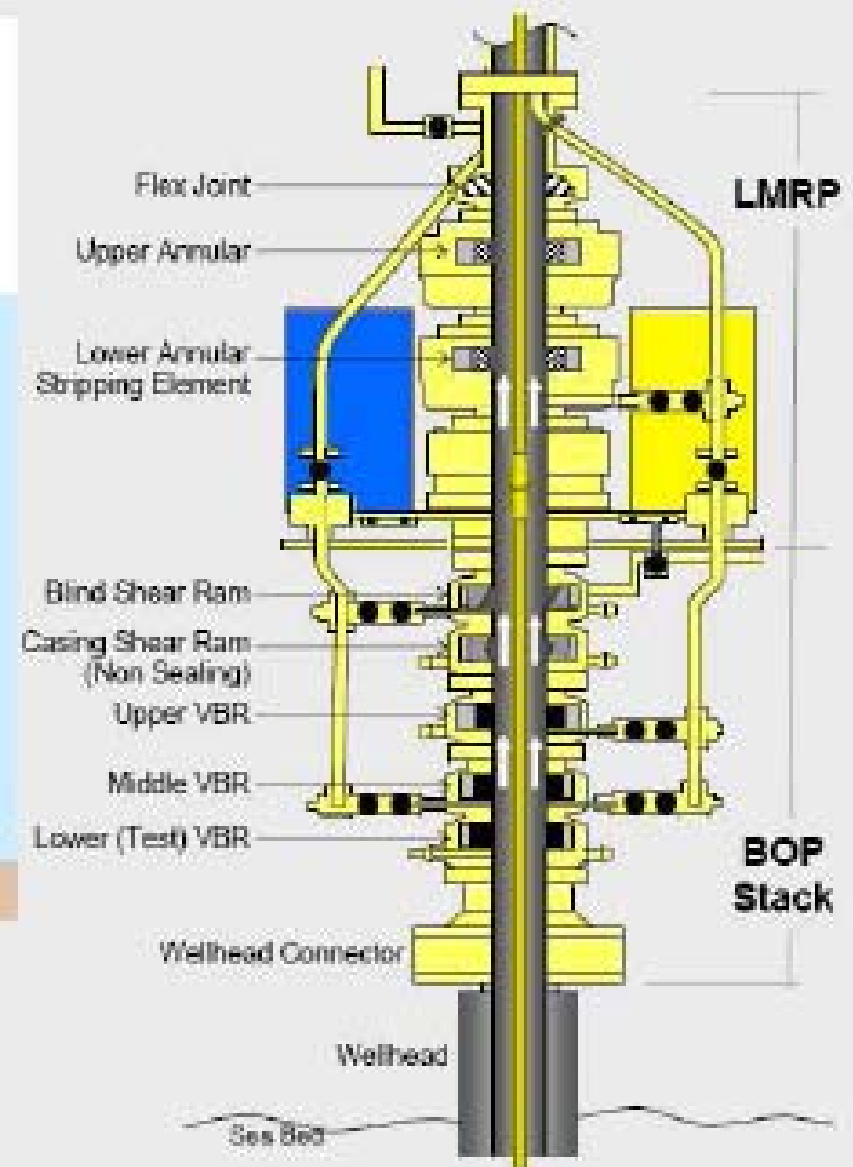
Blowout Preventer (BOP)

- Damage to MUX cables and hydraulic line
 - Opening of annular BOP
- Rig drifted off location
 - Upward movement of the drill pipe in the BOP

- EDS attempts failed to activate BSR
- AMF sequence likely failed to activate BSR

- ROV hot stab attempts to close BOP were ineffective
- ROV simulated AMF function likely failed to activate BSR
- ROV activated auto-shear appears to have activated but did not seal the well

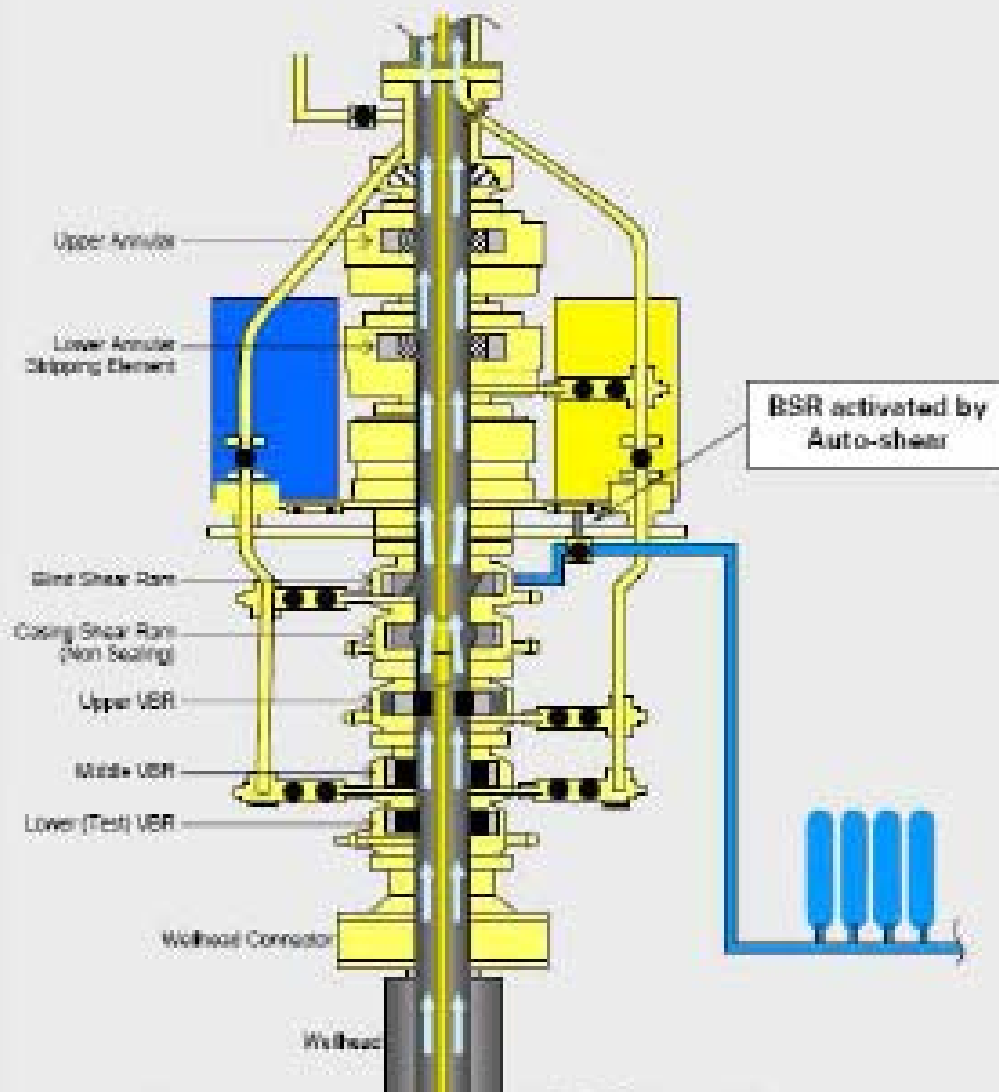
Key Finding #8

The BOP emergency mode did not seal the well

- EDS function was inoperable due to damage to MUX cables
- AMF could not activate the BSR due to defects in both control pods
- Auto-shear appears to have activated the BSR but did not seal the well
- Potential weaknesses found in the BOP testing regime and maintenance management systems
