UNITED STATES COAST GUARD

REPORT OF INVESTIGATION INTO THE CIRCUMSTANCES SURROUNDING THE MULTIPLE RELATED MARINE CASUALTIES AND GROUNDING OF THE

MODU KULLUK

ON DECEMBER 31, 2012

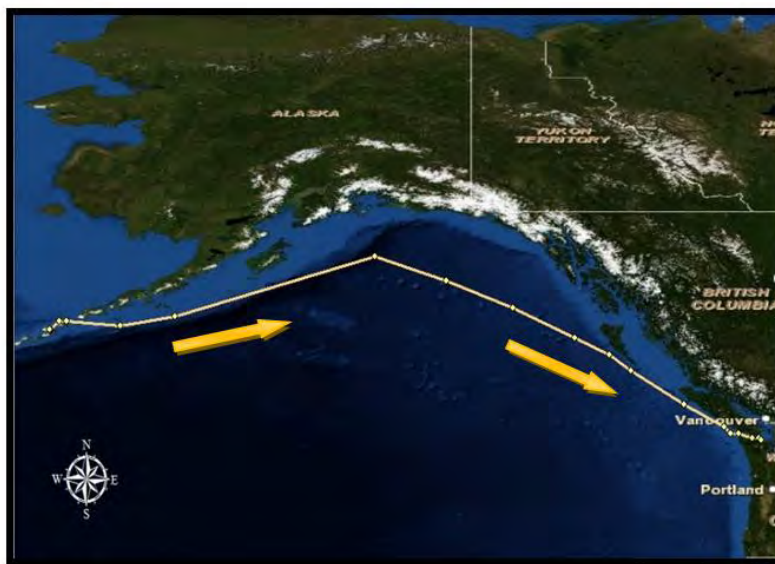
Figure 5: The December 2102 tow route for the voyage from Dutch Harbor to the Seattle area.
(USCG Developed)

21. The route selected for the tow of the KULLUK by the AIVIQ for the December 2012 voyage has been described as a “coastal” or “northerly” route. The route, comprising nearly 1,780 nautical miles, was designed to keep the KULLUK no more than 200 miles from land to allow the tow to remain within Coast Guard Helicopter range should an emergency arise where a crewmember would require medical attention.²² Use of a great circle or more direct route and shorter route for the KULLUK to the Seattle area was not chosen for this reason.

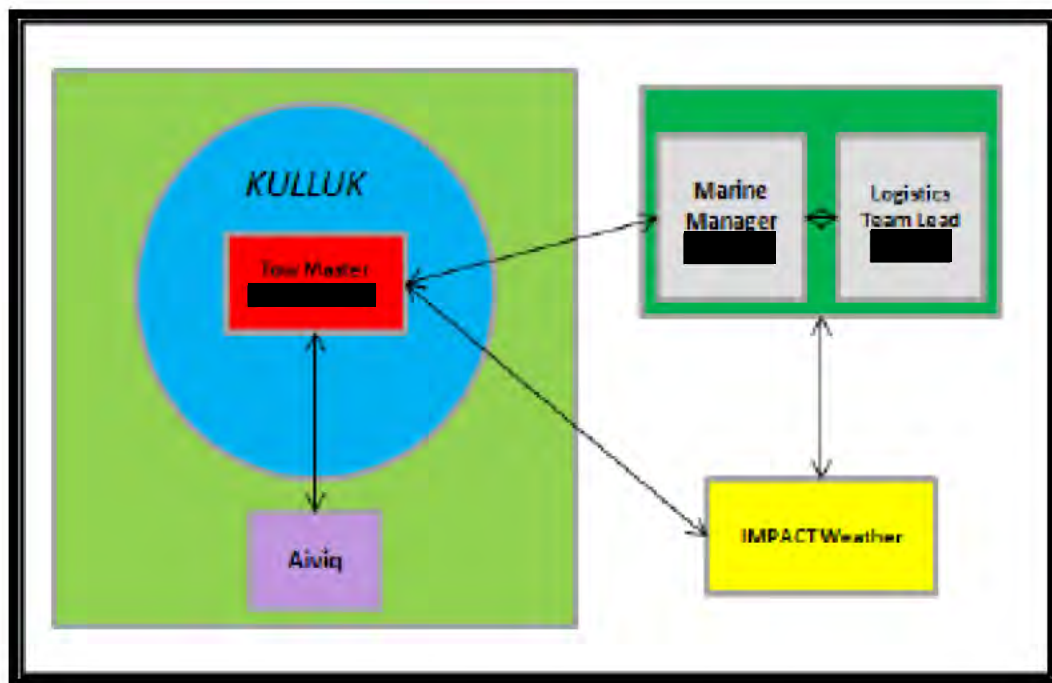
28. There are no specific roles or responsibilities contained in the Towing Plan for the AIVIQ Master, Captain [REDACTED]. He understood that the towing plan directed him to follow the instructions of the Tow Master.²⁸ Figure 6 below addresses interfaces while the KULLUK is under tow.

Figure 6: Interfaces as contained in the KULLUK towing plan dated December 21, 2012 (*Shell Tow Plan, December 21, 2012*)

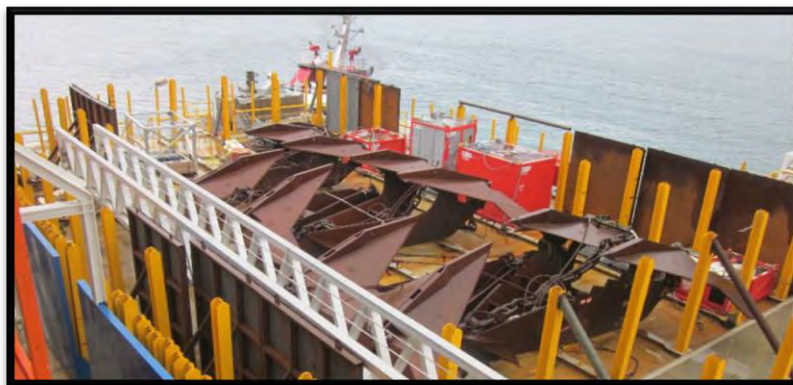
30. While not addressed in the towing plan contingencies, the KULLUK was equipped with a 15 ton “LWT” type survival anchor and the associated diesel powered anchor windlass, chain (900 feet) and ground tackle used to secure the anchor in the stored or deployed position. The additional 5 anchors specified in the plan (see above) were stored on the rig and would require the use of the onboard crane(s) for deployment. As such, they would only be available for mooring in sheltered waters or in favorable weather conditions due to the limitations in using the cranes in a higher sea state.

Figure 7: Five anchors stored aboard the KULLUK before transit. These were for use when the towing operation reached the Seattle Area while the KULLUK awaited dock space availability. (USCG Photo)

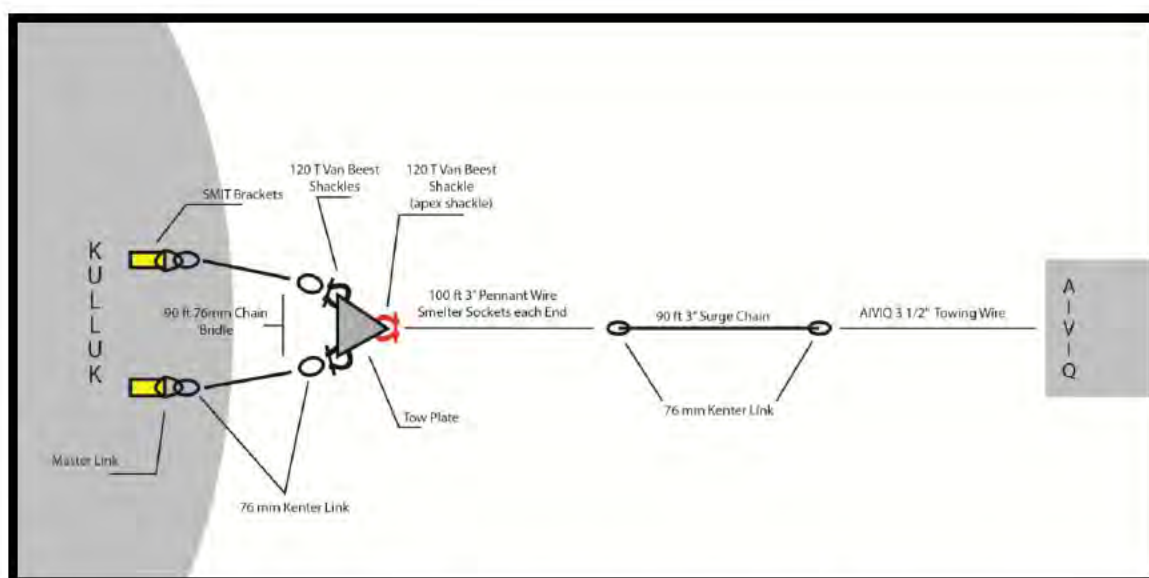
Figure 11: Diagram of towing configuration utilized in the KULLUK/ AIVIQ tows throughout 2012. (*USCG developed*)

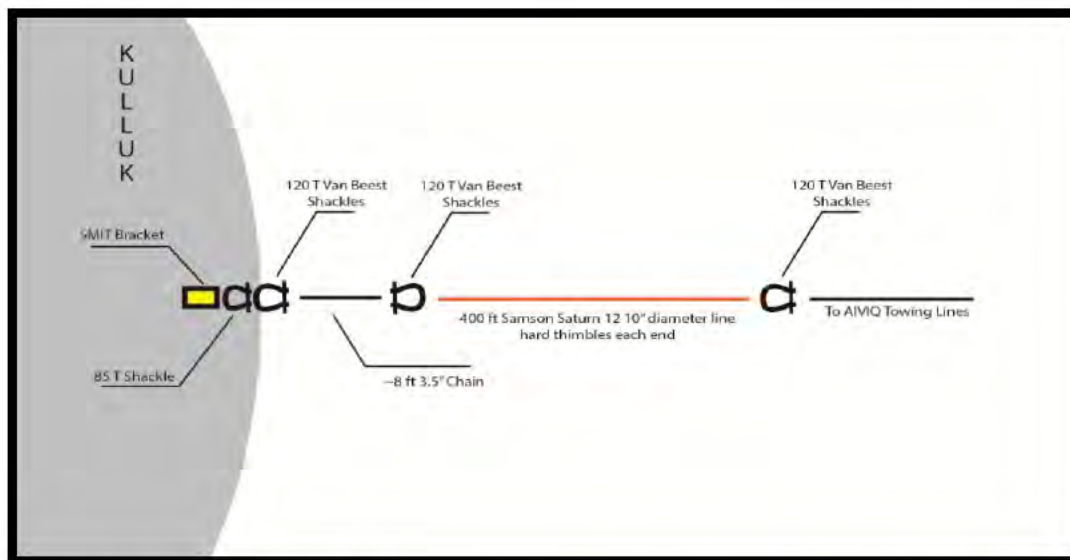
41. The KULLUK was equipped with an emergency towline, designed for use should the primary towing configuration fail. Figure 12 is based upon the actual configuration of the emergency towline configuration for the tow of the KULLUK in December 2012 as detailed in testimony from vessel crewmembers and inspection of the equipment utilized. At the terminus end of the Saturn® 12 line there is an eye with a thimble³⁷ lashed into the eye. A shackle then connected the equipment to the assisting vessels towline. The emergency towline was configured so that it could be easily deployed by the KULLUK crew as necessary.

Figure 12: Diagram of Emergency Towline as designed for use when under tow. (USCG developed)

82. Because the shackle was lost at sea, **the exact nature of the failure cannot be determined.** There are two possible causes. First, the cotter pin fastener for the shackle failed (or fell out) allowing the nut of the shackle bolt to come undone. Figure 12 shows that the cotter key was installed, and one pin was bent over to prevent failure. The second would be that the shackle failure was due to a structural failure of the metal itself, either through cyclic loading fatigue or other defect in material. The loads exerted on the shackle, in excess of 300 tons during the voyage immediately prior to the failure suggest fatigue to be a significant contributor to the failure.

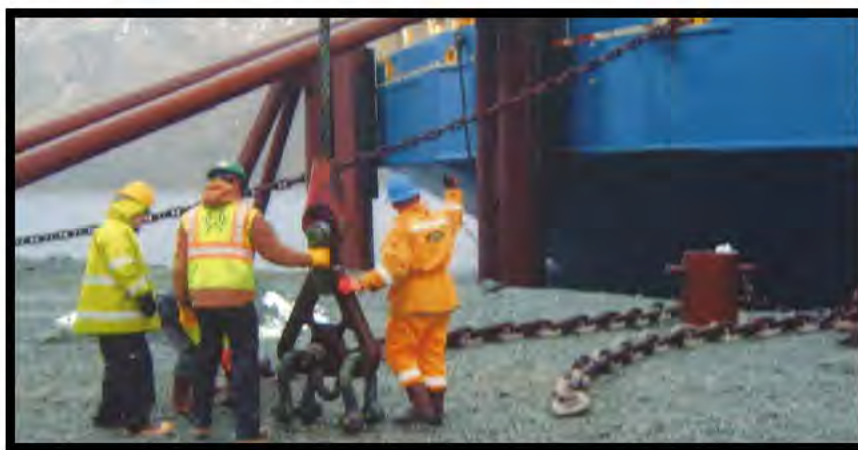
Figure 14: Preparing to Connect the Towing Plate to the Bridle Legs (Photo courtesy of GL Noble Denton, Mr. [REDACTED])

61. The evidence indicates that the 120 ton apex shackle connecting the towing pennant to the towing plate had been in the same location for all previous KULLUK tows. The evidence also indicates that the rotation of shackles to even the wear and usage of these critical components was not part of the towing plan or equipment maintenance procedures.

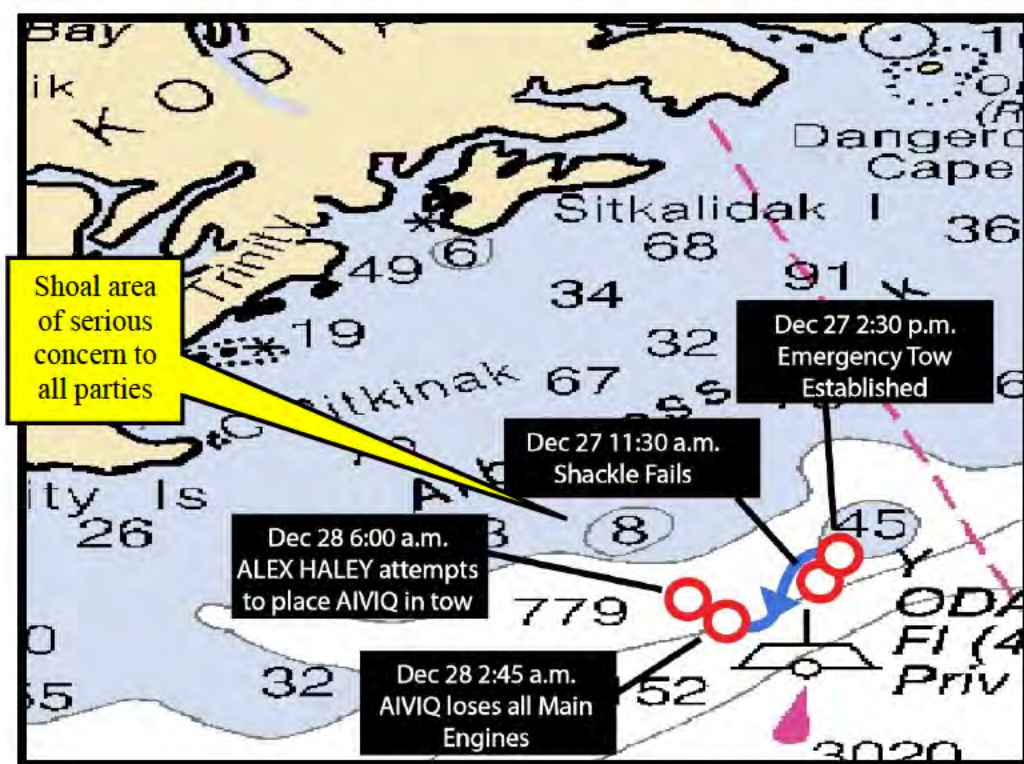
Figure 23: Diagram shows approximate locations of KULLUK between 11:30 a.m. December 27 and 6 a.m. December 28.⁶⁶ Significant events are highlighted and times are approximate. Blue line indicates general direction and location of KULLUK during this period. (USCG analysis)

96. Once the emergency tow was connected, the AIVIQ proceeded on a generally south-westerly course to keep increasing the distance away from Albatross Bank and an eight fathom shoal area (see Figure 23), which was north of their position. This shoal area was of serious concern due to the interaction of the sea and swell height and the 10.7 meter draft of the KULLUK.

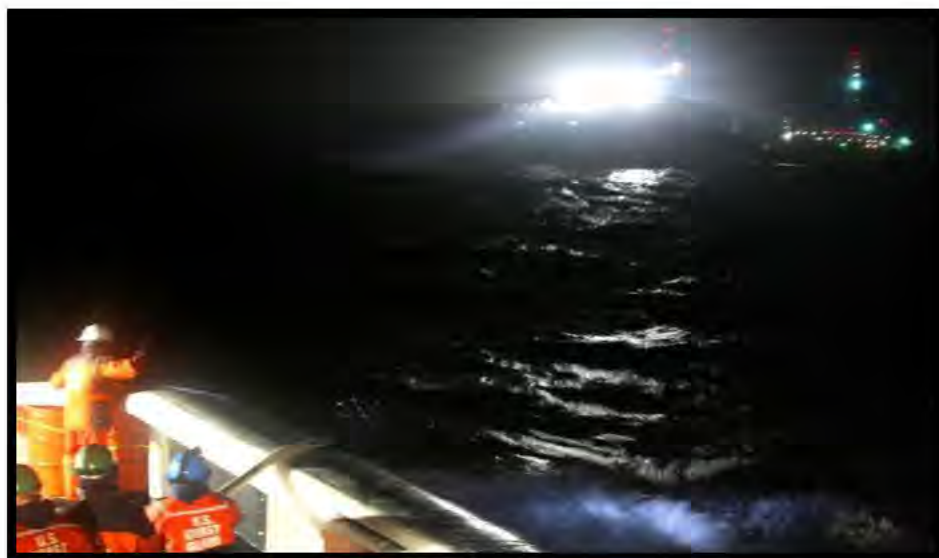
Figure 25: The crew of the USCGC Alex Haley attempt to pass the towline to the bow of the AIVIQ. Bright lights are located on the bow of the AIVIQ and the KULLUK is in the distance at the far right of the photograph. (USCG Photo)

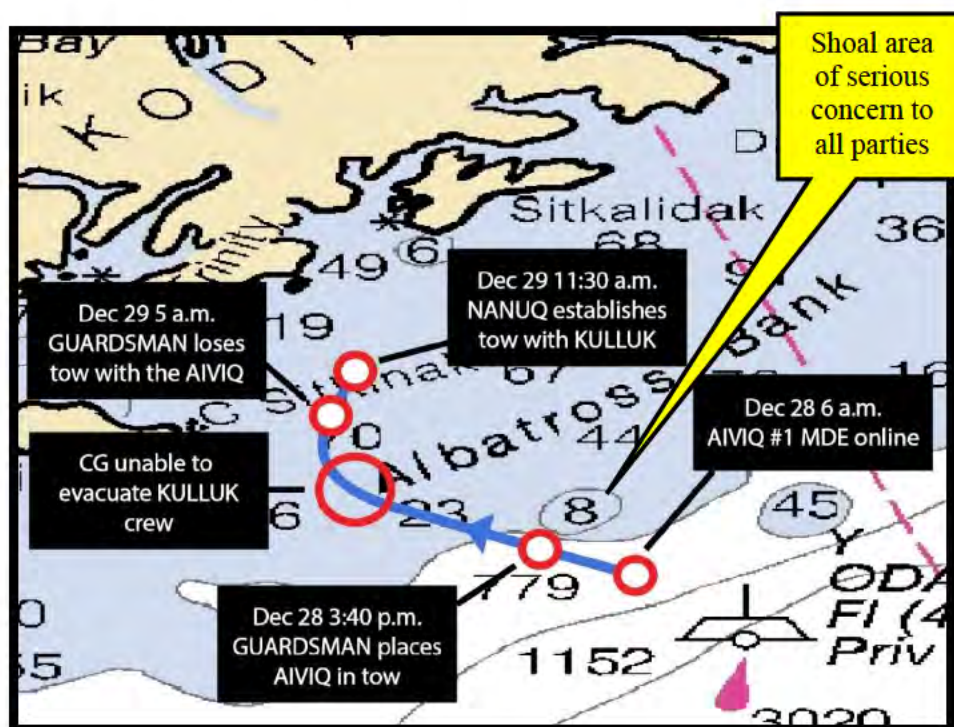
Figure 26: Diagram shows approximate locations of KULLUK between 0600 hrs December 28 and 1130 December 29. Significant events are highlighted. (USCG analysis)

113. With limited power on their #1 MDE and rotating azimuth and tunnel thrusters, the AIVIQ continued to be pulled astern by the KULLUK's wind driven drift, and the vessels were drifting slowly to the northwest. There was considerable concern that the KULLUK would drift on a marked 8 fathom area (see Figure 26), in which there was a chance that the KULLUK would ground or touch bottom in the seas. The drift of the KULLUK narrowly missed this area by approximately 8 miles, drifting to the west of this shallow bank.

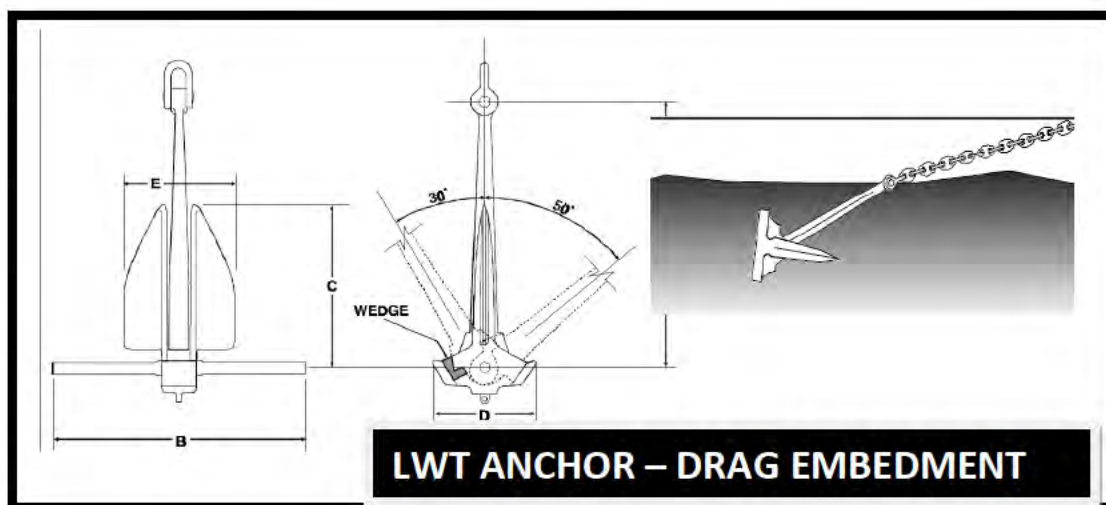
Figure 29: Diagram of a LWT anchor of a similar type carried aboard the KULLUK. The survival anchor was a 15 ton anchor. *(Diagram U.S. Navy Towing Manual composite)*

119. The KULLUK was fitted with one survival anchor which was fitted with the typical ground tackle for a ship's anchor such as hawsepipe, brake and securing device. The windlass for the anchor was located in a compartment on the KULLUK and the chain led out from the windlass onto the deck and then through a hawsepipe to the sea below. The anchor and windlass are located near the starboard quarter of the KULLUK, near the "stern" on the main deck in relatively close proximity to the helicopter deck area which was on the opposite end of the vessel from the main towing equipment, or the "bow" of the KULLUK.

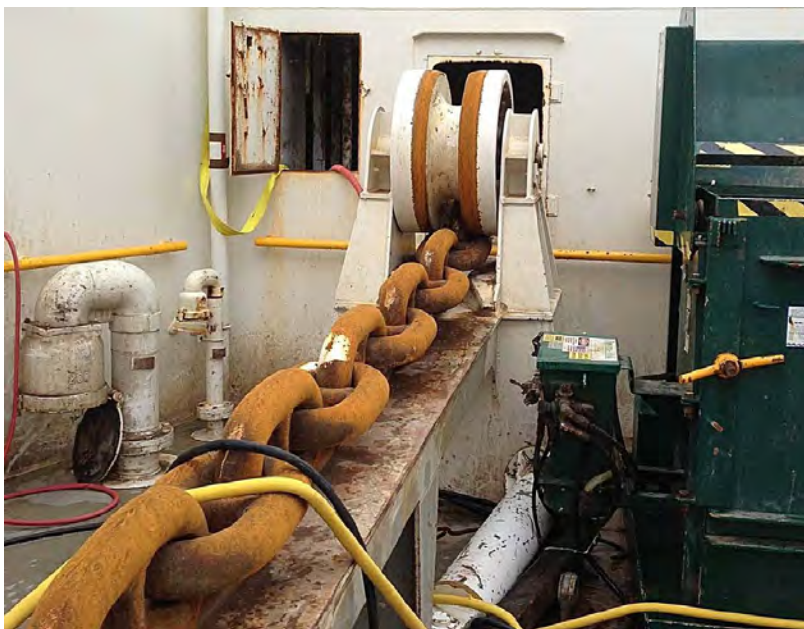
Figure 30: The anchor chain for the survival anchor leading out of the windlass room towards the hawsepipe. (Photo provided by Shell)

120. After the towing gear failure that occurred on December 27 the anchor was reported to have been dropped on two occasions. In one occasion this was as the result of a miscommunication between the KULLUK OIM and Tow Master and the crew of the KULLUK in a high stress situation. The anchor was released then quickly recovered. At this time the anchor was lowered to a reported depth of approximately two to three shots of chain or approximately 180 to 270 feet.

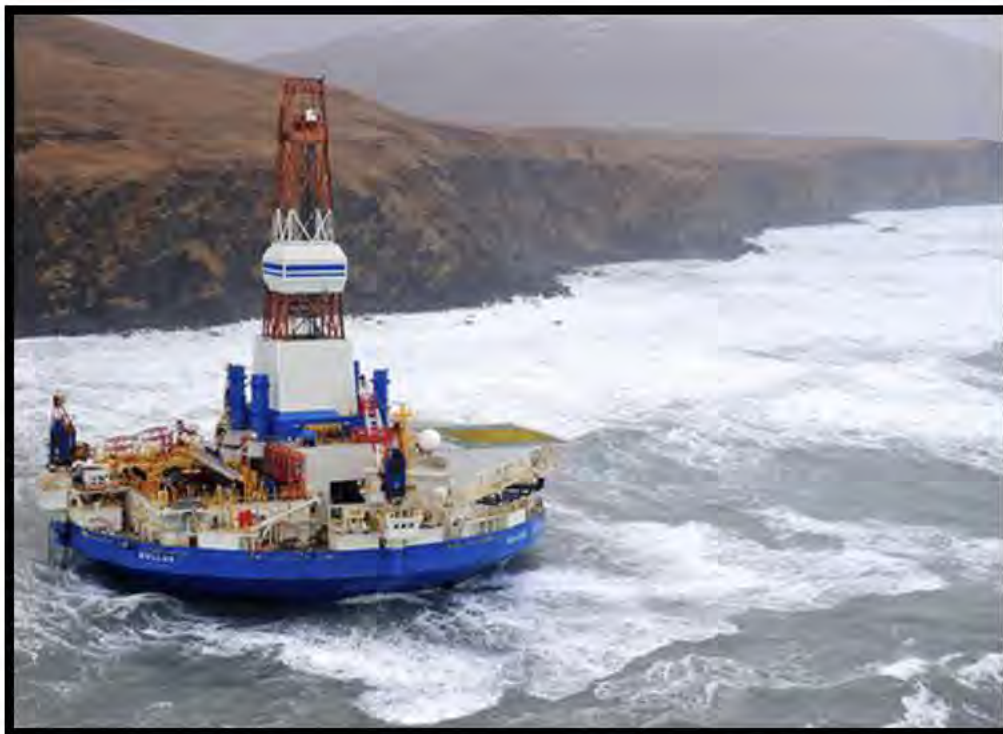
Figure 44: KULLUK grounded in Oceans Bay, Alaska. *(USCG Photo)*

164. As a result of the grounding the KULLUK sustained extensive damage. Topside and underwater inspections were conducted prior to refloating the vessel. The underwater portions of the hull sustained extensive damage due to the grounding and the action of the wave surge effects. Despite this exposure the hull retained watertight integrity. Topside damage to the rig included damage to the actual superstructure and accommodations including damaged railings, ladders, fittings, watertight doors, windows and the adjacent interior spaces. Electrical equipment

such as switchboards, distribution panels and other electrical equipment were exposed to wind driven water and immersion in seawater rendering this exposed equipment questionable for future use. Primary lifesaving equipment was torn off the rig by wave action resulting in the loss or damage to of all life rafts and most life rings. The embarkation ladders, personal flotation devices and immersion suits and firefighting equipment were also damaged. There was down flooding of seawater into numerous interior spaces including engineering spaces. The additional weight of the seawater retained aboard caused an increase in draft for the eventual move back to Dutch Harbor from Kiliuda Bay.

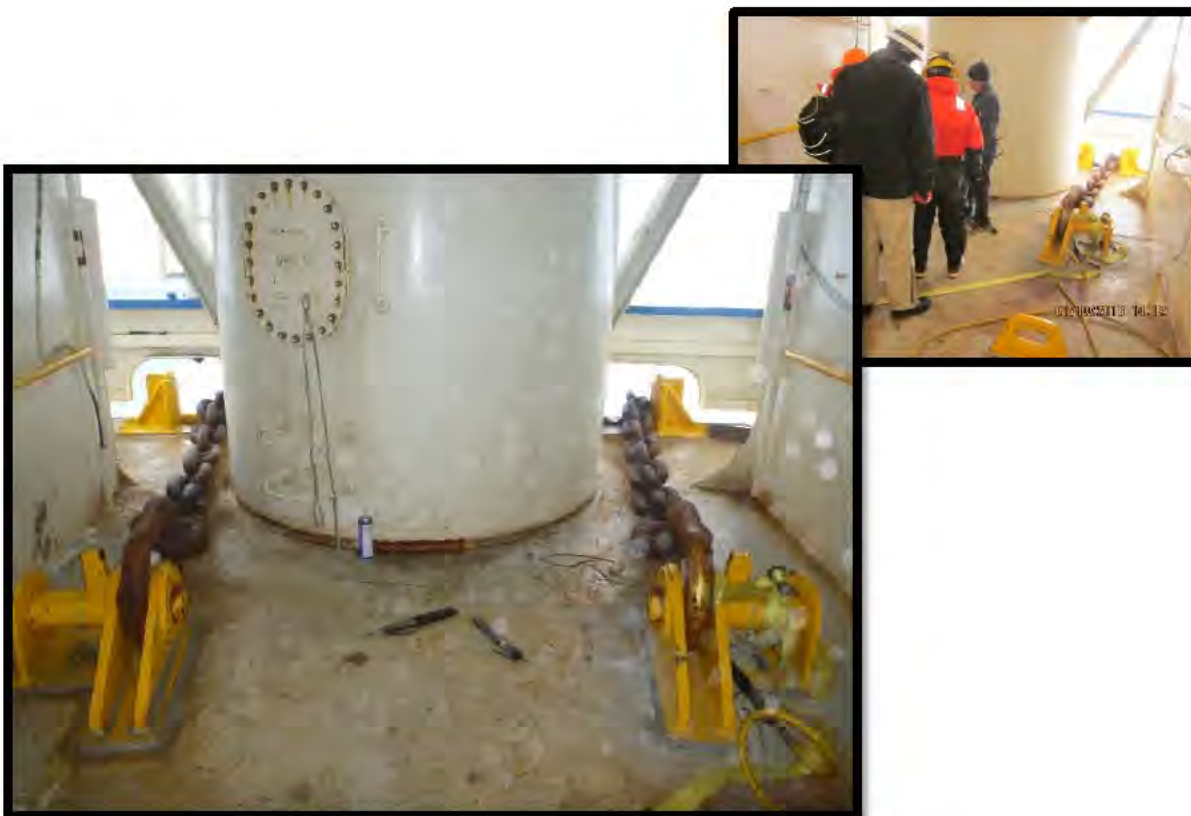
Figure 49: Photo of towing bridle connections to Smit Brackets (USCG Photo)

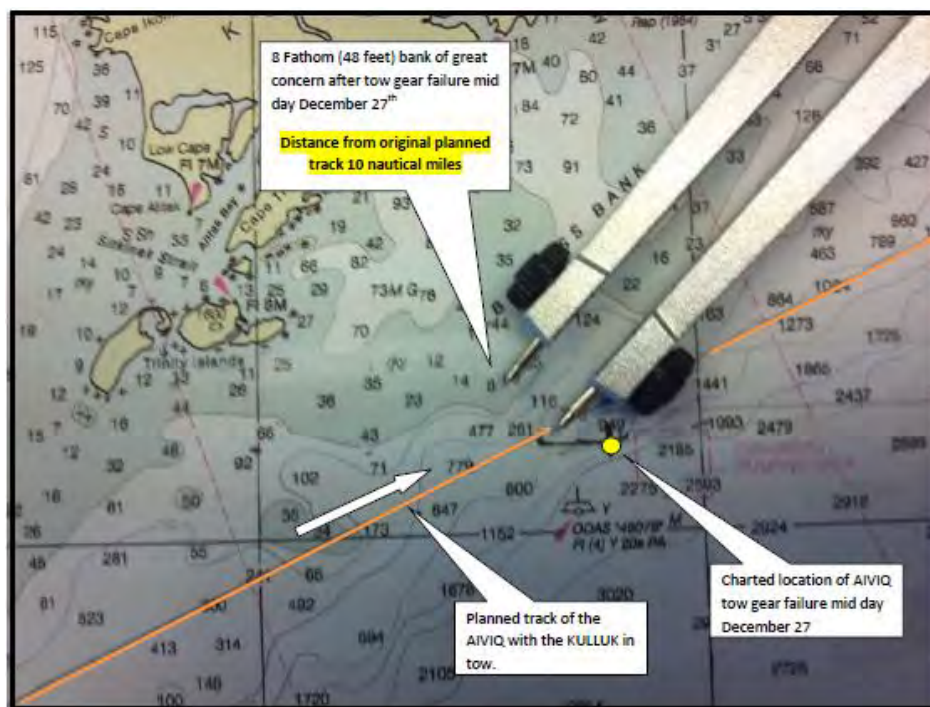
25. In hindsight, this route's proximity to shoal water and land masses proved to be a critical factor in the towing and response operations. At the time of the shackle failure, the KULLUK was approximately 40 miles from the closest point of the islands of Kodiak Island and less than 10 miles from Albatross Bank. The loss of the AIVIQ's engines and extreme weather moved the KULLUK north toward these hazards. This planned route denied the proper sea room necessary should a towline fail or the towing vessel experience a mechanical breakdown, particularly with no assistance or additional towing vessels onsite. Additionally, should the tow need to heave to in the event of a weather event, there was little safe water available to ride out storms.

Figure 50: Chart showing planned track line for towing of KULLUK demonstrating close approaches to land and other hazards. (USCG Developed)

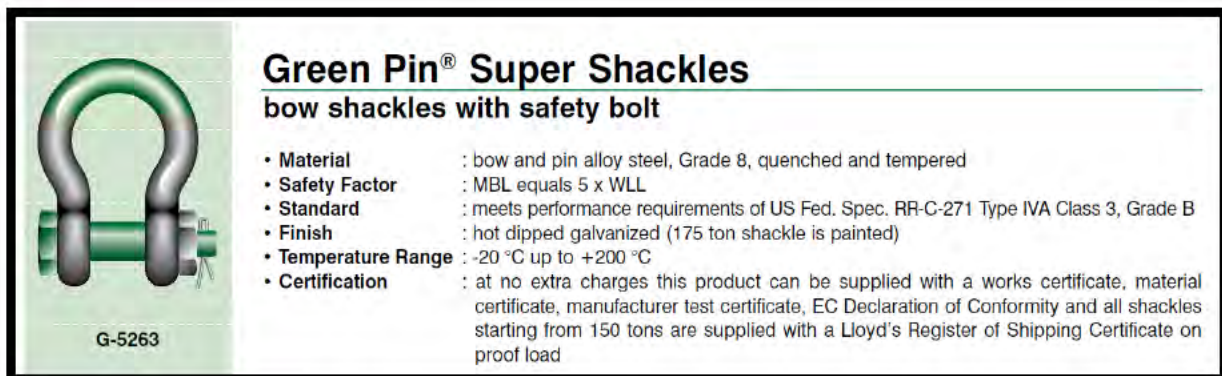
38. The apex shackle that failed at approximately 1135 on December 27 has been identified as a Van Beest Green Pin Super Shackle.⁹⁵ It was one of six that were incorporated into the tow to replace the 85 ton shackles originally intended. As all the remaining 5 shackles were from the same "YP" manufacturing batch, it is assumed that the missing shackle is of that batch as well. During the investigation, Shell provided documentation that suggests that these "YP" batch shackles were purchased from Van Beest in 2007.⁹⁶ The work and usage history of the shackles could not be definitively ascertained, other than they were incorporated as part of the KULLUK towing configuration since July of 2012. Testimony suggests that these shackles may not have seen usage prior to this time.

Figure 54: Description of Van Beest Green Pin Super Shackles from the manufacturer's catalog. (*Van Beest product catalog available on the internet*)

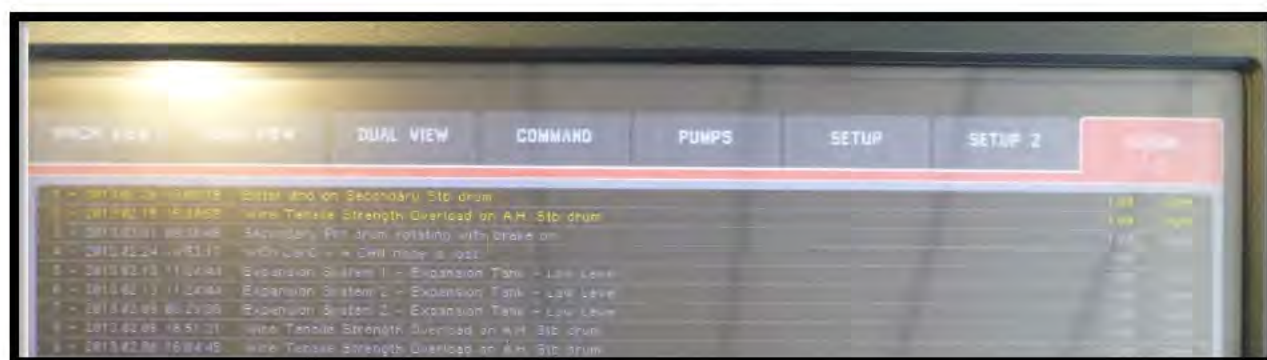
Figure 59: Towcon alarm screen indicating alarms received on the bridge monitor, requiring acknowledgement of the bridge officers. Alarms indicated are for a later time period than investigation scope. (USCG Photo)

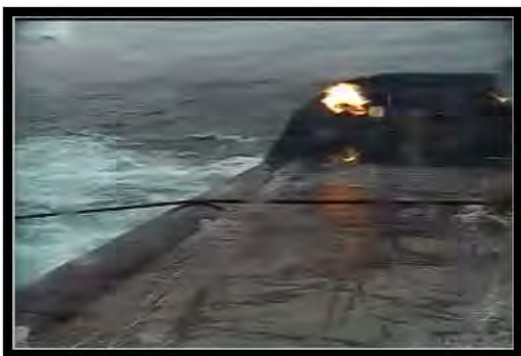
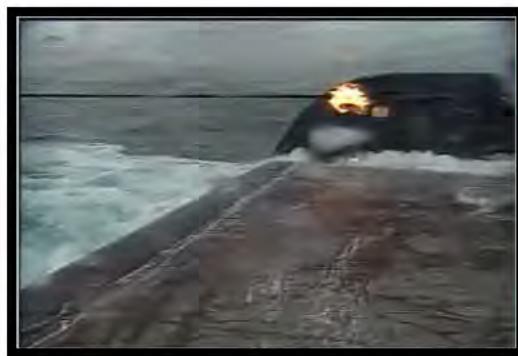
Figure 61: Starboard aft CCTV stills showing fluctuations in towline tension. Still on left shows lower tension at 10:12:42. Still on right shows high tension at 10:12:48. (*AIVIQ CCTV Provided by ECO*)

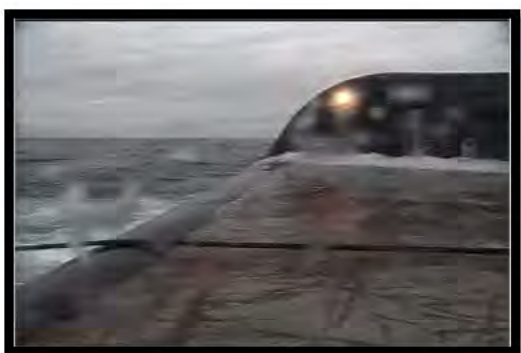
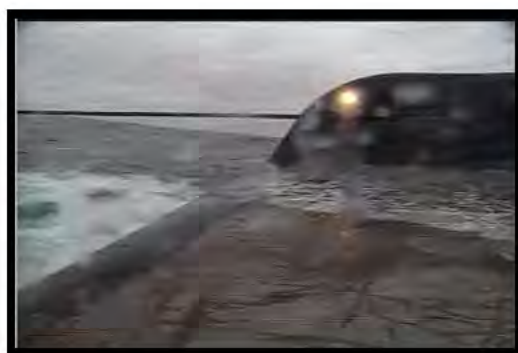
Figure 62: Starboard aft CCTV stills showing fluctuations in towline tension. Still on left shows lower tension at 11:17:14. Still on right shows high tension at 11:17:18. (*AIVIQ CCTV Provided by ECO*)

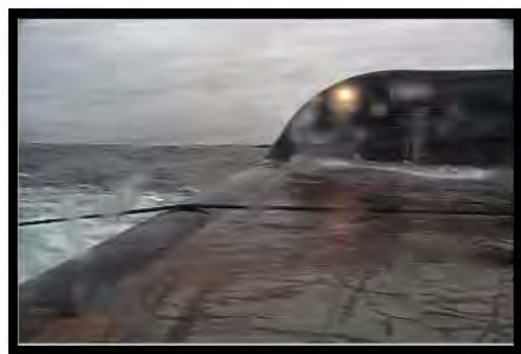
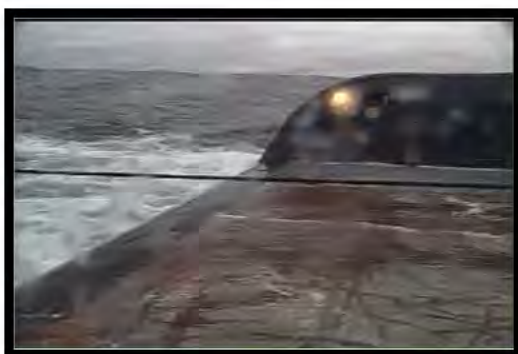
Figure 63: Starboard aft CCTV stills showing fluctuations in towline tension. Still on left shows lower tension at 11:31:49. Still on right shows high tension at 11:31:58. (*AIVIQ CCTV Provided by ECO*)

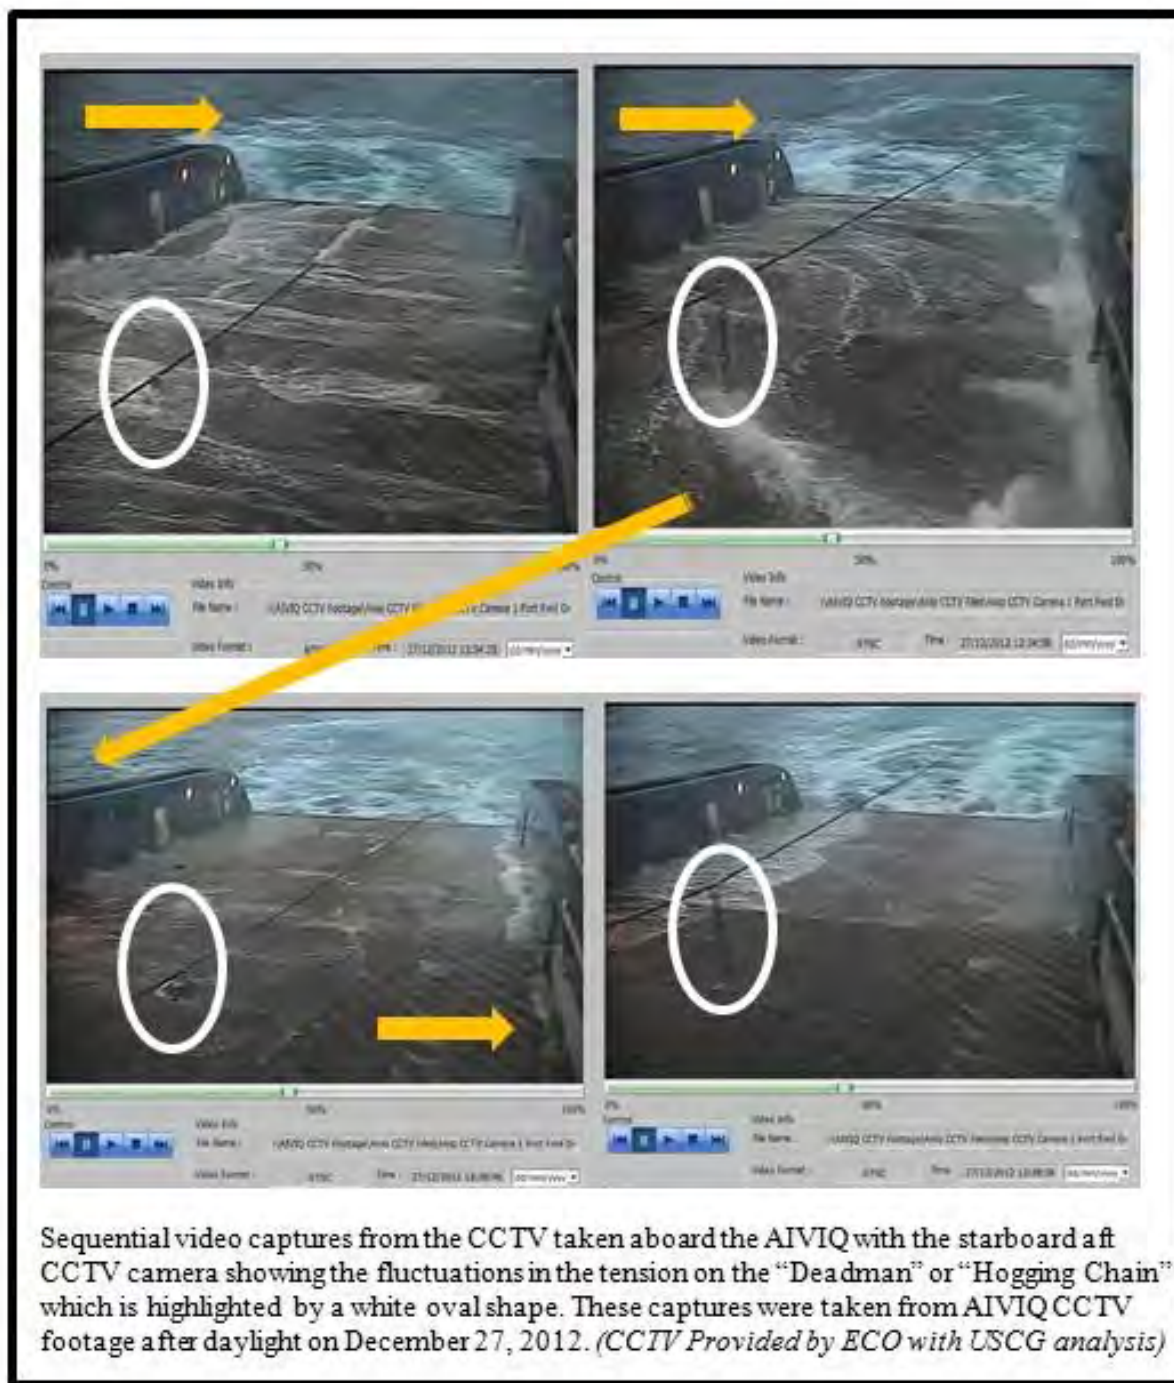
Figure 66 – Movement of the Deadman or Hogging Chain aboard the AIVIQ on the morning of December 27, 2012.

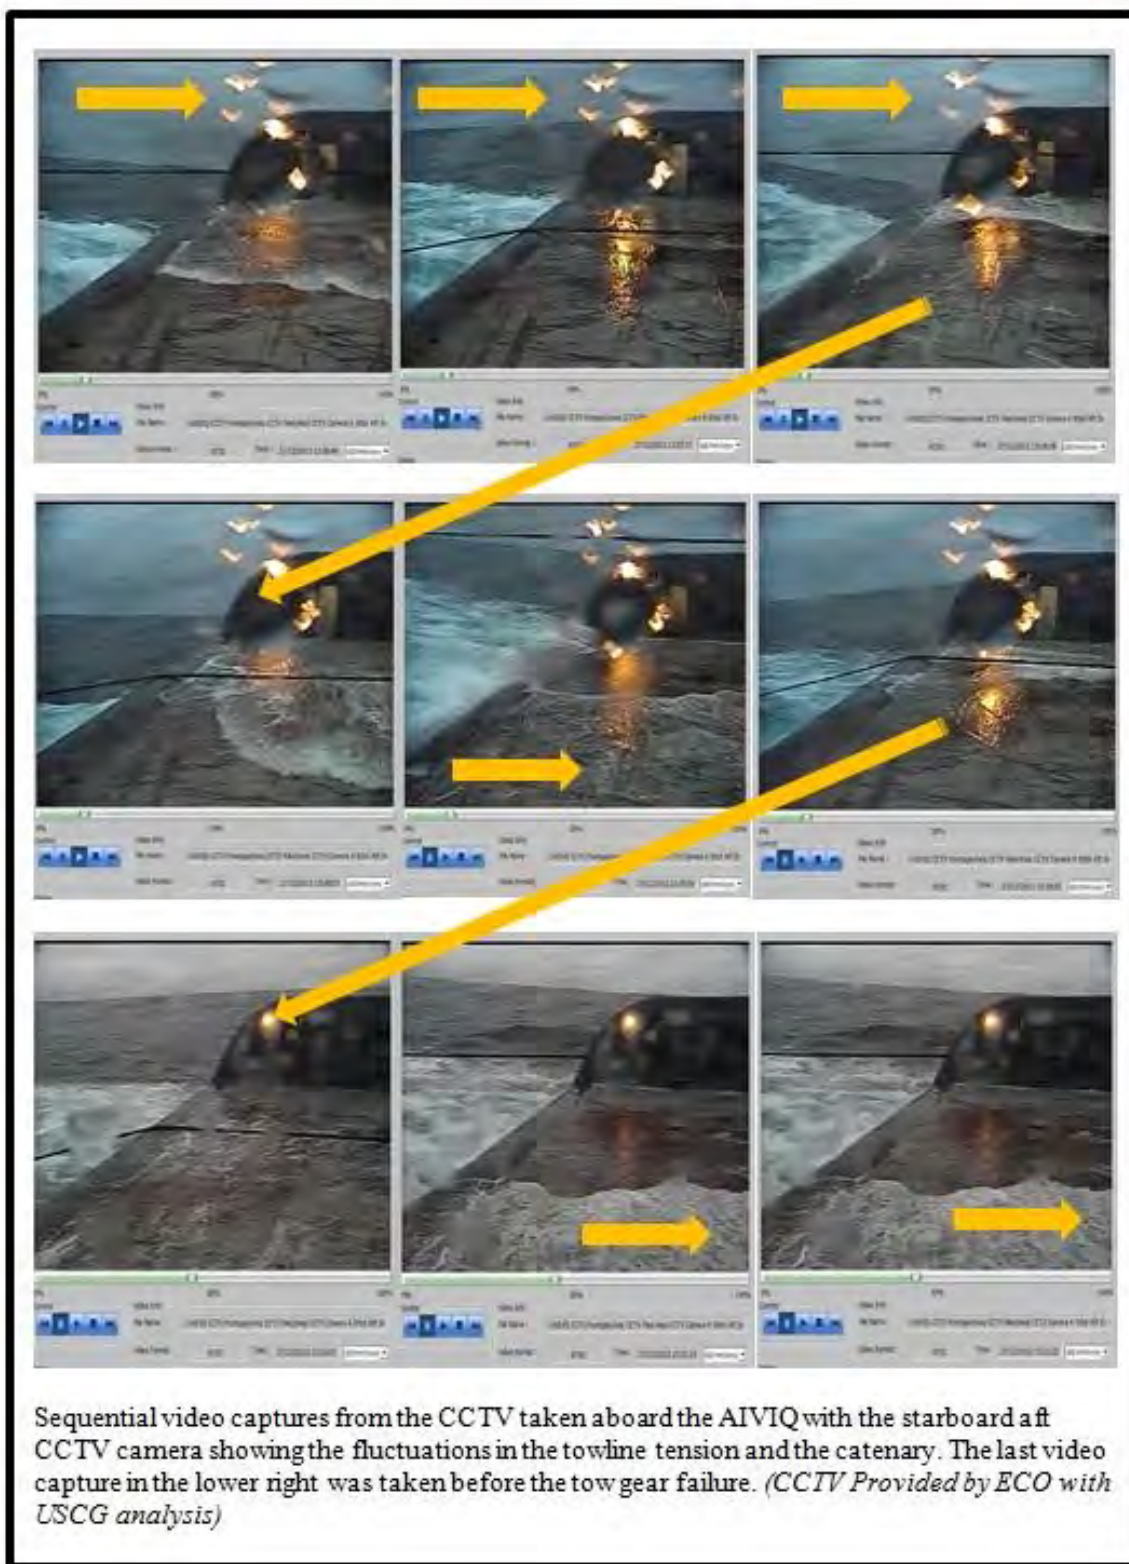
Figure 67 – Movement of AIVIQ towline and tension on the line on the morning of December 27, 2012.

78. As configured, the shackle that failed incurred the full load of the towline between the KULLUK and AIVIQ. The bridle shackles on either side of the towing plate generally shared the load. From the findings, the tow winch strain monitoring system logged 38 separate occasions during the morning of December 27 of towline loading over 300 tons. Additionally, video evidence from the 3rd Mate [REDACTED] on watch shows load fluctuations from 28 to 228 tons within the period of a few seconds, providing further proof of extreme fluctuations in the towline tension while towing the KULLUK. This event would not be logged in the towing system, so it is unknown on how many occasions the readings were high but went unrecorded as an alarm as they did not meet the 300 ton alarm threshold.

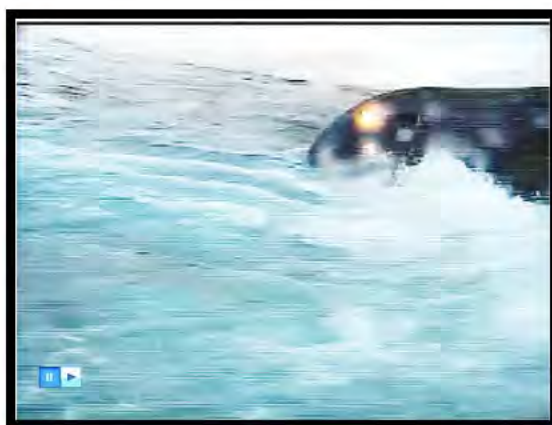
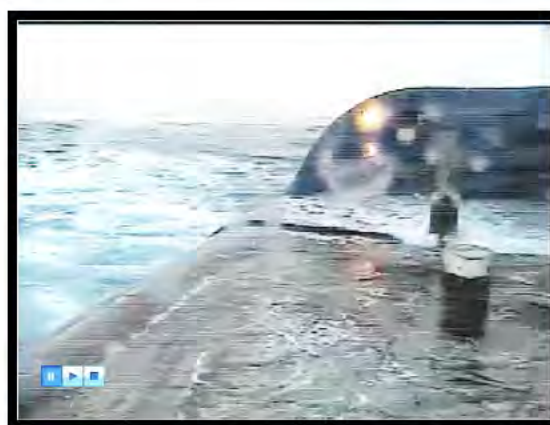
97. Analysis of the CCTV footage shows that between the hours of 1400 and 2400 on December 27, the AIVIQ routinely took water onto the aft working deck in a nature similar to the stills contained as Figure 70 and 71. This would create an environment whereby the tank vents, located in the safety deck area would be subject to water immersion, potentially being completely submerged at times. Any failure of the check type vents would allow water into the common vent/overflow header.

Figure 70: (left) Still from Starboard Stern CCTV showing seawater flowing over aft working deck and entering safety deck area at 15:16:47 on December 27. (right) Safety deck area at 15:16:55 after water clears from deck. Port side aft safety deck hatchway is visible. *(AIVIQ CCTV Provided by ECO)*

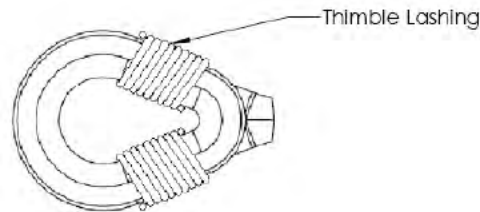
118. The failure of the apex shackle was discussed previously in the analysis. The emergency towline was a capable 400 foot line, possessing a breaking strength of over 400 tons. Testimony indicates that the AIVIQ attempted to maintain a lower tension on the line during the course of the tow, and Towcon data retrieved for the time period indicate that the tension never reached 300 tons during usage of the line. The failure occurred at the AIVIQ side of the towline at the eye end of the emergency towline. Codura® chaff protection was provided in the area of the eyes in the end of the towline consisting of the abrasion resistant material around the line itself and a steel thimble held in place with lashings as detailed in the illustration below.

Figure 74: Diagram of the end of the emergency towline with Codura® abrasion protection and metal thimble lashed into place (*Courtesy of the Sampson Rope Technologies, Inc.*)

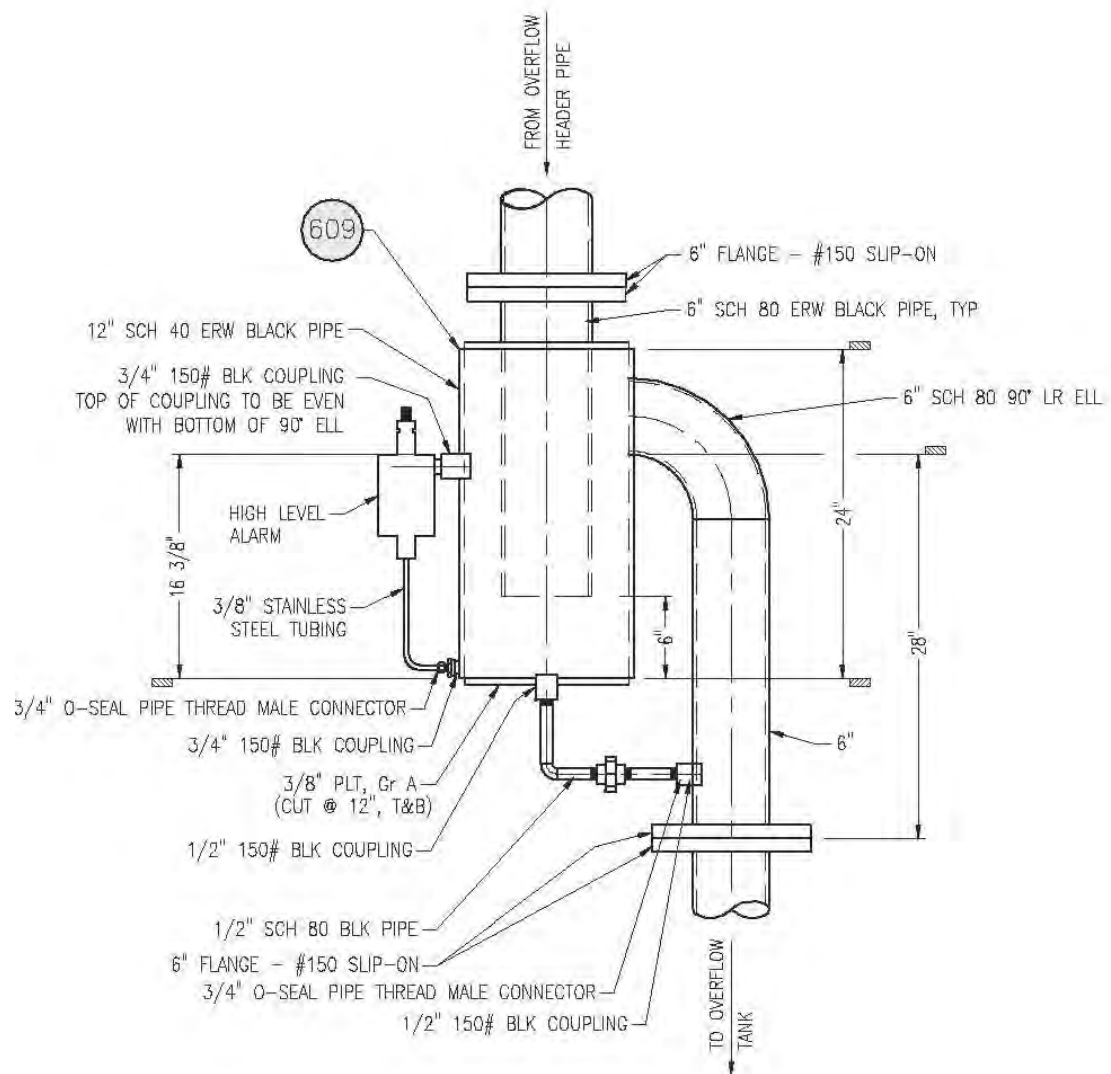
- ii. Reference (q) shows an overflow alarm sensor arrangement (see Figure 1). The 8-inch vent/overflow headers are each reduced to 6-inch pipe prior to reaching the overflow alarm sensor arrangement. Per references (e) and (f), the crew experienced many problems with the fuel oil vent/overflow alarm system prior to the casualty.

Figure 1 - Fuel Oil Overflow Alarm Sensor Arrangement (Source: reference (q))

- iv. Reference (f) shows the circuit breaker for the fuel oil vent/overflow alarm was opened during the Midnight to Noon watch on 12/26/2012. In reference (c), the Chief Engineer indicated that during rough seas, with a full load of fuel, a certain amount of fuel would overflow into the FO Overflow Tank. If seawater entered the vent and overflow system, it would cause an overflow alarm condition.
