THE BUREAU OF OCEAN ENERGY MANAGEMENT,
REGULATION AND ENFORCEMENT

REPORT REGARDING THE CAUSES OF THE APRIL 20, 2010
MACONDO WELL BLOWOUT

September 14, 2011

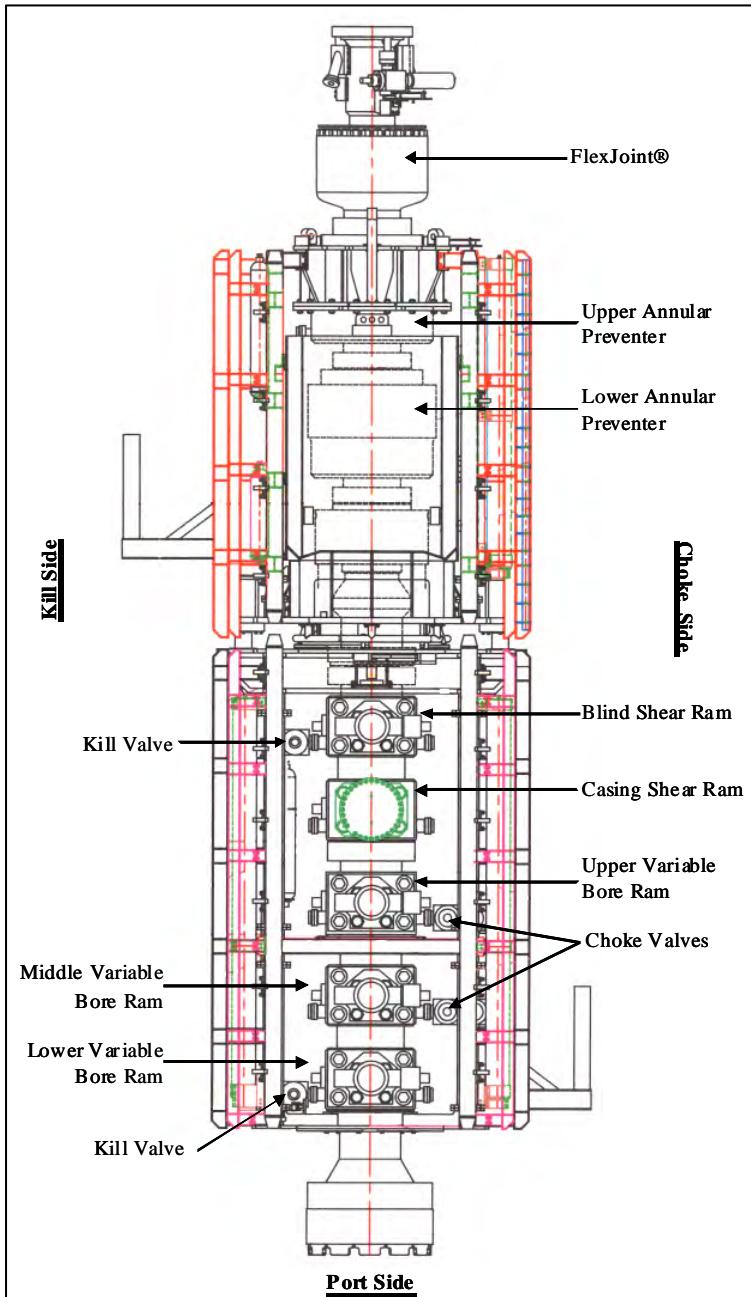
The *Deepwater Horizon* BOP assembly consisted of two major sections: the stack and the lower marine riser package (see Figure 10). At the time of the blowout, the major components of the *Deepwater Horizon* main stack consisted of the following:

Figure 10 – Schematic of the *Deepwater Horizon* BOP Stack
