## Macondo Well Deepwater Horizon Blowout: Lessons for Improving Offshore Drilling Safety

# Macondo Well *Deepwater Horizon* Blowout

LESSONS FOR IMPROVING  
OFFSHORE DRILLING SAFETY

Committee on the Analysis of Causes of the  
*Deepwater Horizon* Explosion, Fire, and Oil Spill to  
Identify Measures to Prevent Similar Accidents in the Future

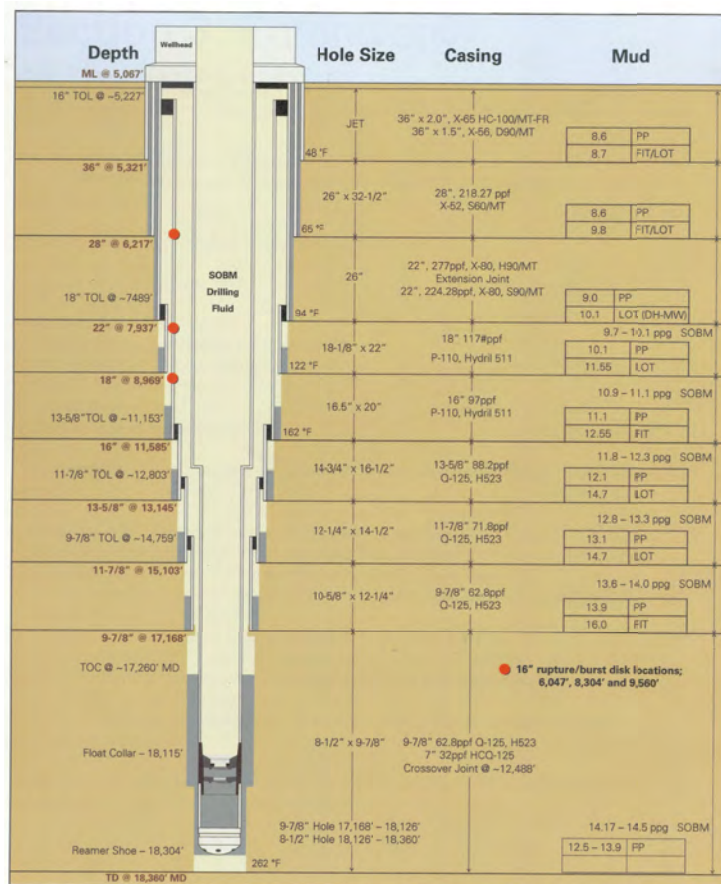
**FIGURE 2-2** Final wellbore architecture for Macondo well. Source: BP 2010, p. 19. Reprinted with permission; copyright 2010, BP.

occurred. The shallowest possible escape point would have been 7,937 feet had a rupture disc and the top of the 18-inch liner failed (see Figure 2-2). This is about 2,937 feet below the ocean floor. Depending on the flow rate, pressure, and formation type, flow at this point might find a pathway to the ocean floor and cause a breach outside of the well. Therefore, a more robust design from a downhole blowout point of view would be to lower the possible point of escape from the wellbore to a deeper point where eventual breaching at the seafloor is impossible or at least very unlikely. This could be done by running a deeper casing string as a long string rather than as a liner and sealing it in the wellhead.

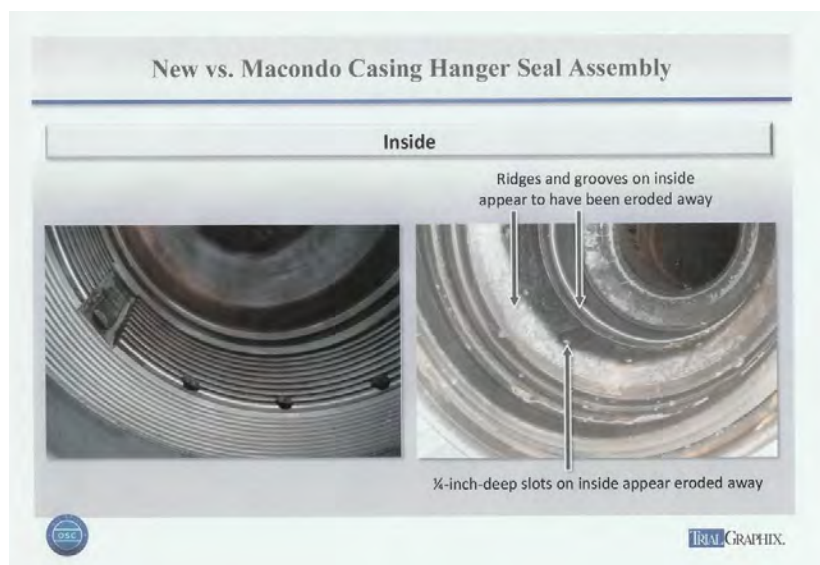
**FIGURE 2-9** View inside casing hanger. Source: Presidential Commission 2010, Slide 118.

This type of circulation was not done completely at the Macondo well to reduce the possibility of exceeding the fracture pressure because of unforeseen pressure surges. This decision by BP also cut down on the time spent circulating. Failure to perform the minimum circulation could leave debris inside the casing or annulus that may plug it. Any hydrocarbons in the annulus may result in a well control problem.

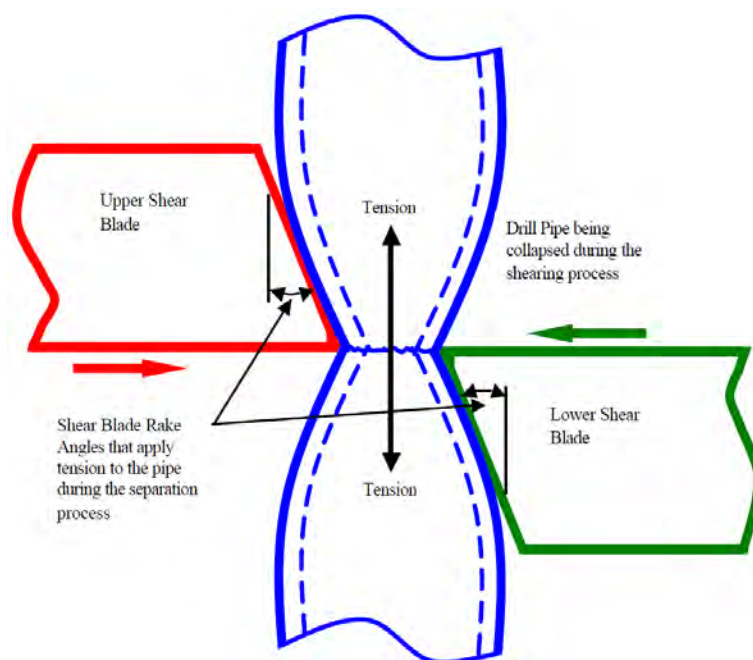
**FIGURE 3-3** Upper and lower shear blades crushing the drill pipe and beginning the shearing (or breaking) operation. Source: West Engineering Services, Inc. 2004, p. 2-2. Reprinted with permission; copyright 2004, West Engineering Services, Inc.

- In the cutting process, the shear rams collapse or mash the pipe, and as the pipe is crushed, the blade angle pulls the metal into tension and breaks it in a tensile mode of failure (Figure 3-3). Depending on the ram blade design, the blade can flatten the pipe to a great extent, which in turn can prevent the ram from closing completely and sealing even if the pipe is centered.

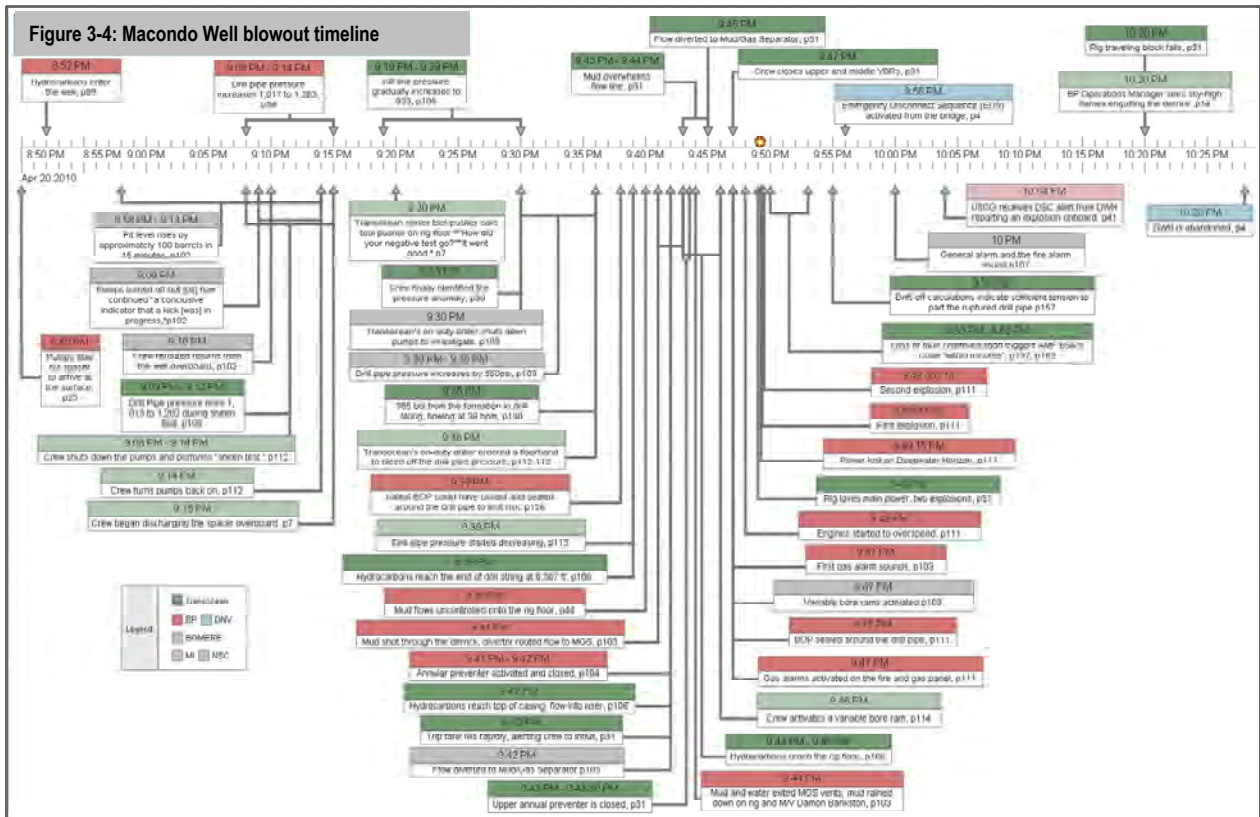
FIGURE 3-4 Macondo well blowout timeline. Source: Committee.

***Summary Finding 3.1:*** The loss of well control was not noted until more than 50 minutes after hydrocarbon flow from the formation started (see timeline in Figure 3-4), and attempts to regain control by using the BOP were unsuccessful. The BSR failed to sever the drill pipe and seal the well properly, and the EDS failed to separate the lower marine riser and the *Deepwater Horizon* from the well.

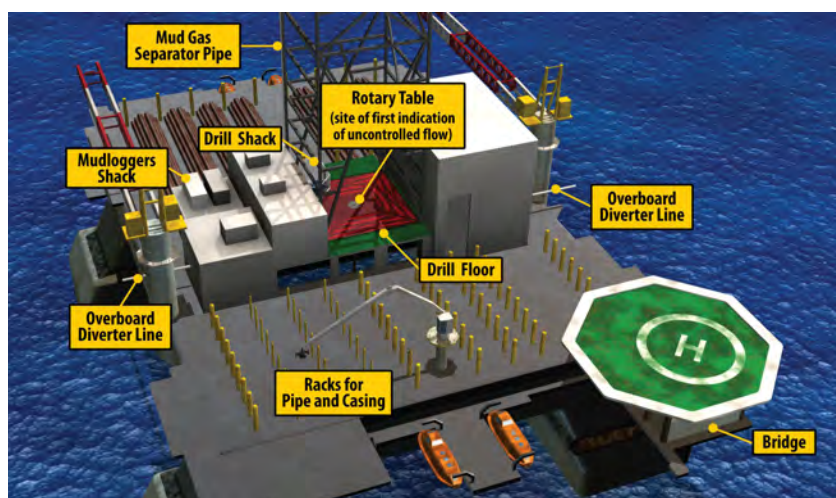
The only path, other than straight up through the derrick or through the MGS system vents, through which uncontrolled hydrocarbon flow could have been directed is through 14-inch diverter lines, which were positioned to send the flow overboard at about derrick floor level (see Figure 4-2). Testimony cited above indicates that this did not occur, and why there was no hydrocarbon flow along that path remains an unresolved question.<sup>10</sup> According to BP's analysis, the overboard diverter flow of hydrocarbons might have delayed the formation of the explosive cloud that surrounded the rig (BP 2010, 128).
