# SAFETY ALERT

## WORK PLATFORM DROPPED INTO SEA

ALERT 8-20

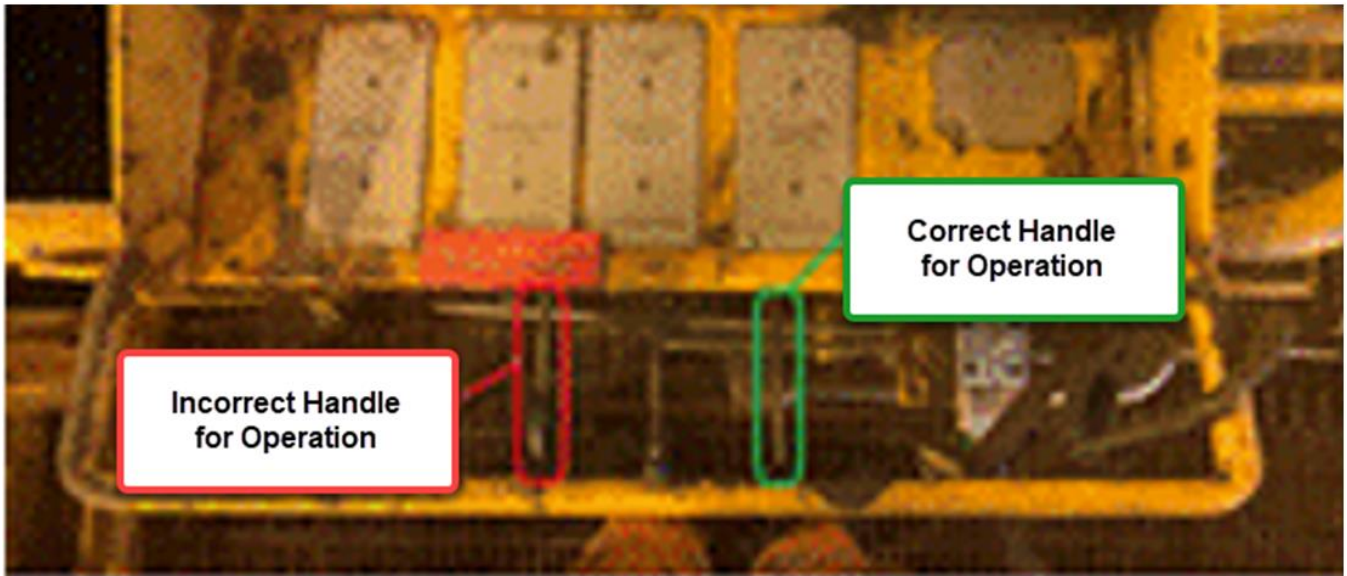
While maneuvering the BOP trolley work platform, the platform operator intended to move the platform closer to the riser, but inadvertently activated the wrong lever on the control panel. This action released the work platform securing pins, dropping the platform into the sea. Two personnel were on the platform when it was accidentally released and were restrained by their Self Retracting Lifelines (SRLs) and retrieved without injury. *(Images on Pages 2, 3)*

The control panel is of poor ergonomic design, with the securing pin retraction and trolley travel control levers being of similar look, size and design and housed together in a bank of levers. In addition, the orientation of the panel is such that the operator is facing the opposite direction (to the controls) when looking at the work area. To sum, the design of the working platform did not eliminate the risk of platform dropping to sea, thus prevention measures were reliant on operational procedures.

Following this incident, an engineering solution has been designed that prevents the trolley platform from falling in the event the platform securing pins are inadvertently released. It is recommended that all members review support mechanism on any similar platforms to ensure the design is such that accidental release of pins will not result in an uncontrolled drop of the platform.

Until engineered solutions have been implemented across the fleet, rigs are recommended to review procedures, work plans, work tempo and task-based risk assessments to ensure sufficient risk controls are in place. Simple interim measures should include the installation of a manually operated isolation valve, capable of being locked out, to prevent inadvertent functioning of the platform securing pins.
