SAFETY ALERT

Uncontrolled release of Hydraulic Gooseneck Ring

ALERT 6-21

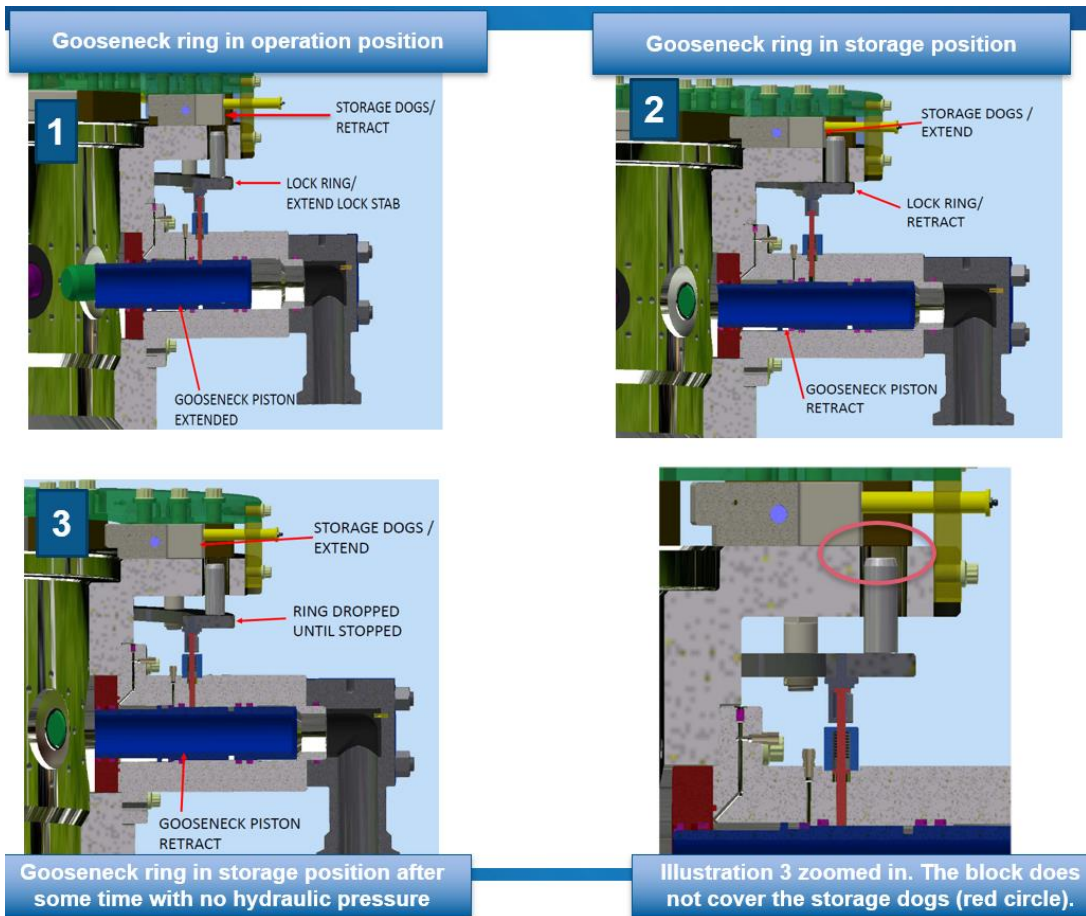
During pulling of the BOP, the gooseneck ring dropped from its storing position on the tension ring and landed on the flex joint. When the BOP entered the splash zone, it experienced less resistance from the air compared to the sea. This, combined with some rig movement, created a pendulum effect when the BOP was almost out of the splash zone, resulting in the riser colliding with the gooseneck ring, and the gooseneck ring dropping onto the flex joint. Immediately after the gooseneck ring dropped, the BOP was raised clear of the splash zone and secured in the under-hull guides. The dropped gooseneck ring affected the integrity of the storage dogs and storage dog locking mechanism and resulted in downtime.

Fig-6: Tension Ring. The gooseneck ring is stored onto the tension ring by extending all storage dogs into a profile on the tension ring.
