Nitrogen Cylinder Rupture

Alert 25-3

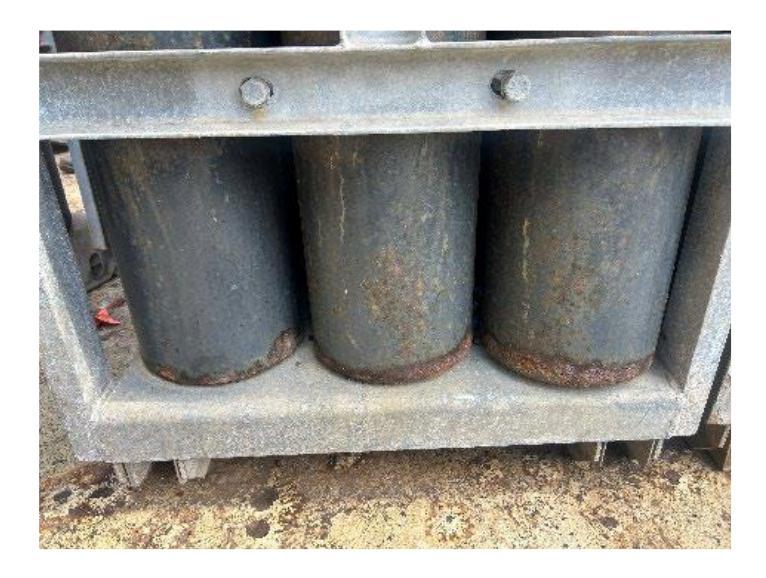
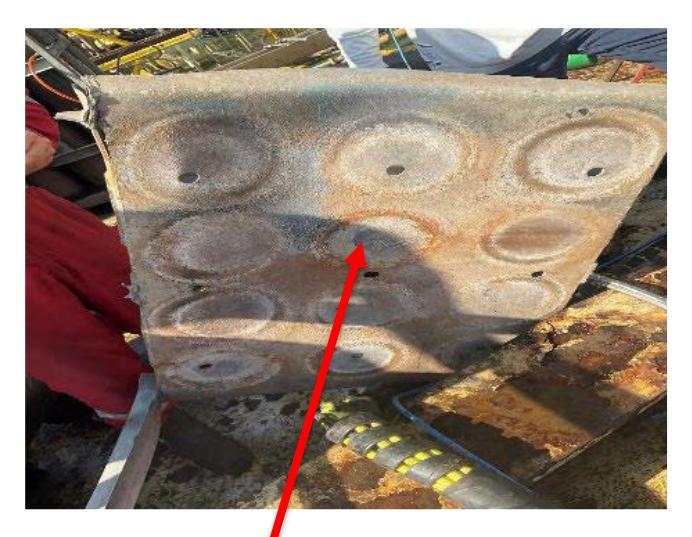
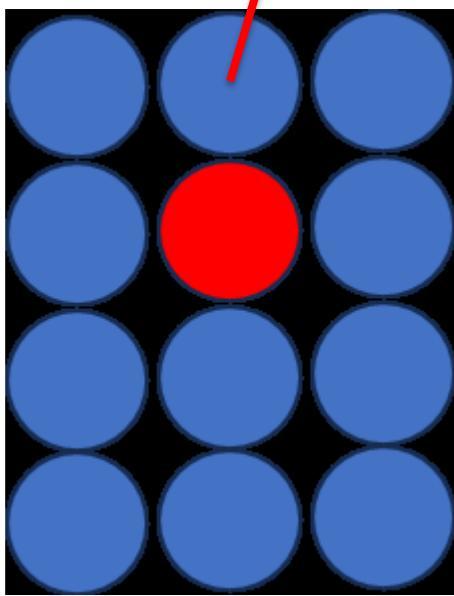
Initial findings indicate the cylinder rupture was the result of exterior wall loss. Investigation is ongoing and results will be shared upon completion.

- The base of the cylinder that ruptured was heavily corroded.
- Other cylinders in the quad had evidence of similar but less severe corrosion.
- Despite compliance with the Department of Transportation (DOT) special permit regulations, deficiencies in the design and material of the racks contributed to this event. This exposed the limitations of current inspection protocols and the susceptibility of cylinder integrity to the marine environment.

The cylinder that ruptured was located in the middle of the quad and therefore not easy to thoroughly inspect without disassembly of the quad.
